STAR ONLINE PUBLICATION

Case Number: S2608000006 Rev. B

Models Affected: 2026 Jeep Cherokee (KM)

Symptom/Vehicle Issue: Limp Home Mode, Red Wrench Lamp Illuminated. DTCs P0C01-00 - Drive Motor A Current High And/Or P0C04-00 - Drive Motor B Current High

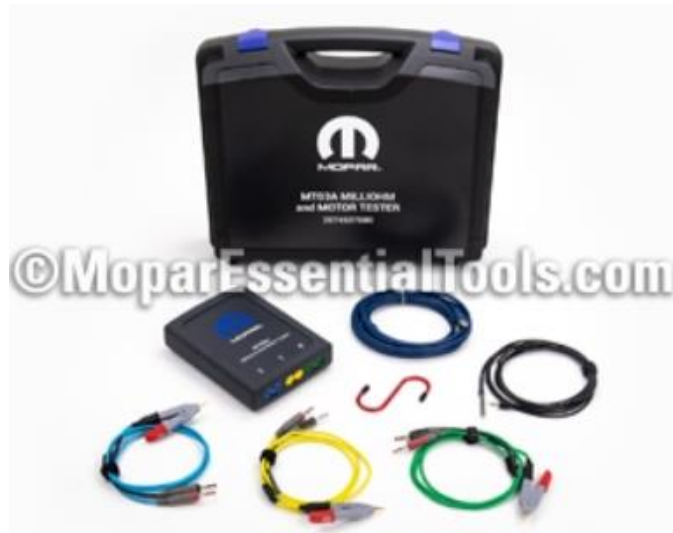
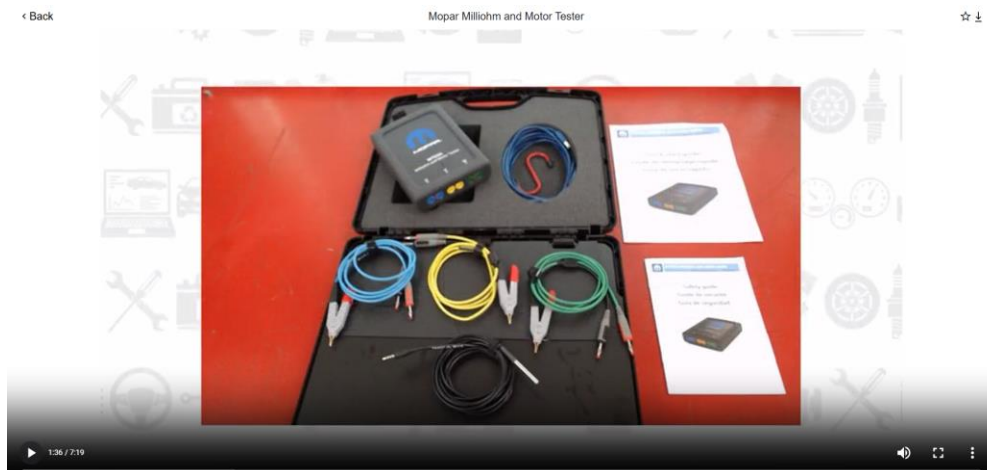
Mopar Pico Milliohm and Motor Test Kit (Tool # 2074507080)

If visual inspection does not clearly identify the issue. You will need to measure resistance values of the motors in Milliohms (0.001 Ohms). This will require the use of Mopar Pico Milliohm and Motor Test Kit (Tool #: 2074507080).

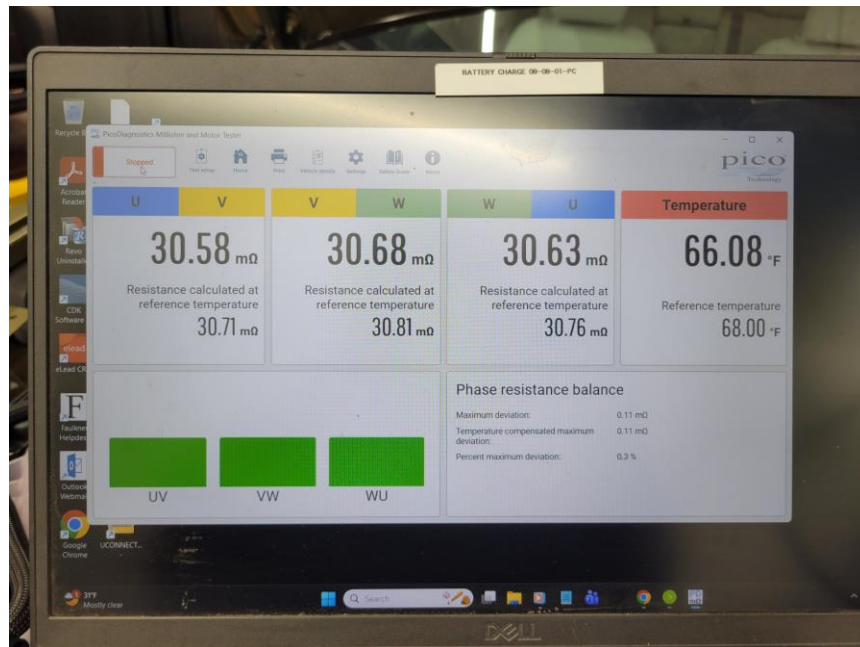
An image/screenshot showing the resistance values and percentage of deviation displayed in the Pico software should be attached to the STAR case. Pico software allows multiple measurements to be taken at the same time, and readings should be captured this way.

Example Image/Screenshot Of Pico Software Simultaneously Displaying The 3 Required Motor Resistance Readings and Deviation
