GROUP	MODEL
CHA	2021-2024MY Sorento (MQ4a) <u>and</u> 2023-2024MY Sportage (NQ5a)
NUMBER	DATE
126 (Rev 2, 05/06/2026)	October 2024

TECHNICAL SERVICE BULLETIN

FRONT BRAKE DISC REPLACEMENT & BURNISHING

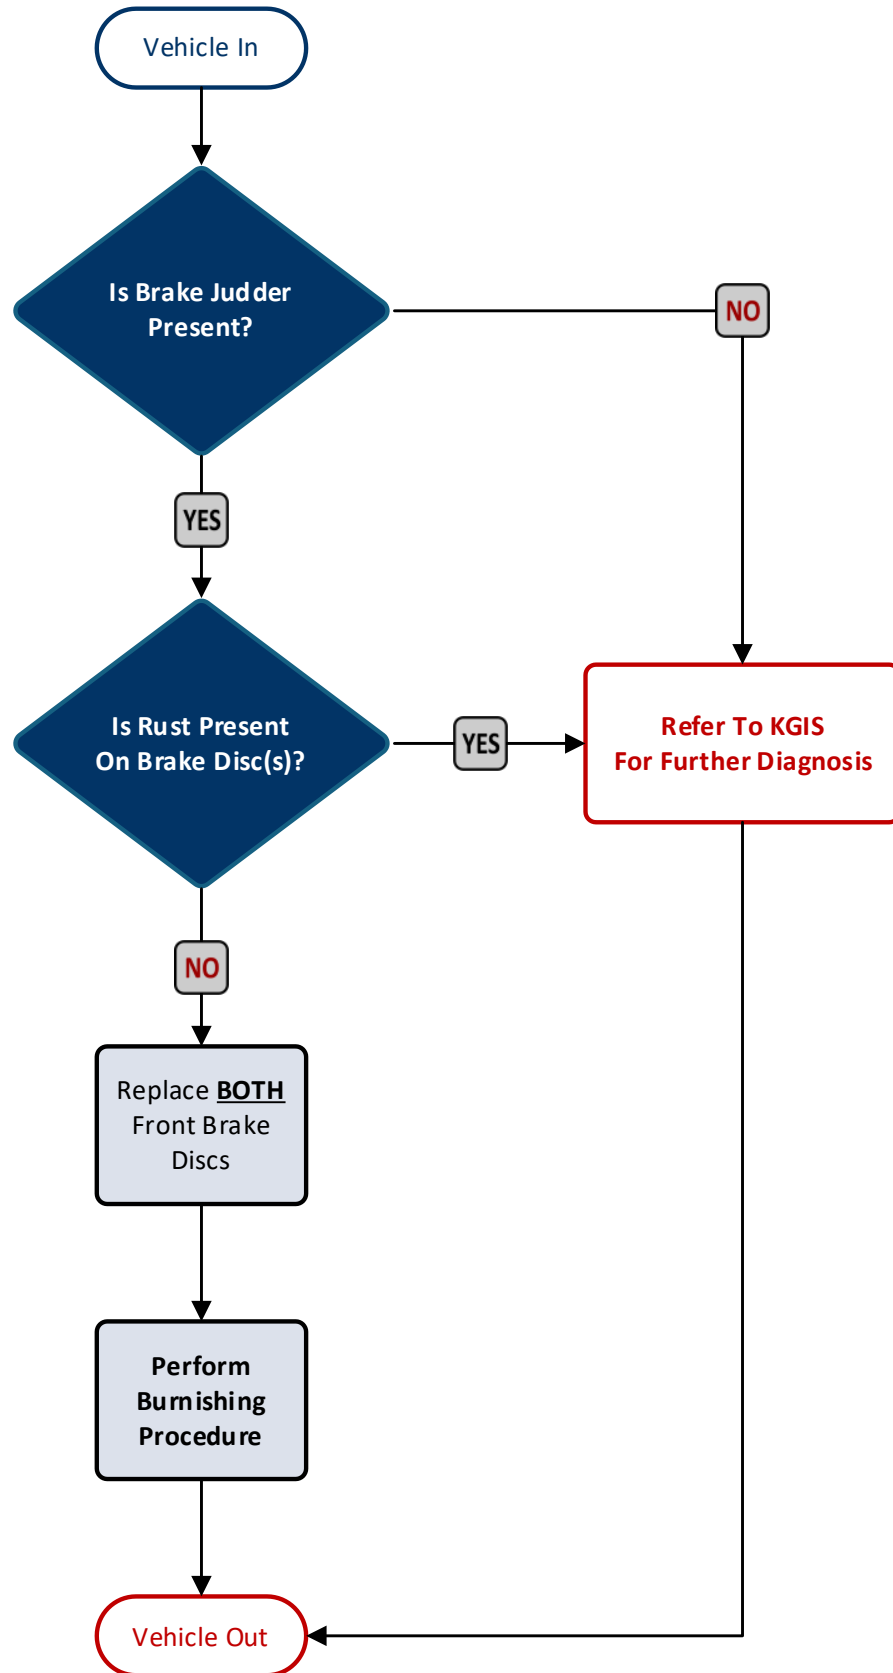
Flowchart:

This bulletin provides the procedure to replace the front brake discs on certain 2021-2024MY Sorento (MQ4a) vehicles produced from July 26, 2021 through March 28, 2024 and 2023-2024MY Sportage (NQ5a) vehicles produced from January 7, 2022 through May 20, 2024 to address a customer's complaint of brake judder. The affected vehicles may exhibit a vibrating and/or pulsing sensation (front brake disc judder) in the steering wheel, brake pedal, and/or seat when the brakes are applied during driving. Follow the procedure outlined in this publication to address the customers' concern of brake judder and replace both front brake discs on the applicable vehicle.

1. Replace **both** front brake discs (A) by referring to "Brake System → Brake System → Front Brake Disc → Repair procedures" in the applicable Shop Manual on KGIS.

1. Drive the vehicle and accelerate to 50 MPH.
2. Apply the brakes using moderate force, and slow the vehicle to 10 MPH. This action should take approximately six (6) seconds.
3. With as little cooling time as possible, repeat steps 1 and 2 ten (10) times.
4. Confirm normal brake operation.
