SERVICE BULLETIN

APPLICABILITY: 2020-22MY Legacy
 2020-22MY Outback(Including Wilderness)
NUMBER: 15-261-20R

SUBJECT: Reprogramming File Availability for Optimization of Gen 4 Denso CP1 Infotainment Systems
DATE: 03/10/20
REVISED: 05/15/26

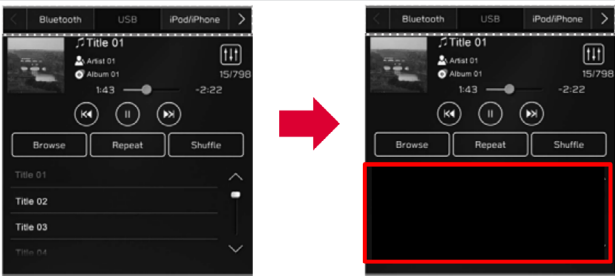
| Number | Symptoms to be Improved: |
|---|---|
| 4 | When selecting a track from the list within the currently playing playlist the track list display may disappear. (iPhone iOS 16.4 or later). |

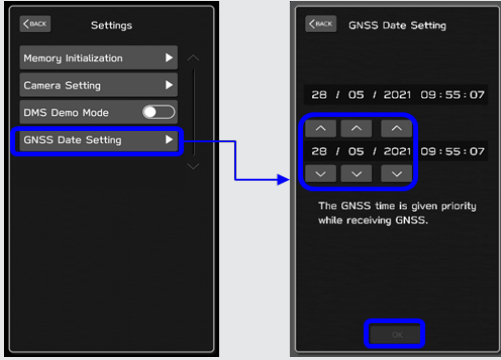
| Number | Symptoms to be Improved: |
|---|--|
| 39 | When the clock was set to "AUTO," the date and time are shifted to a date approximately 20 years in the future due to anomalous values received from GPS or other reasons. If it occurs, the date and time cannot be corrected manually and have to be reset by disconnecting the battery terminal. As a countermeasure, a setting screen to manually adjust the clock display in the "AUTO" setting is to be added to the Dealership Mode (Dealership Mode->Settings->GNSS Data Setting). |

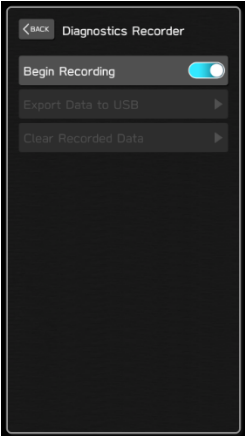
| Number | New Functions and Enhancements |
|---|---|
| 4 | <p>When getting CCU USB logs at the Diagnostics Recorder screen in the Dealership Mode, it was necessary to turn off ""Begin Recording"" to ""Export Data to USB."" And after the log acquisition, it was necessary to turn ""Begin Recording"" ON again. The system interface is improved so that ""Begin Recording"" is automatically switched ON after log acquisition has been accomplished.</p> |

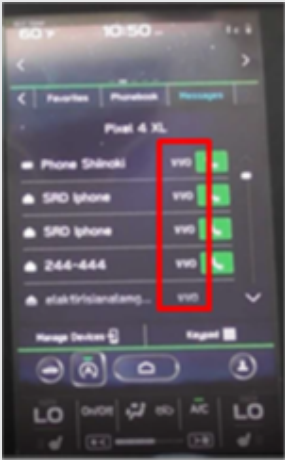
| Number | Symptoms to be Improved: |
|---|--|
| 16 | <p>When selecting “Phone->”>”Message,” message received time is displayed incorrectly as “1/1/0.”</p> <p>It can occur with an Android phone with a specific Android OS (Pixel 6, Pixel4a, Pixel4XL, Xperia etc.) in which time zone data is attached to the message receiving time.</p> |

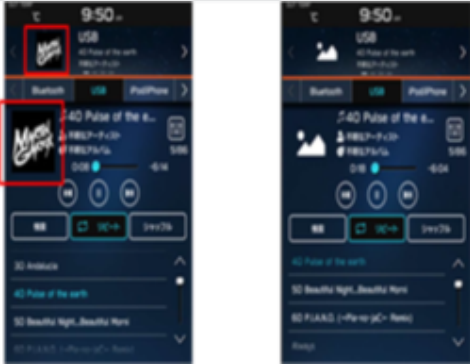
| Number | Symptoms to be Improved: |
|---|--|
| 18 | <p>Cover art of previous music is displayed when playing music without cover art in USB audio. It can occur when music with and without cover art is mixed and stored together a single USB.</p> |

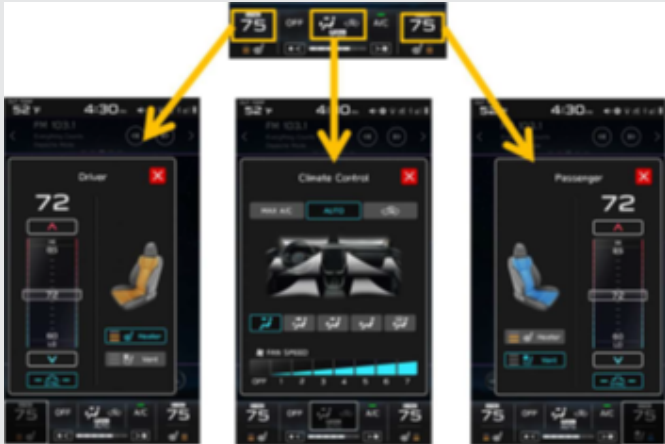
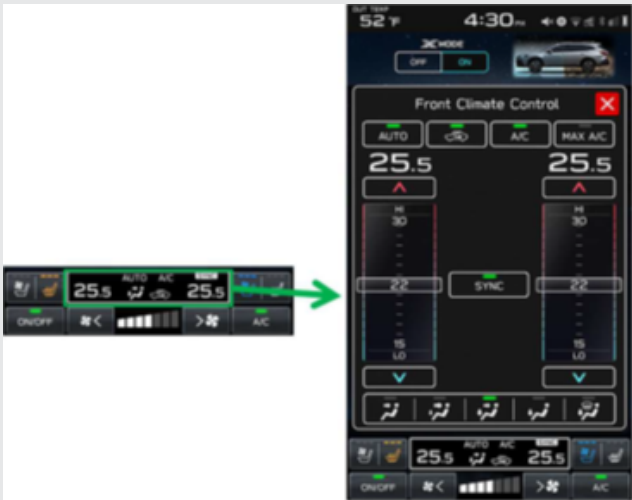
| Number | New Functions and Enhancements |
|---|---|
| <p>2</p> | <p>Air conditioner control interface is changed to that of 23MY.</p> <p>Current (-22MY) screen transition:</p> <p>23MY screen transition:</p> |

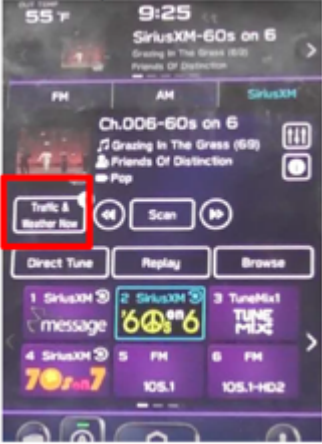
| Number | Symptoms to be Improved: |
|---|---|
| 25 | <p>No response when touching “Traffic & Weather Now (TWN)” on SMX screen.</p> |

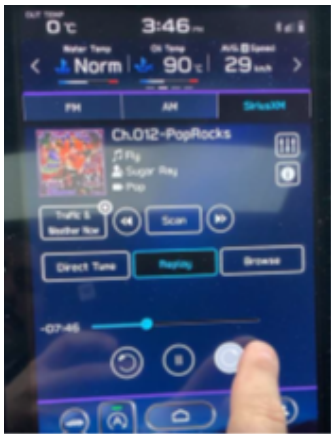
| Number | Symptoms to be Improved: |
|---|---|
| 29 | <p>“Fast forward” does not work in SXM replay function. (Fast Rewind works.)</p> |

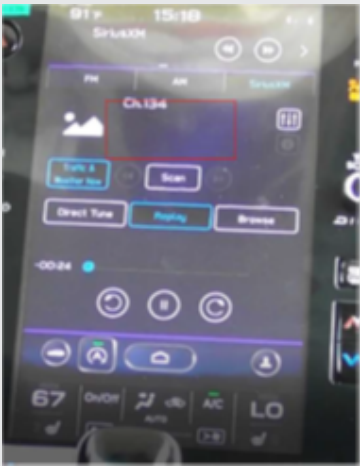
| Number | Symptoms to be Improved: |
|---|---|
| 30 | <p>The team logo is not displayed on Sports Flash screen when the SXM screen had been selected as audio source at the previous ignition off timing.</p> |

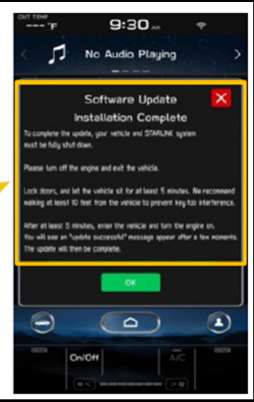
| Number | Symptoms to be Improved: |
|---|--|
| 2 | <p>Clarification of the post-FOTA procedure instructions required to complete the update. The screenshot below will appear and explain what must be done to complete the update installation.</p> <div style="border: 1px solid black; padding: 5px; margin: 10px 0;"> <p>Software Update Installation Complete To complete the update, your vehicle and STARLINK system must be fully shut down. Please turn off the engine and exit the vehicle. Lock doors, and let the vehicle sit for at least 5 minutes. It is recommended to walk at least 10 feet from the vehicle to prevent key fob interference. After waiting at least 5 minutes, enter the vehicle and turn the engine on. An "Update Successful" message will appear after a few moments. The update will then be complete.</p> </div> |

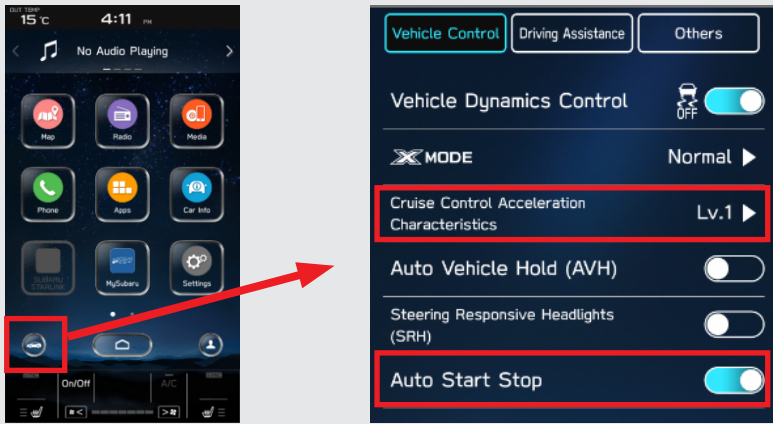
| Number | New Functions and Improvements: |
|---|---|
| 4 | <p>The ISS (Auto Start Stop) button has been moved to the upper layer in the Car Setting menu. By touching the “Car Setting” icon, the Auto Start Stop and Cruise Control Acceleration Characteristics menus can be accessed immediately, whereas selecting “Others” in the Car Setting screen was required to access these menus.</p> |

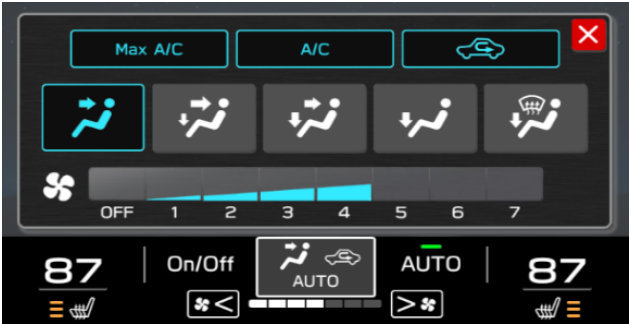
| Number | New Functions and Improvements: |
|---|---|
| 5 | <p>HVAC control buttons of base grade are now larger and easier to see.</p> |

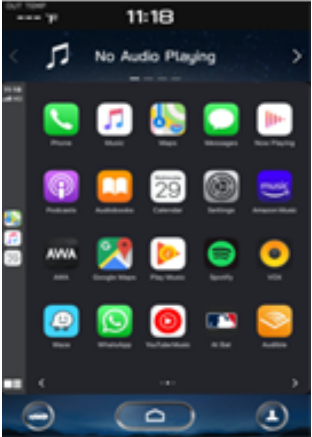
| Number | New Functions and Improvements: |
|---|--|
| 9 | <p>CarPlay screen is now expanded from half size (horizontal) to full screen (vertical).</p> |

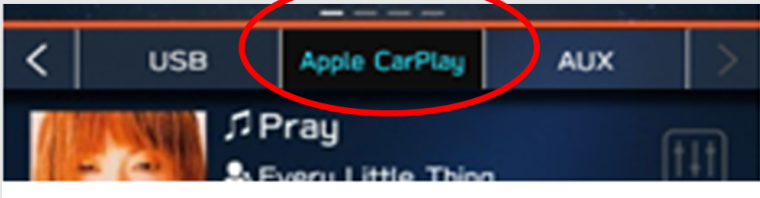
| Number | New Functions and Improvements: |
|---|--|
| 10 | <p>When using CarPlay or Android Auto, a “CarPlay” or “Android Auto” tab will now appear on the Media tab bar. By selecting this tab, music data and metadata can be browsed.</p> |

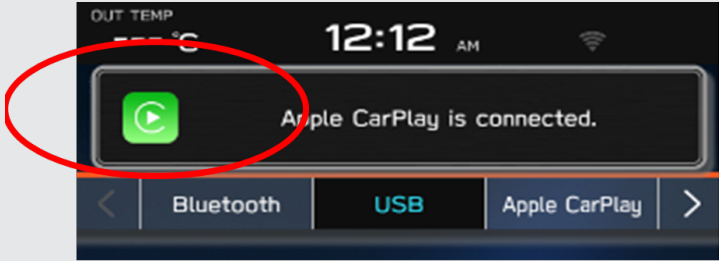
| Number | New Functions and Improvements: |
|---|--|
| 12 | <p>By touching the new CarPlay button located at the top of the CID, the CarPlay menu can be accessed easily.</p> |

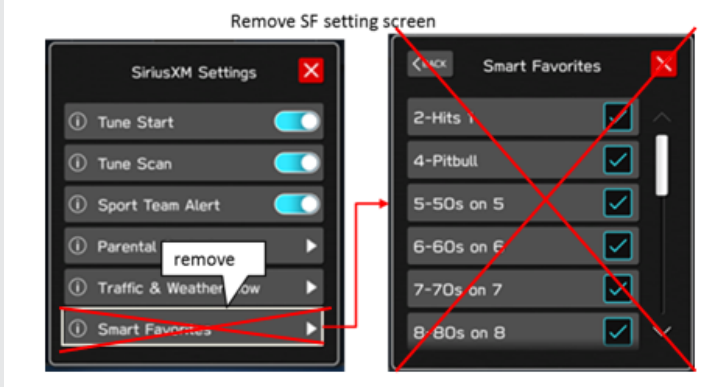
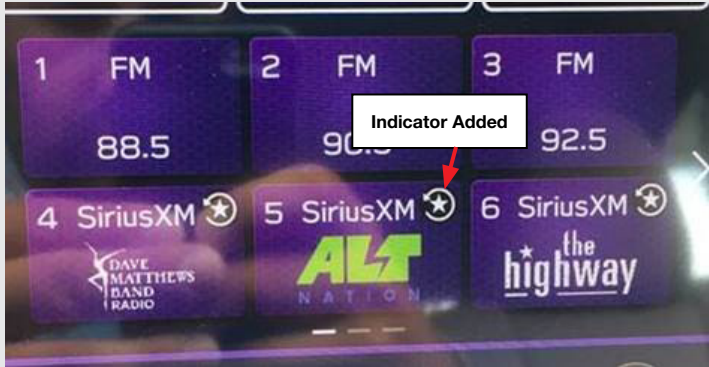
| Number | New Functions and Improvements: |
|---|--|
| 16 | <p>1. Sirius XM Smart Favorites menu has been removed from SiriusXM Settings</p> <p>2. Going forward first 10 set Sirius XM presets are now smart favorites by default</p> <p>3. Smart favorite channel has “star” added to the preset button</p> |
