SERVICE BULLETIN

APPLICABILITY: 22-23MY WRX Models **NUMBER:** 15-301-22R
SUBJECT: Reprogramming File Availability for Optimization of Gen 4 Denso CP1 Infotainment Systems **DATE:** 09/09/22
REVISED: 05/15/26

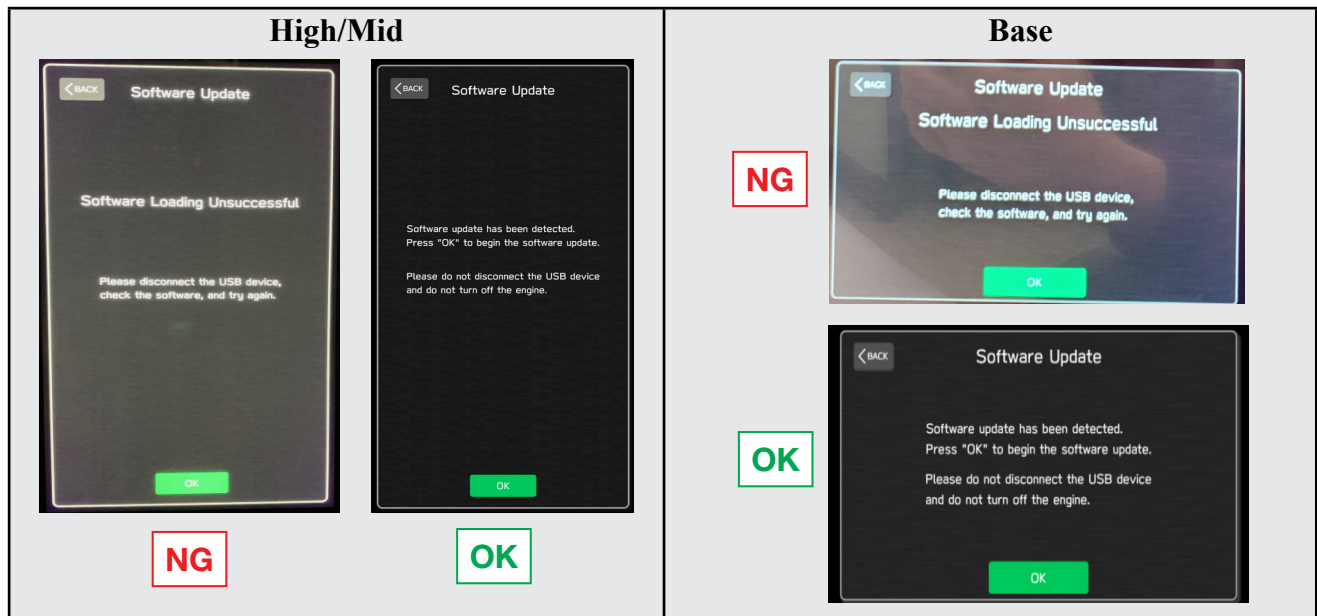
NOTE: If after plugging in the USB, the screen displays a **Software Loading Unsuccessful** message, confirm the USB device has been properly formatted and the the software on the device matches the system being reprogrammed (example: Base software is being used to update a Base system) and retry.

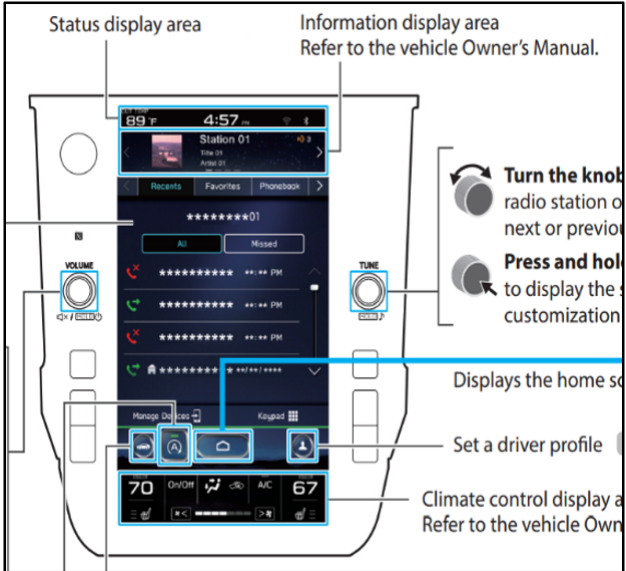
Number	Symptoms to be Improved:
1	While welcome animation on CID is displayed and the driver's door is left open, if turning ignition OFF/ON, the CID screen will be black screen.
2	After starting the engine, the loading animation remains and the screen does not transition remaining blank.
3	When the “All” tab is pressed on the TravelLink Sports screen, a blank screen appears.
4	During Bluetooth audio playing, the CID screen turns into a black picture.
5	<p>The Information Display Area at the top of the CID screen displays a different information screen from the last time.</p>

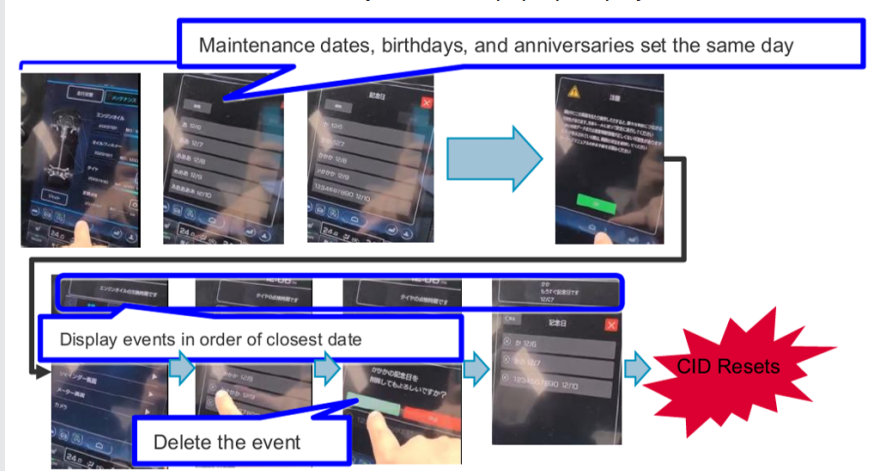
Number	Symptoms to be Improved:
10	<p>If a same date is set to maintenance date, birthday, and anniversary date, pop-ups will appear in sequence on the top of the CID after engine is started when the day comes. Under this condition, if an operation is performed to delete the maintenance date, birthday or anniversary date registration within a few seconds immediately before the pop-up display, the CID screen will reset.</p>

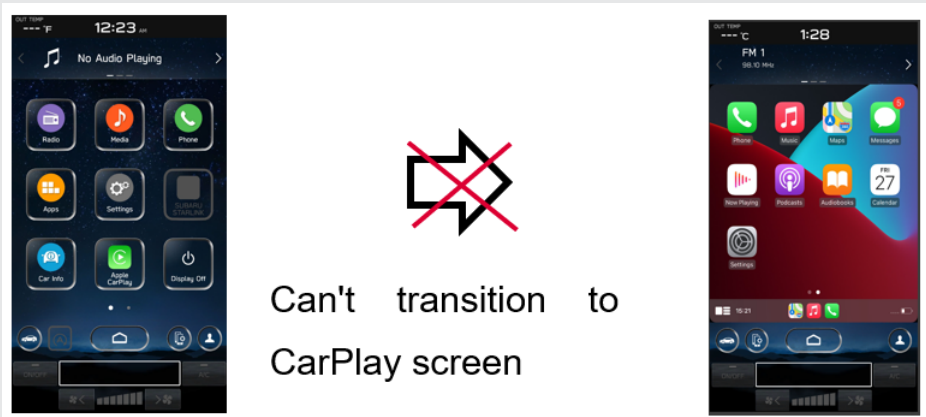
14	<p>When the engine is started with the iPhone connected via USB, CarPlay does not start even if the CarPlay icon on the home screen is pressed. <Hint> This can be resolved by reinserting the USB cable.</p>

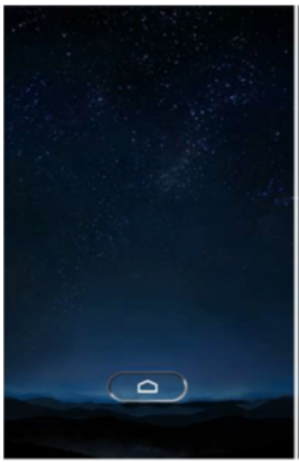
Number	Symptoms to be Improved:
1	Unexpected CP1 system reboot resulting from an inter reset to sync internal communication with Bluetooth module.
2	CID restarts itself right after engine is started.
3	CID resets and reboots.
4	<p>Right after starting up, the CID is blank only displaying the background without icons.</p>

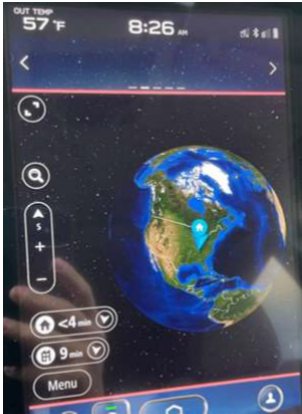
Number	Symptoms to be Improved:
7	Sound is lost when playing Bluetooth audio even though the screen is displayed without problem. It can occur when the audio source is switched repeatedly between the Bluetooth and others.
8	SXM radio output is lost after terminating a handsfree phone call.
9	No audio played back when using CarPlay.
10	Sound volume control does not work while using Android Auto.
11	Cyclic short noise like a drilling or vibration is heard from speakers.
12	After the engine is started, a message of “Loading Navigation...” continues to be displayed, but the map is not displayed.
13	Vehicle position on navigation map erroneously moves to zero degrees latitude and zero degrees longitude (0°N 0°E or west of Africa in the Atlantic ocean).
14	<p>Navigation map scale is changed to the lowest setting (globe is displayed).</p>

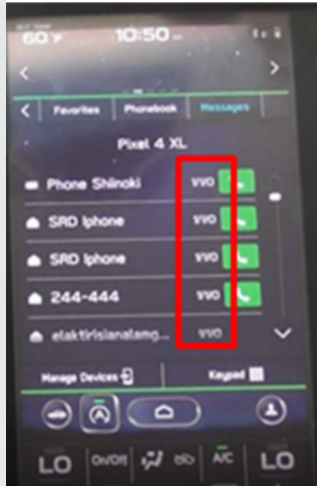
Number	Symptoms to be Improved:
16	<p>When selecting “Phone->”Message,” message received time is displayed incorrectly as “1/1/0.”</p> <p>It can occur with an Android phone with a specific Android OS (Pixel 6, Pixel4a, Pixel4XL, Xperia etc.) in which time zone data is attached to the message receiving time.</p>

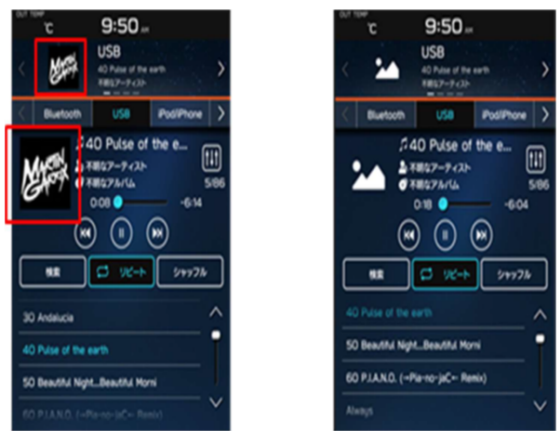
17	<p>Even when using the same mobile device that was paired previously, a message of “Are you sure you want to activate this profile?” is prompted and confirmation is needed to activate the device.</p>
18	<p>Cover art of previous music is displayed when playing music without cover art in USB audio. It can occur when music with and without cover art is mixed and stored together a single USB.</p>

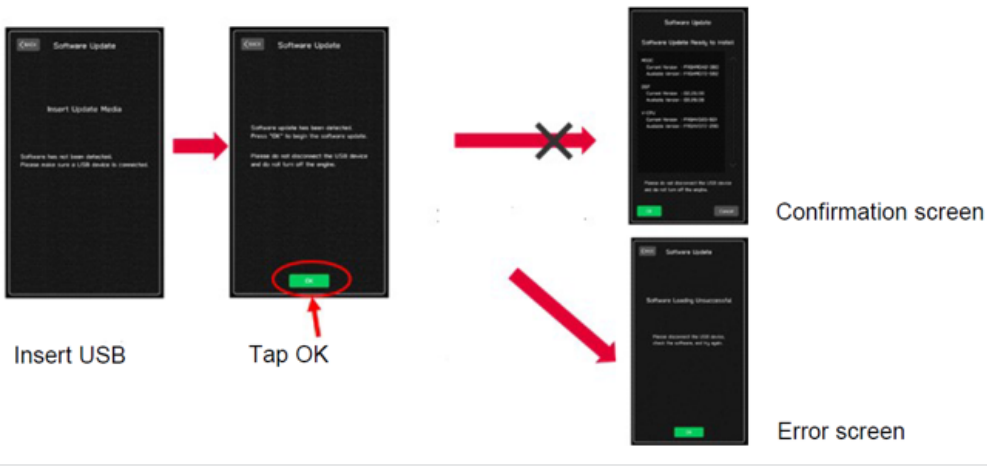
Number	Symptoms to be Improved:
12	<p>When conducting USB reprogramming, the screen transition to error screen instead of confirmation screen.</p>

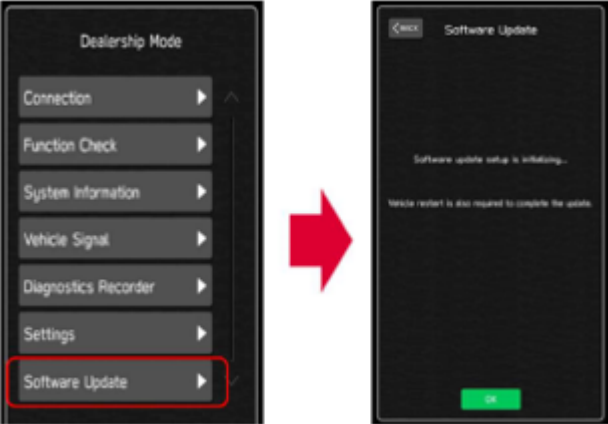
<p>The diagram illustrates the intended flow and a common failure point. It shows three screens: 1. 'Insert USB' screen. 2. A screen with a green 'OK' button, where a red circle highlights the button and a red arrow points to it with the text 'Tap OK'. 3. A 'Confirmation screen' showing update details. A red arrow with a large 'X' over it points from the 'OK' screen to the 'Confirmation screen', indicating a failed transition. Another red arrow points from the 'OK' screen to an 'Error screen'.</p>
13	<p>When “Software Update” is selected in the Dealership Mode, the following initialization process does not end more than 20 minutes. *</p>

<p>The diagram shows two screens. The first is 'Dealership Mode' with a list of options: Connection, Function Check, System Information, Vehicle Signal, Diagnostics Recorder, Settings, and Software Update. The 'Software Update' option is highlighted with a red box. A red arrow points to the second screen, 'Software Update', which shows 'Software update setup is initializing...' and 'Vehicle restart is also required to complete the update'.</p> <p>Note* In case this USB update failure occurs, retry updating according to the instructions in “Appendix A”</p>

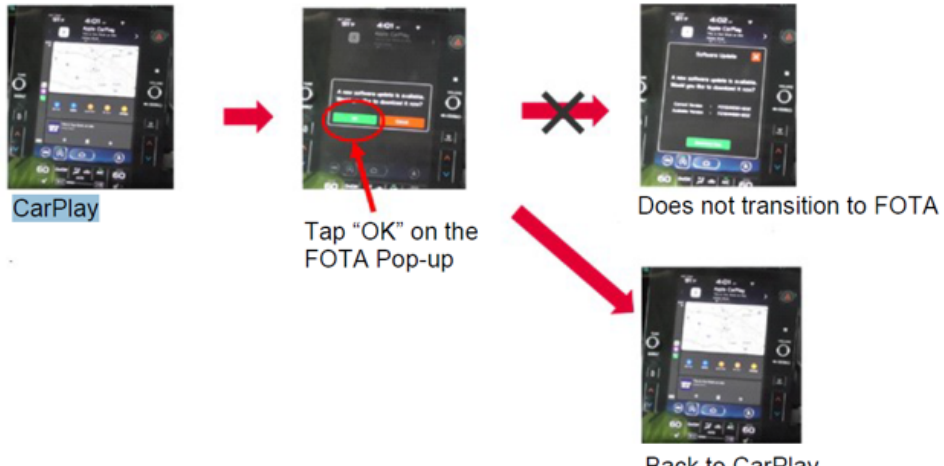
14	<p>When the FOTA pop-up (new software availability notification) is displayed while the CarPlay is being used, the display comes back to CarPlay screen even if the customer tries to get into the FOTA screen.</p>

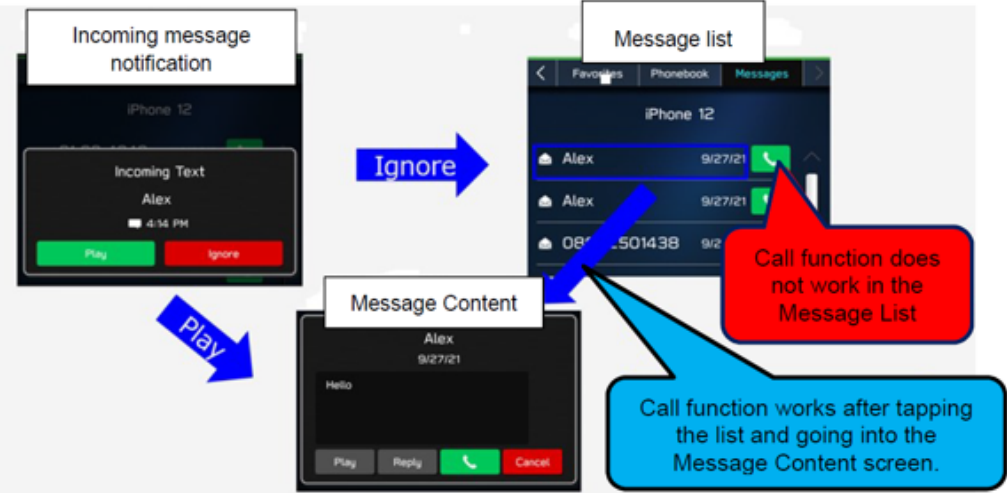
Number	Symptoms to be Improved:
15	<p>Call function does not work in the Message List (after ignoring the incoming message notification.). However, the call function can still be used after getting into the Message Content screen by tapping the message list.</p>

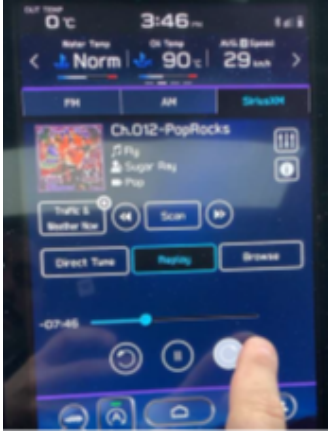
Number	Symptoms to be Improved:
29	<p>“Fast forward” does not work in SXM replay function. (Fast Rewind works.)</p>

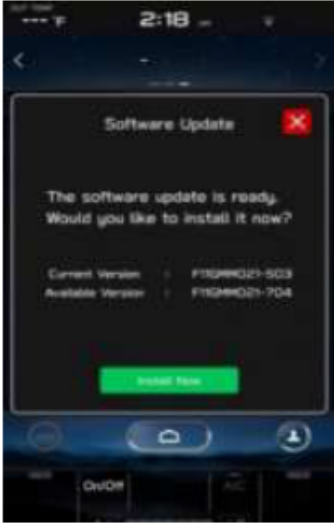
<p>Note* Even if this symptom occurs, after approximately 2 minutes, the system resumes, and the CID comes back to the below screen. Customer can then push the “Install Now” to proceed with the installation.</p>
