Check engine light with fault code P3005CA in MRD1 (CDI)

Topic number	LI49.20-N-078466
Version	4
Function group	49.20 - Exhaust gas aftertreatment
Date	5/8/26
Validity	Sprinter 907 OM654
Reason for change	Remedy update

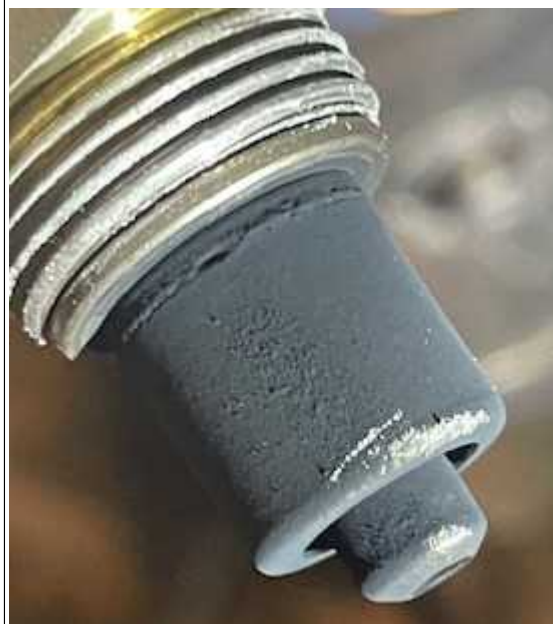
Soot Sensor.jpg

1. Damage to the Diesel Particulate Filter (DPF) unit.
2. The N74 (Soot Particulate Sensor Control Unit) identifies soot or debris located downstream of the SCR Catalyst (underbody).

Soot Sensor Covered in Soot

- If soot was found during step 1 or if this vehicle had the Diesel Particulate Filter (DPF) replaced prior due to failure and the fault returned, please complete the below steps:
- Remove the 'SCR Catalytic Converter, underbody', place a white cloth/rag on the floor, and lightly tap the 'SCR Catalytic Converter, underbody' onto the floor to see if any soot comes out. Repeat this inspection on both ends of the SCR catalytic converter. If soot is found on the rag, please replace the 'N74 (Soot Particulate Sensor Control Unit)' and 'SCR Catalytic Converter, underbody' with the needed components.
