<b>Topic</b>	Software Update   Window Short Drop Deletion   Continental GT/GTC   26MY (SC26 /08)
<b>Market area</b>	United States E05 Bentley USA and rest America (6E05)
<b>Brand</b>	Bentley
<b>Transaction No.</b>	2081624/1
<b>Campaign number</b>	ED87
<b>Note</b>	
<b>Type</b>	
<b>US code</b>

Software Update | Window Short Drop Deletion | Continental GT/GTC | 26MY  
(SC26/08)

Release date: May 19,  
2026

# Retailer Glass Measurement Procedure for GT BY634

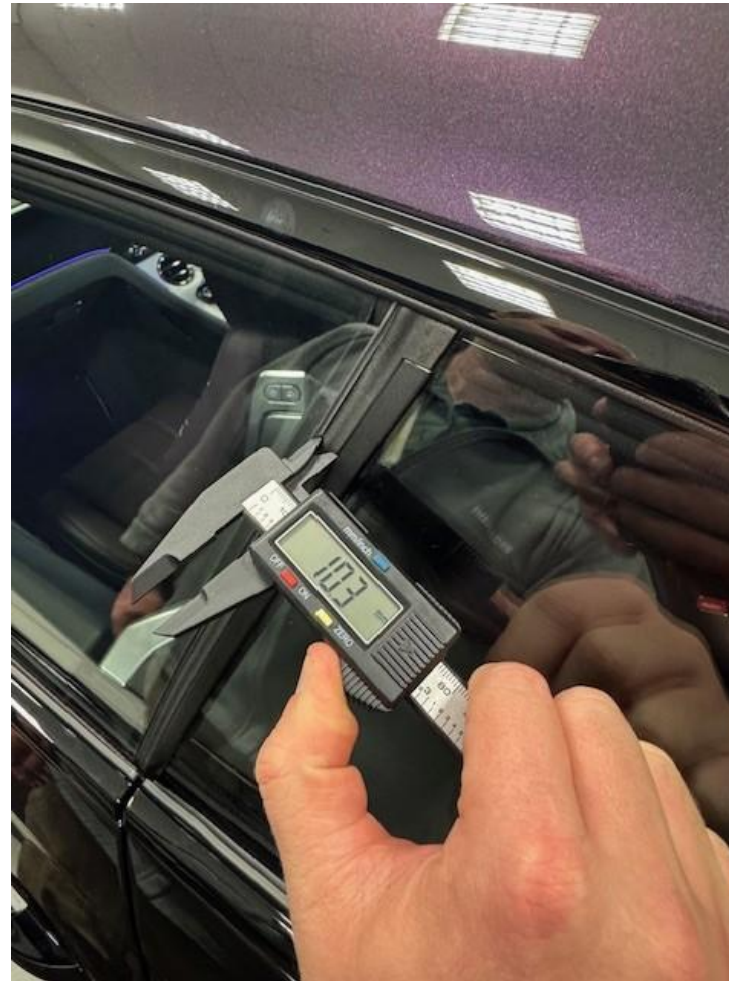
# INTERLOCK POINT 6

50mm from seal

Record measurement

**Specification**  
11mm ± 1mm  
(Ruler/vernier)

**Repair Group 64 'Slide glass checking and adjusting'**

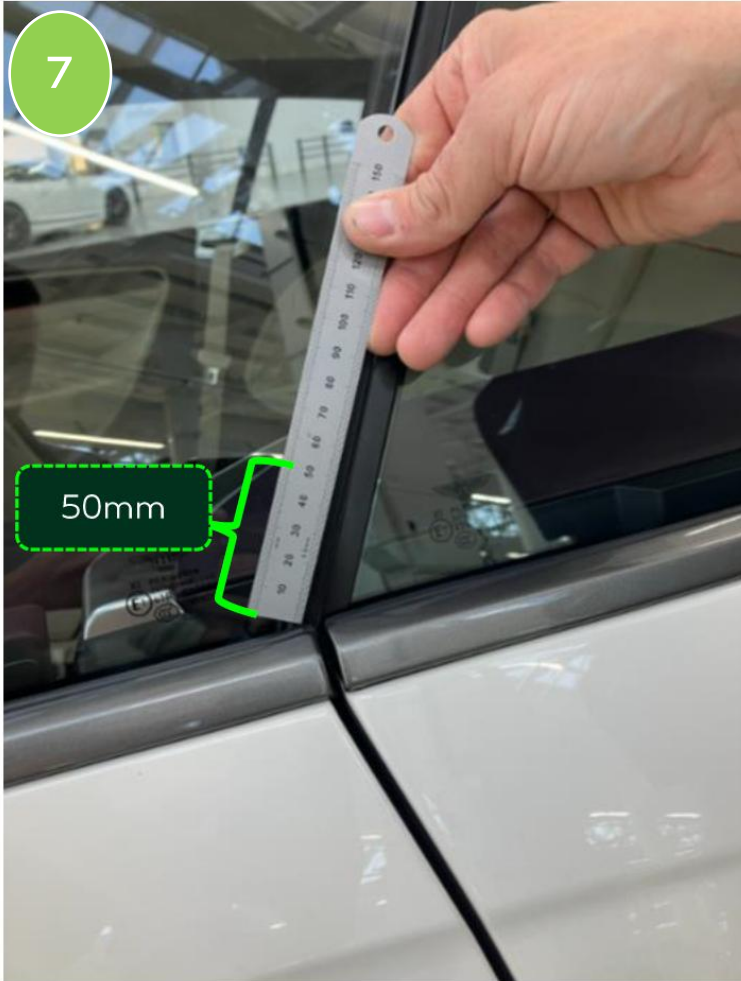
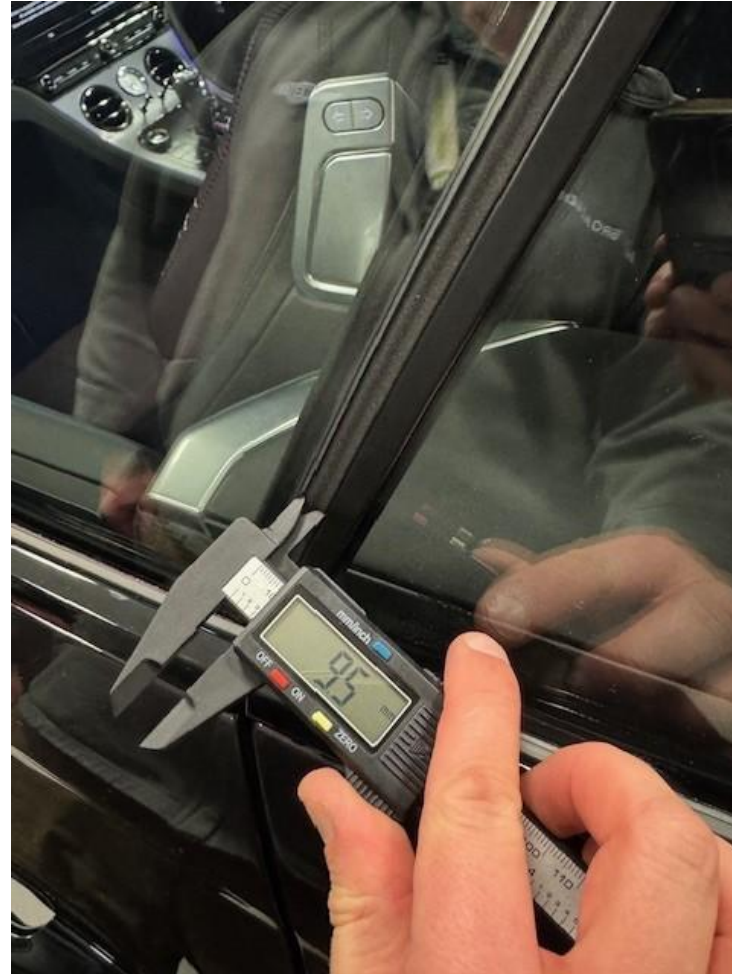
# INTERLOCK POINT 7

50mm from seal

Record measurement

**Specification**  
11mm ± 1mm  
(Ruler/vernier)

**Repair Group 64 'Slide glass checking and adjusting'**

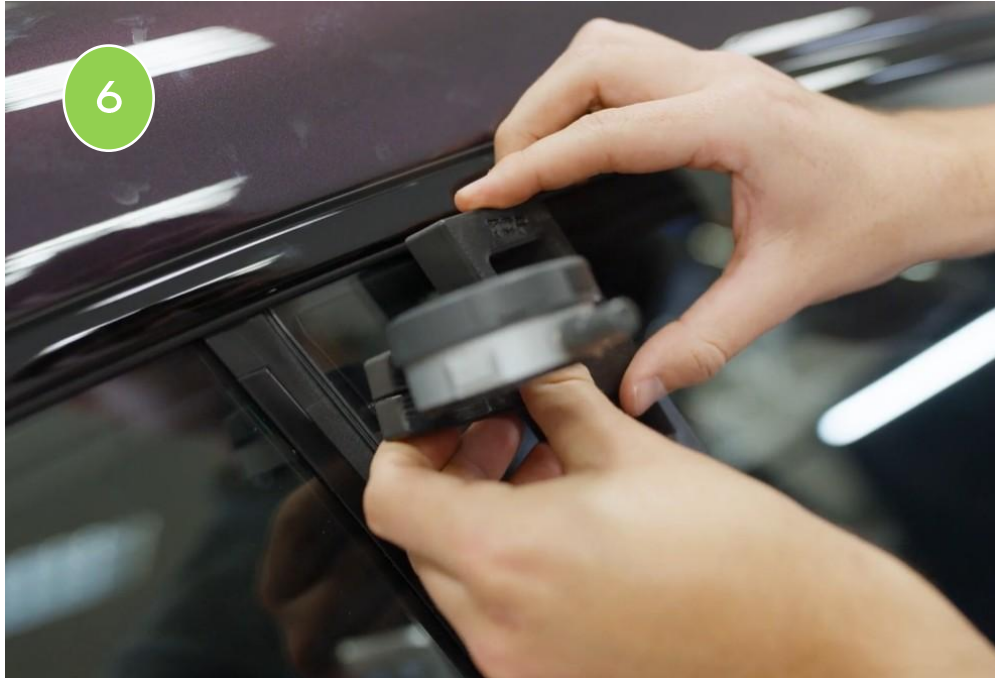
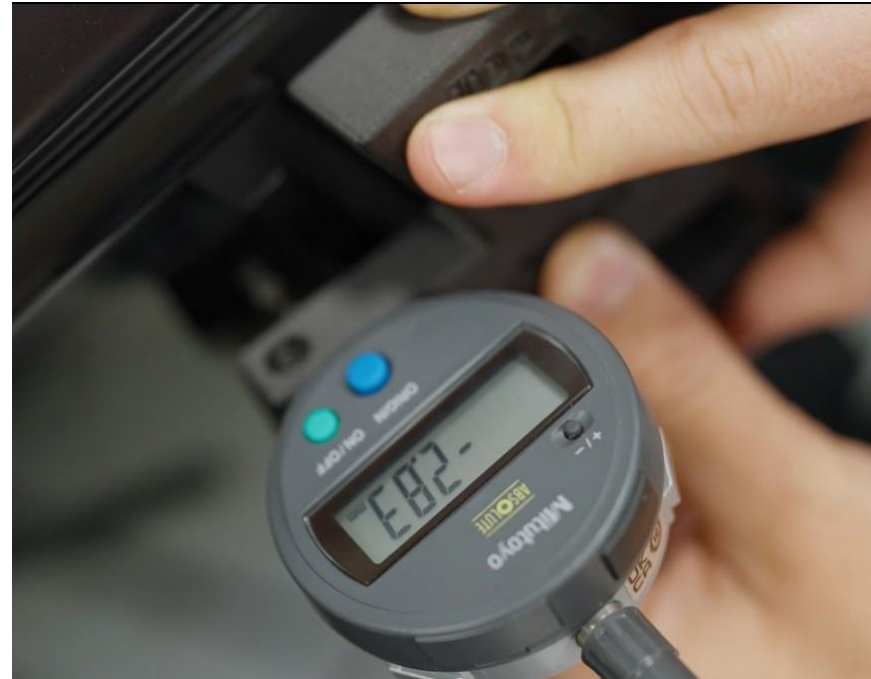
# PROFILE POINT 6 (DIGITAL DTI GAUGE) \*USE TO SET\*

Align and position the tool on the front window so that its contact face rests flat against the upper bright ware trim, zero / origin the tool.

Then slide it along the surface until it makes full, even contact with the rear glass.  
Record the measurement.

**Specification**  
0mm +0 / -2.5mm

**If the measurement is out of specification refer to ElsaPro Repair Group 64 'Slide glass checking and adjusting'**

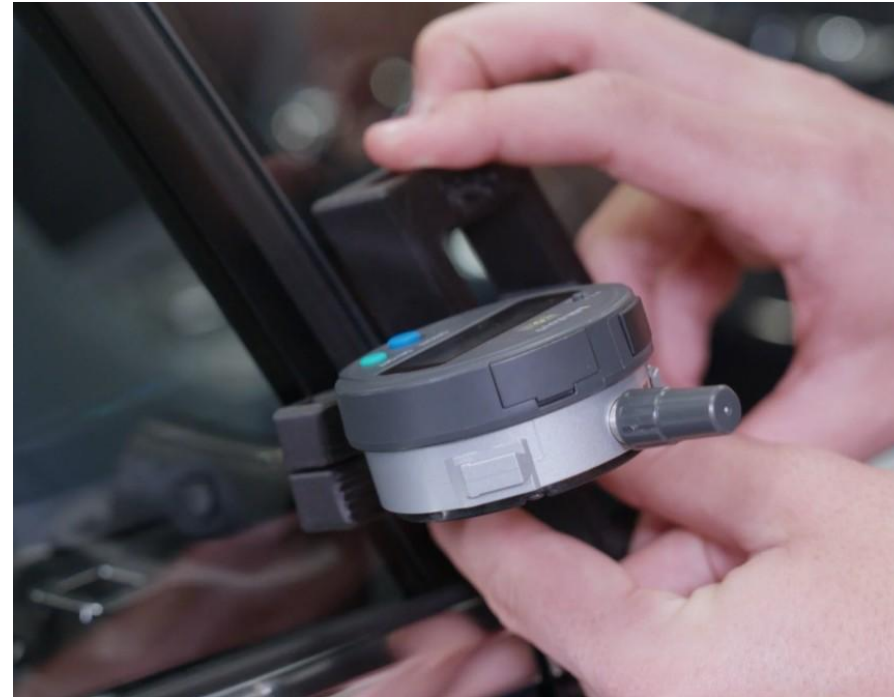
## PROFILE POINT 7 (DIGITAL DTI GAUGE) \*USE TO SET\*

Align and position the tool on the front window so that its contact face rests flat against the lower bright ware trim, zero / origin the tool.

Then slide it along the surface until it makes full, even contact with the rear glass.  
Record the measurement.

**Specification**  
0mm +0 / -2.5mm

**If the measurement is out of specification refer to ElsaPro Repair Group 64 'Slide glass checking and adjusting'**

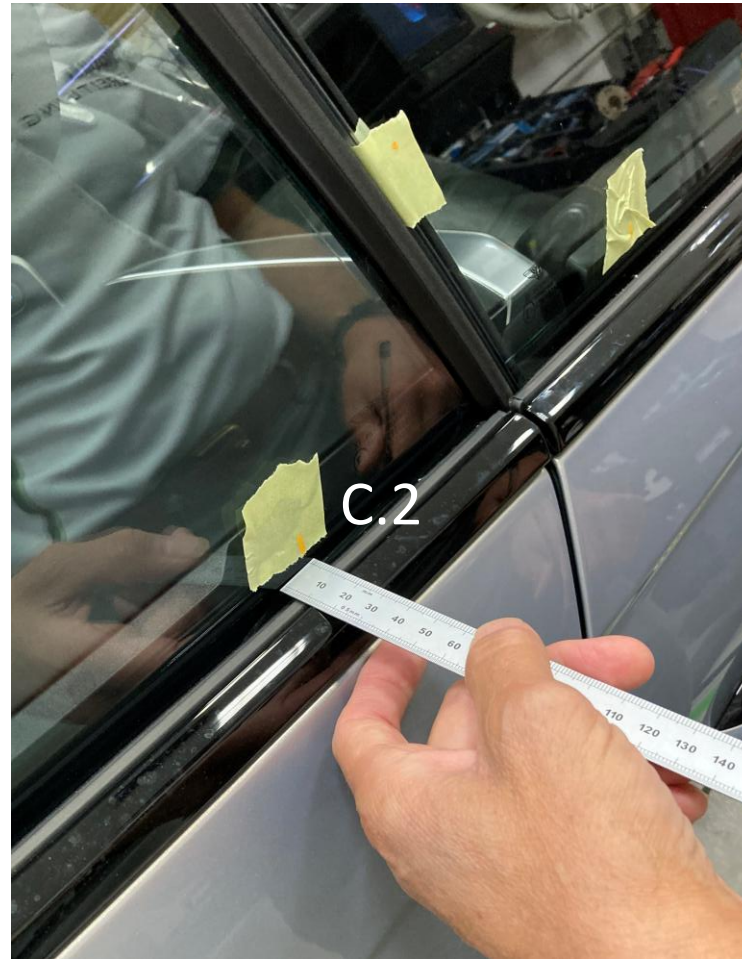
Measure seal to window gap (C.2)

If the measurement is out of specification refer to ElsaPro **Repair Group 64** 'Slide glass checking and adjusting'
