## Technical product information

Topic	Window Drop Glass Operation   Continental GT/GTC   25-26MY
Market area	Bentley: worldwide (2WBE),China 796 VW Import Comp. Ltd (Vico), Beijing (6796)
Brand	Bentley
Transaction No.	2080372/2
Level	EH
Status	Released for publishing
Release date	May 19 2026

Window Drop Glass Operation | Continental GT/GTC | 25-26MY

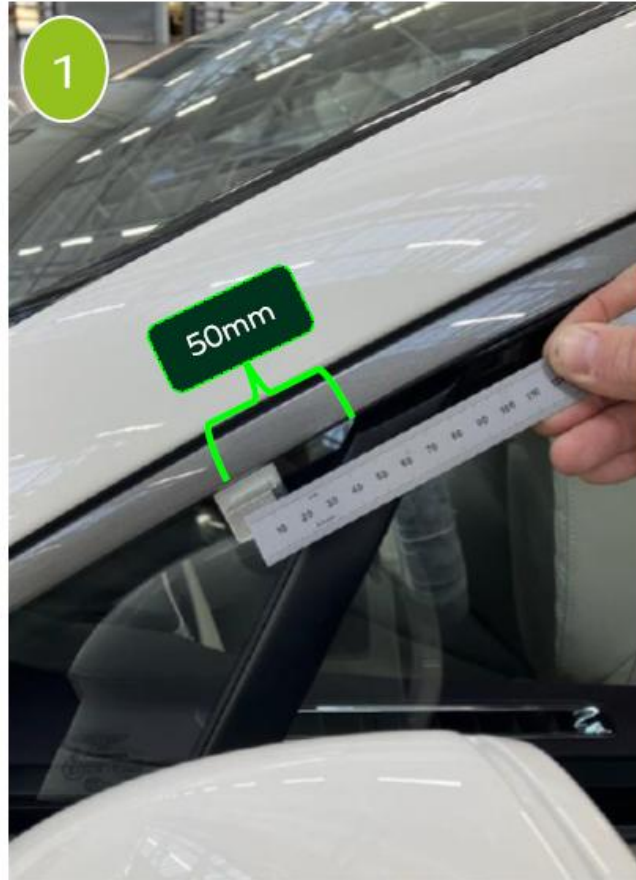
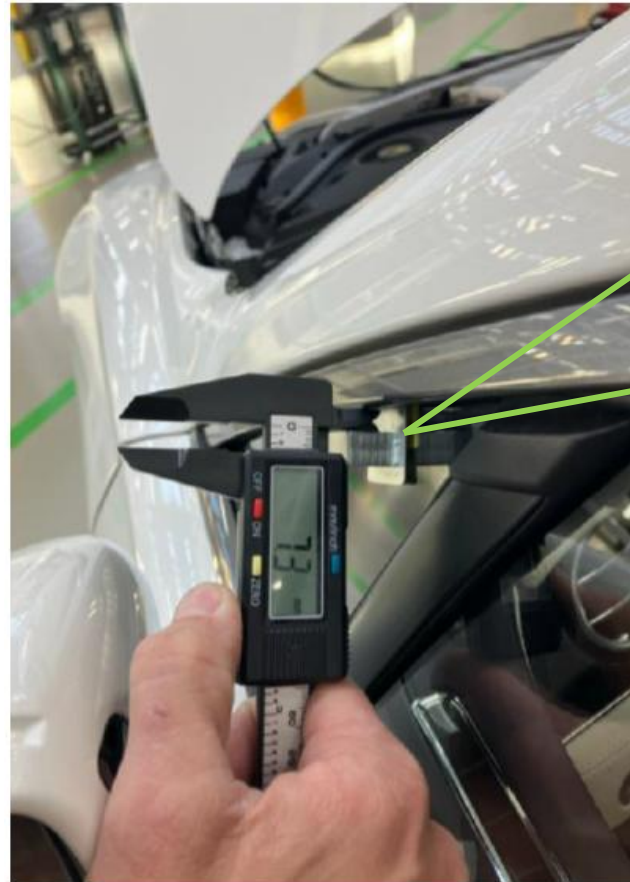
# INTERLOCK POINT 1

Place block 50mm in front of front div bar

Record measurement for all interlock points

From block to bright ware for all interlock points

**Specification**  
7.5mm  $\pm$  1mm  
(Interlock Tool WT10549/1)  
If the measurement is out of specification refer to ElsaPro Repair Group 64 'Front door quarter glass – To adjust'

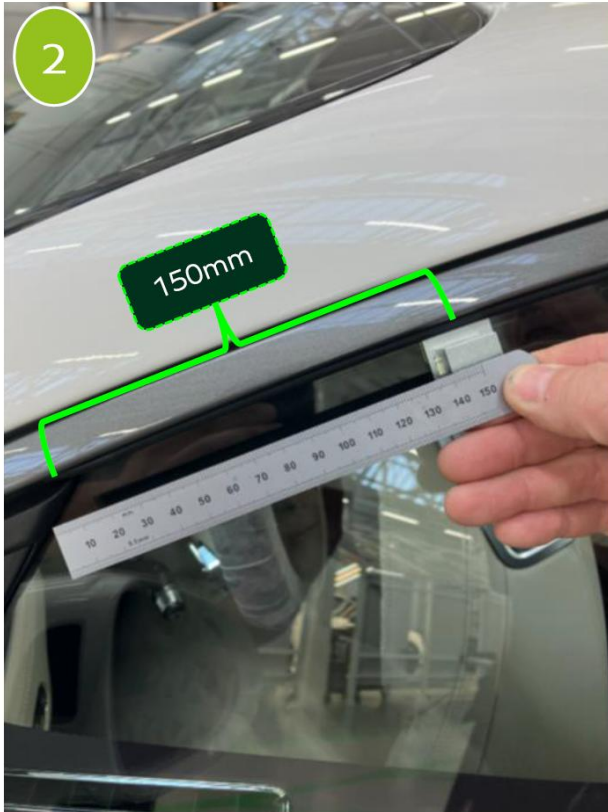
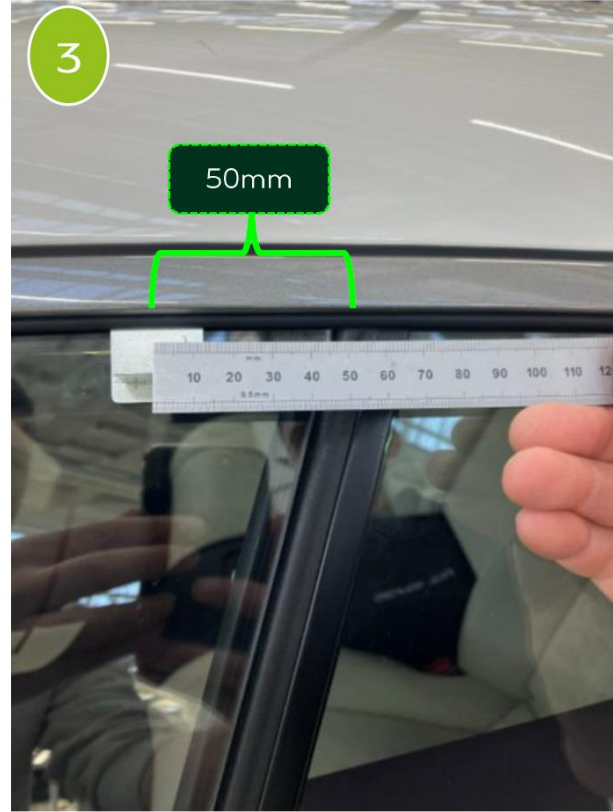
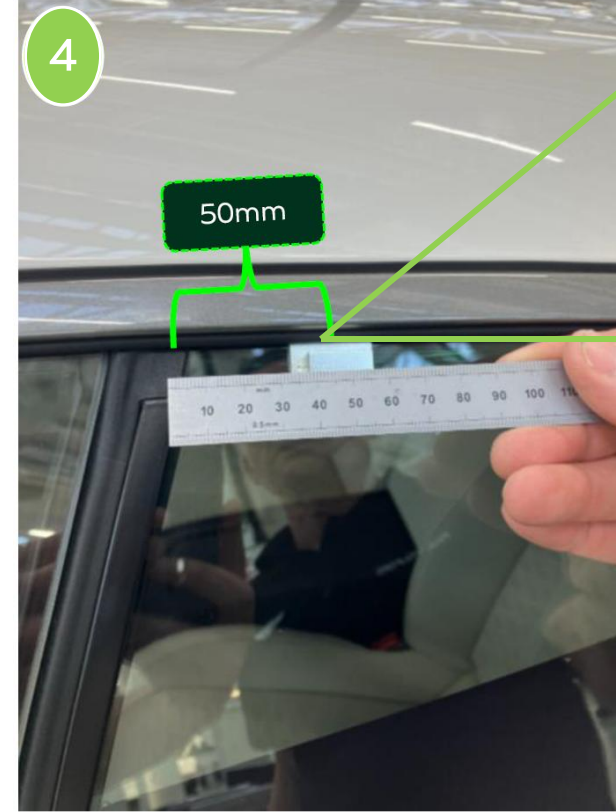
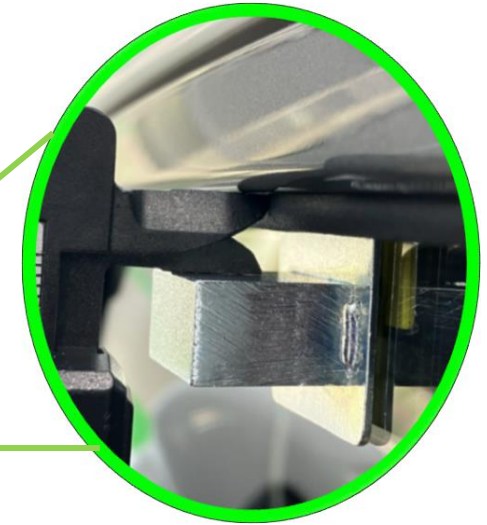
# INTERLOCK POINTS 2, 3, 4

Place block 150mm behind corner of front div bar

Place block 50mm in front of rear div bar

Place block 50mm to rear of rear div bar

**Specification**  
8mm ± 1mm  
(Interlock Tool WT10549)

If the measurement is out of specification refer to ElsaPro

**Repair Group 64 'Slide glass checking and adjusting'**

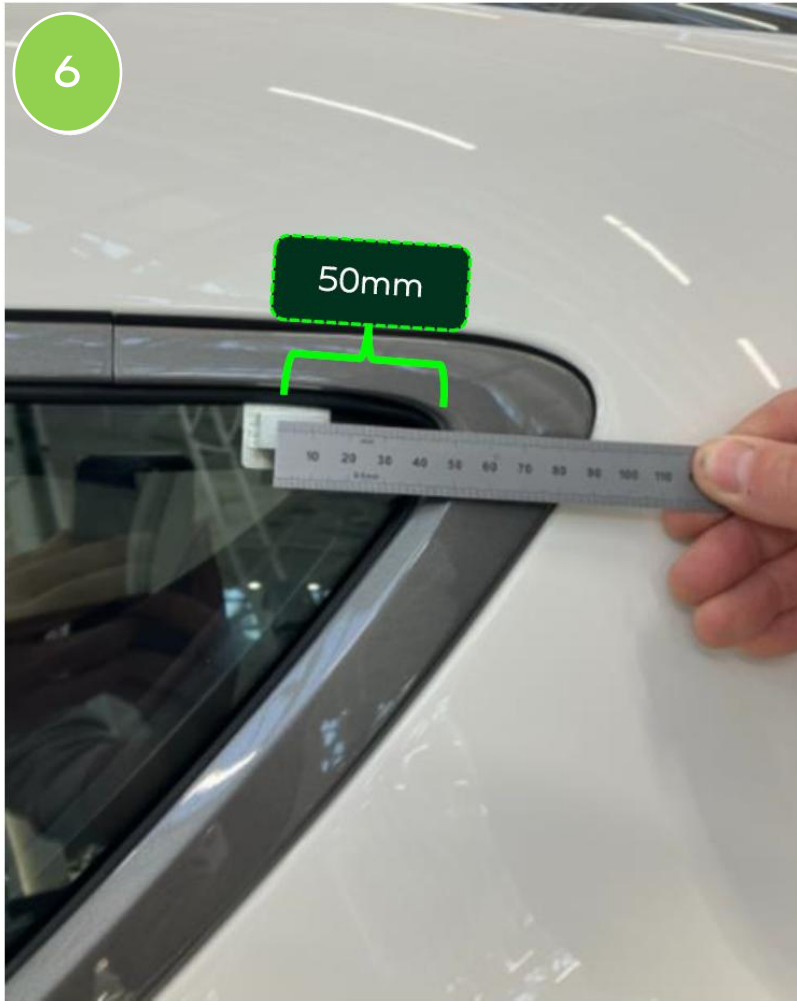
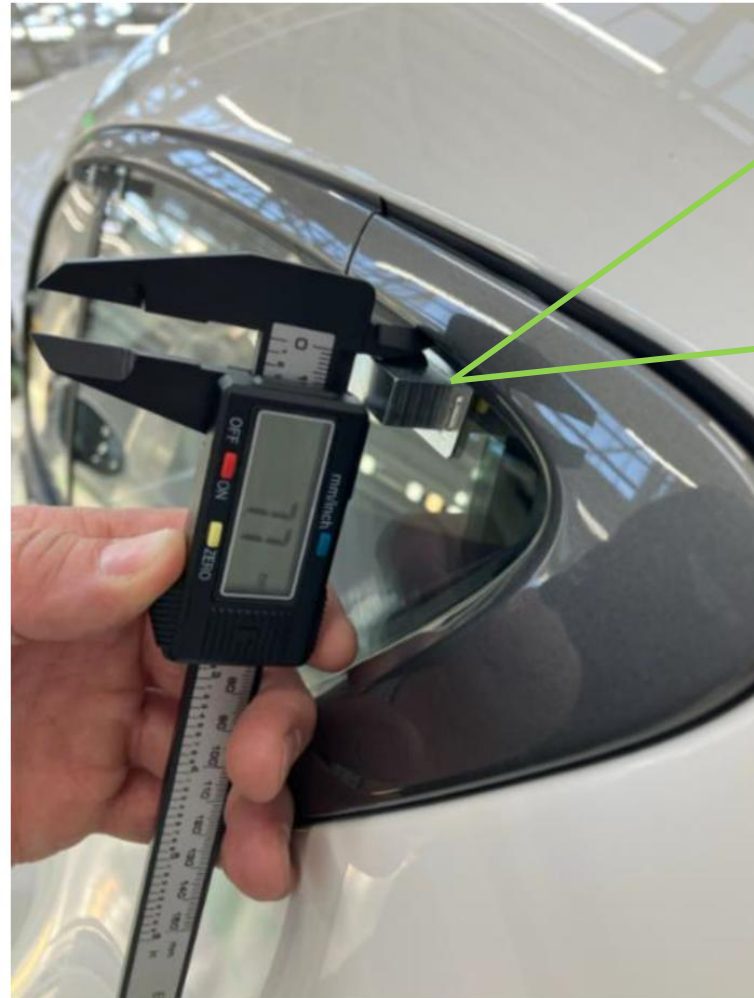
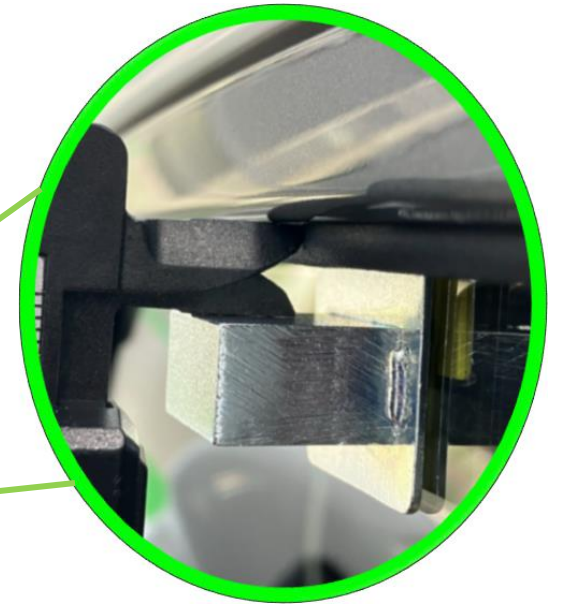
# INTERLOCK POINT 6

Place block 50mm from corner point of bright ware

Record measurement for all interlock points

**Specification**  
8mm  $\pm$  1mm  
(Interlock Tool WT10549/1)

If the measurement is out of specification refer to ElsaPro

**Repair Group 64 'Slide glass checking and adjusting'**

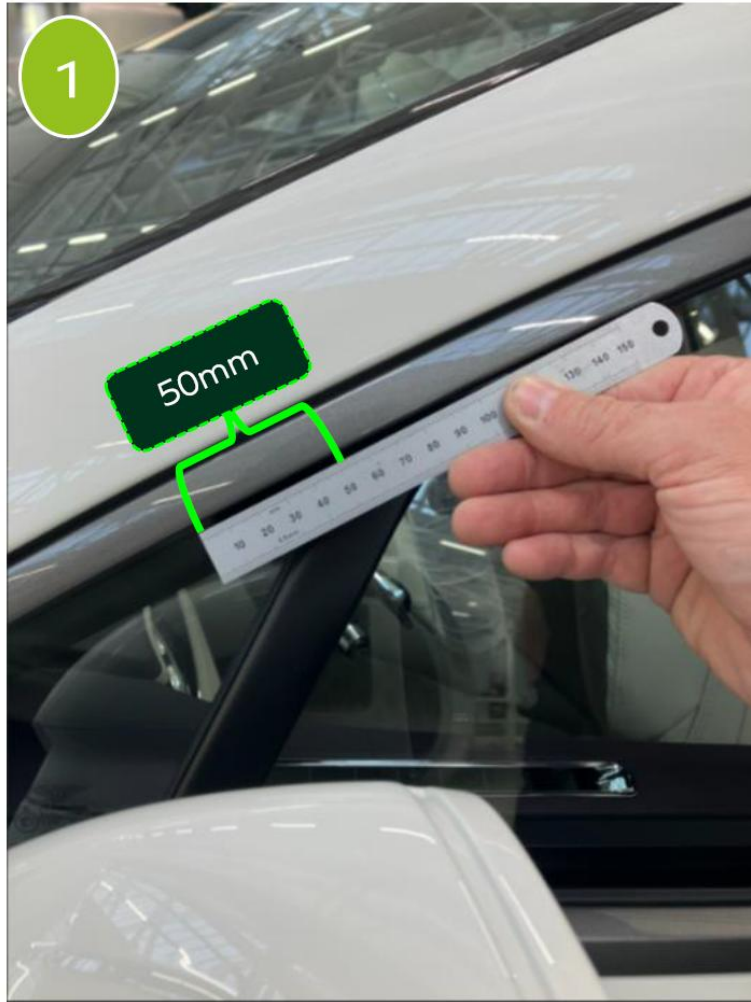
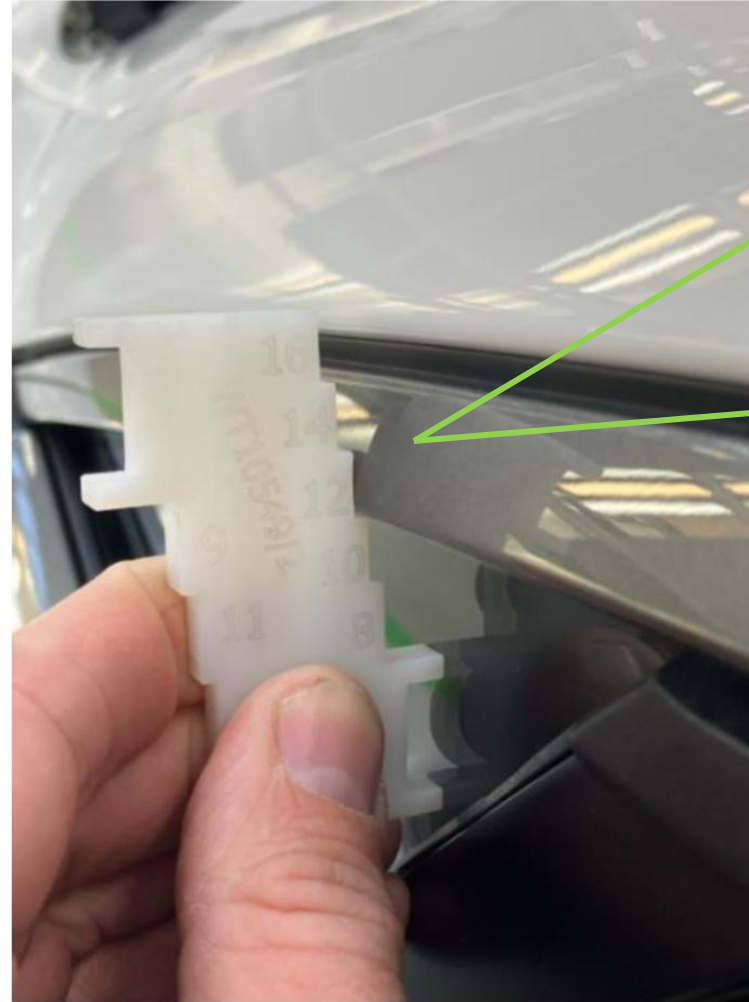
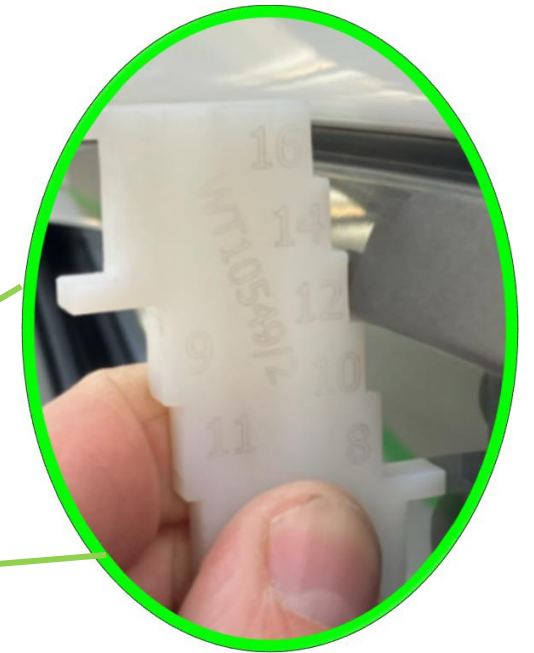
# PROFILE POINT 1

50mm in front of front div bar

Flat against glass to brightware

**Specification**  
10mm ± 1mm  
(Profile Tool WT10549/2)

If the measurement is out of specification refer to ElsaPro

**Repair Group 64 'Slide glass checking and adjusting'**

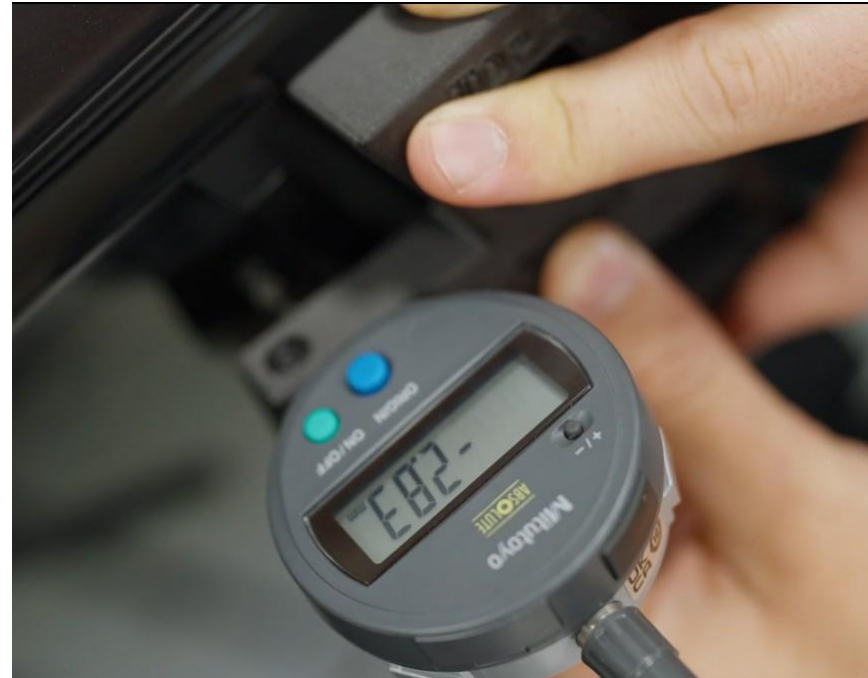
# PROFILE POINT 6 (DIGITAL DTI GAUGE - LATEST TOOL)

Align and position the tool on the front window so that its contact face rests flat against the upper bright ware trim, zero the tool.

Then slide it along the surface until it makes full, even contact with the rear glass.  
Record the measurement.

**Specification**  
0mm +0 / -2.5mm

**Repair Group 64**  
**'Slide glass checking and adjusting'**

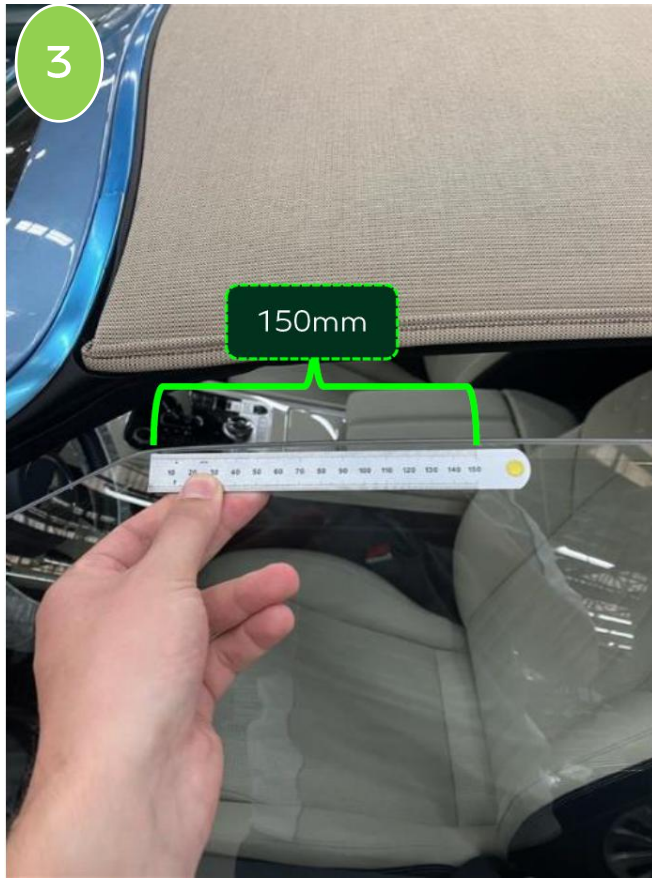
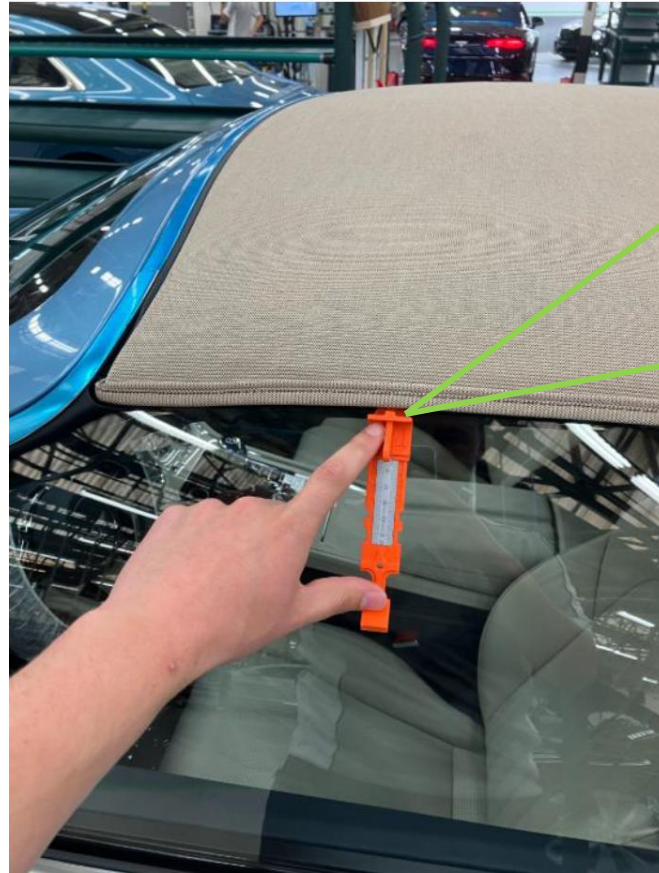
# INTERLOCK POINT 3

150mm from front corner of window glass as shown

**Specification**  
7mm ± 1mm  
(Interlock Tool WT10554)

If the measurement is out of specification refer to ElsaPro Repair Group 64 'Front door quarter glass – To adjust'

*If the specification for interlock points 2, 3 or 4 cannot be achieved through normal adjustment, refer to page 6 of the glass reset procedure.*

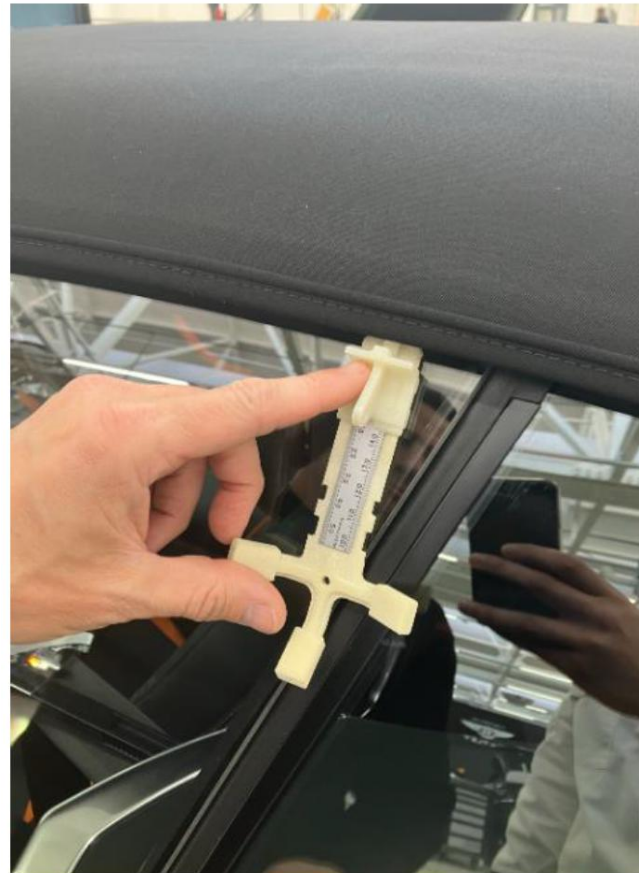
50mm from rear edge of the front door glass as shown

**Specification**  
8.5mm  $\pm$  1mm  
(Interlock Tool WT10554)

If the measurement is out of specification refer to ElsaPro Repair Group 64 'Front door quarter glass – To adjust'

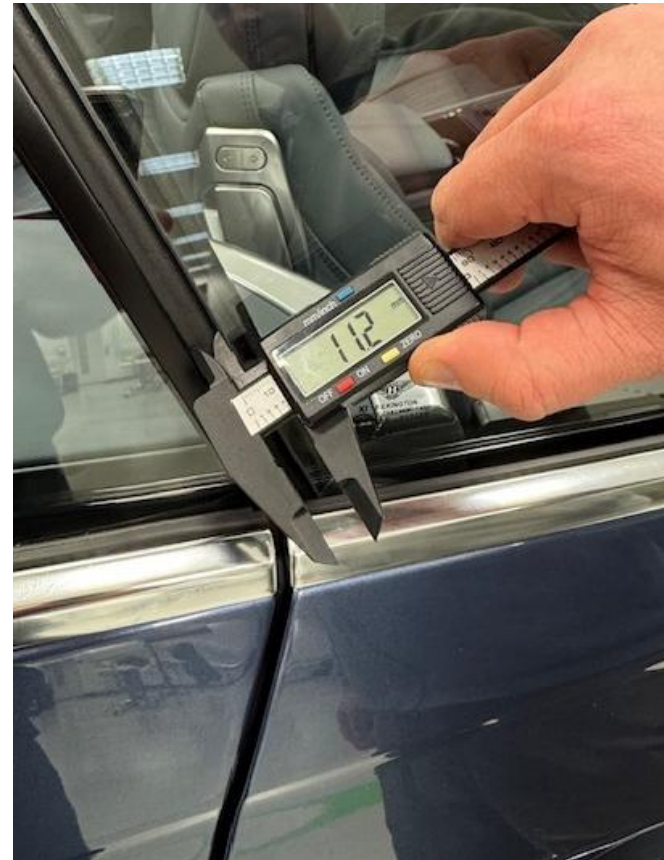
# INTERLOCK POINT 6 ROOF UP & DOWN

50mm from corner

**Specification**  
11mm ± 1mm  
(Ruler/vernier)

If the measurement is out of specification refer to ElsaPro Repair Group 64 'Front door quarter glass – To adjust'

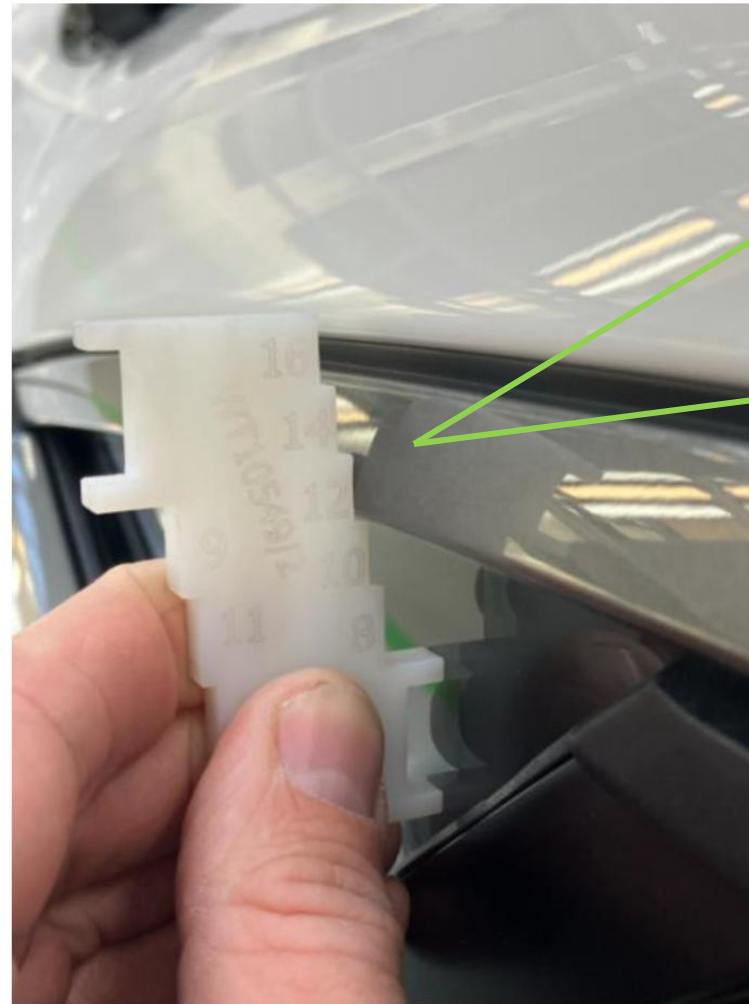
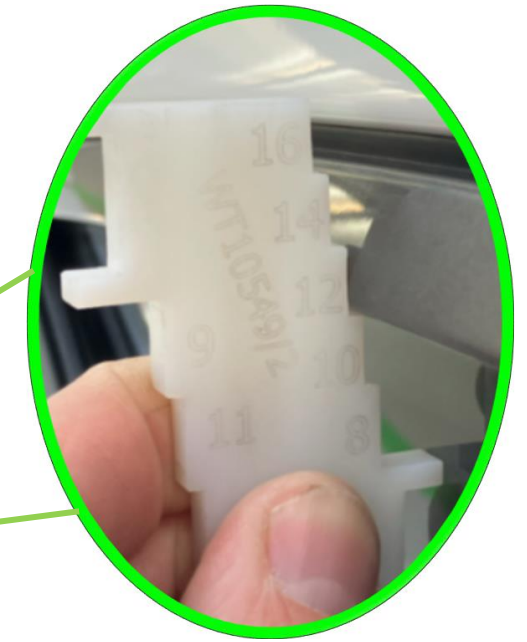
# PROFILE POINT 1

50mm in front of front div  
bar

Flat against glass to  
brightware

**Specification**  
10mm  $\pm$  1mm  
(Profile Tool WT10549/2)

If the measurement is out of  
specification refer to ElsaPro  
**Repair Group 64 'Slide glass  
checking and adjusting'**

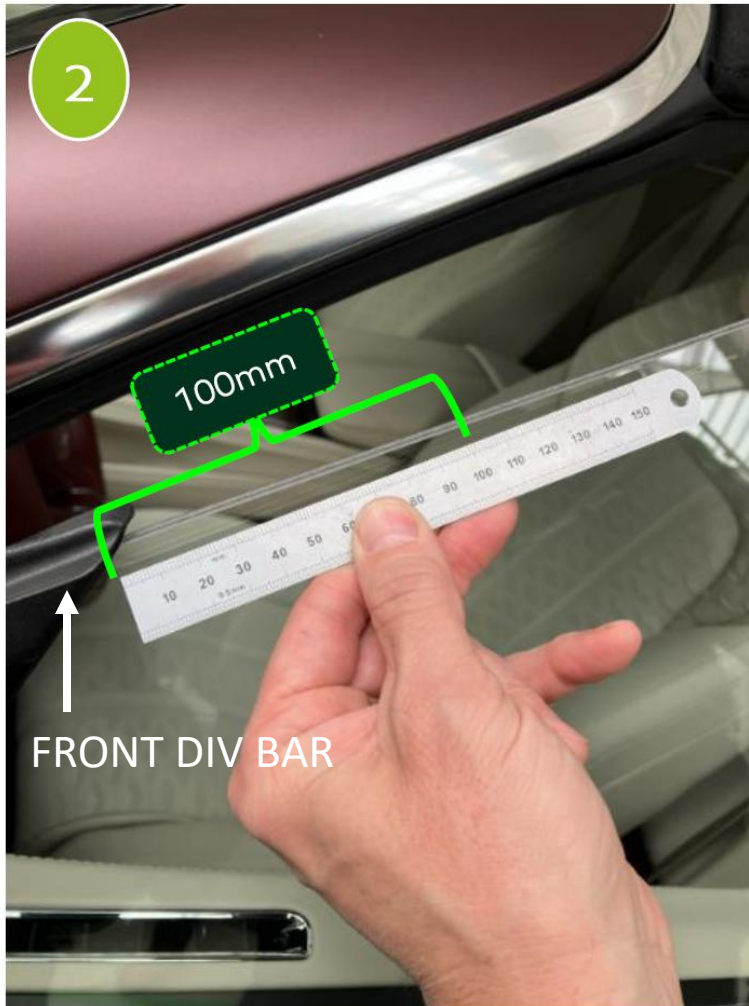
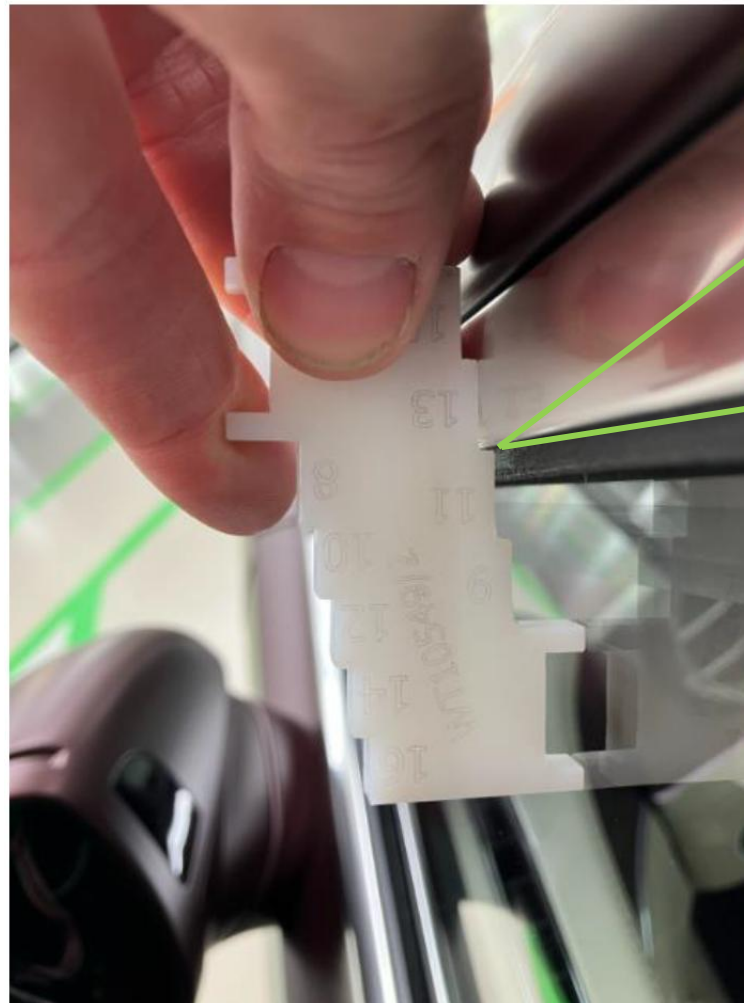
# PROFILE POINT 2

Place block 50mm in front of front div bar

Flat against glass to brightware

**Specification**  
14mm ± 2mm  
(Profile Tool WT10549/2)

If the measurement is out of specification refer to ElsaPro Repair Group 64 'Slide glass checking and adjusting'

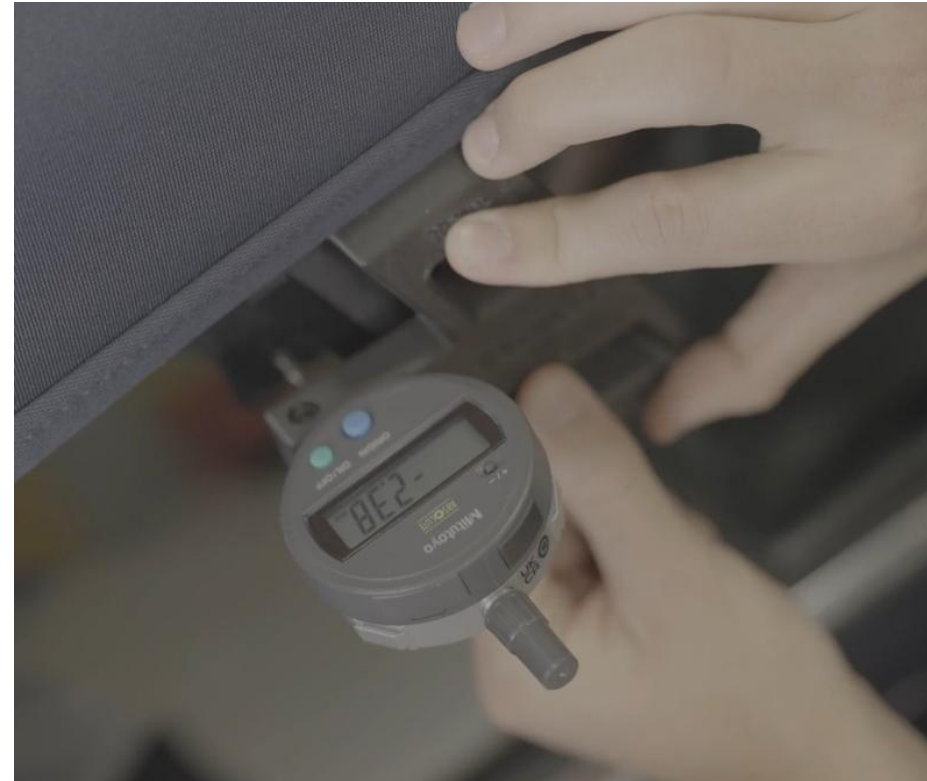
# PROFILE POINT 3 ROOF UP (DIGITAL DTI GAUGE - LATEST TOOL)

**Specification**  
0mm +0 / -2.5mm

If the measurement is out of specification refer to ElsaPro

**Repair Group 64**  
**'Slide glass checking and adjusting'**

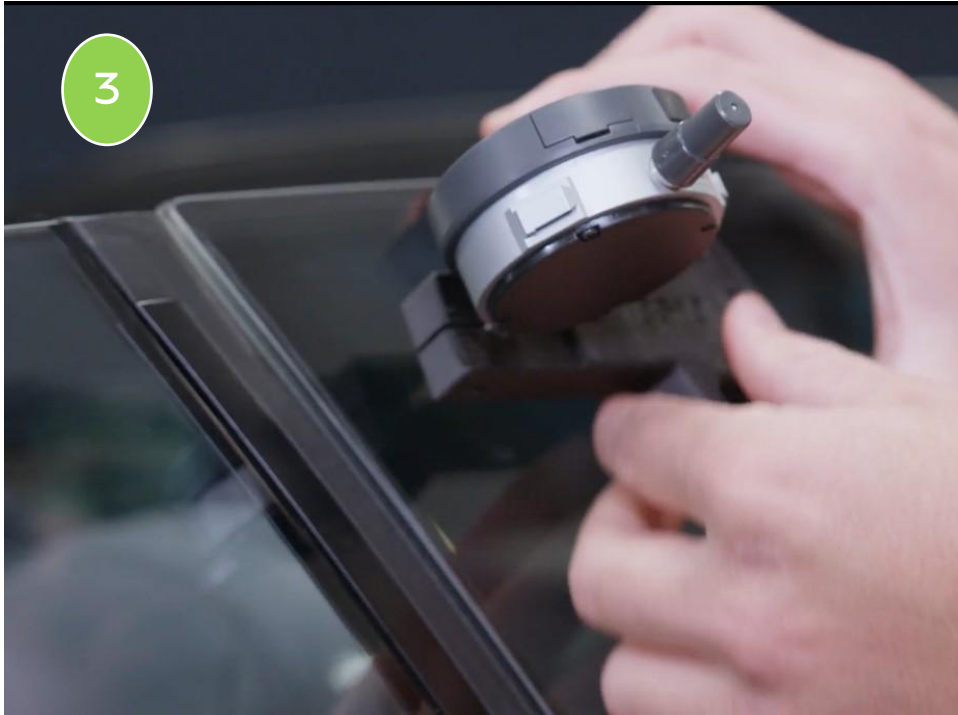
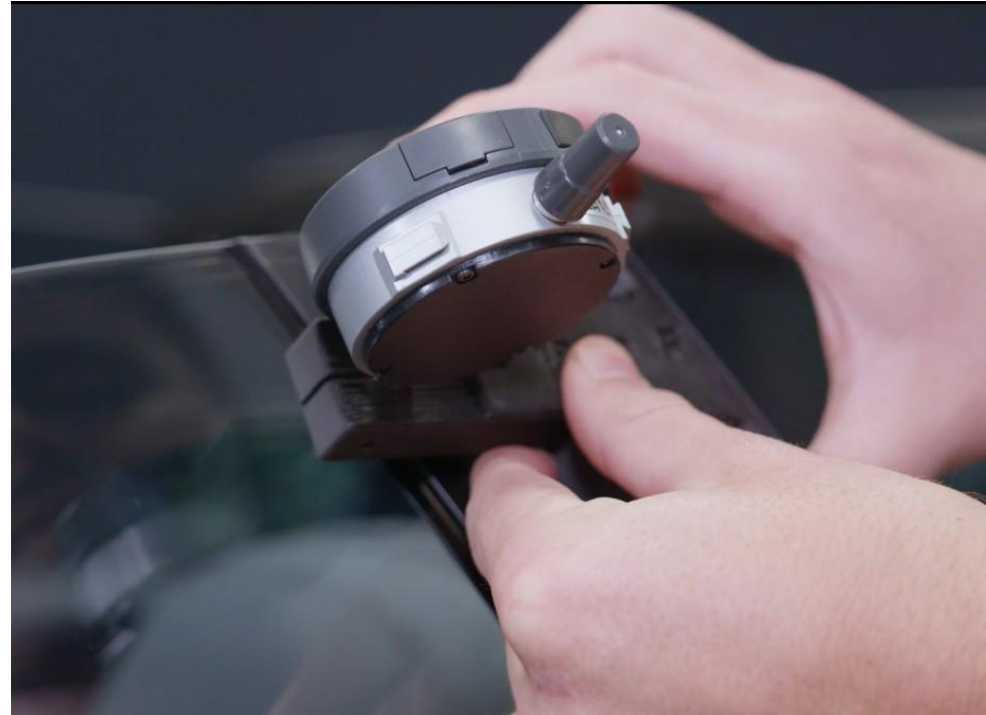
## PROFILE POINT 3 ROOF DOWN (DIGITAL DTI GAUGE - LATEST TOOL)

**Specification**  
0mm +0 / -3mm

**Repair Group**  
**64 'Slide glass checking and adjusting'**

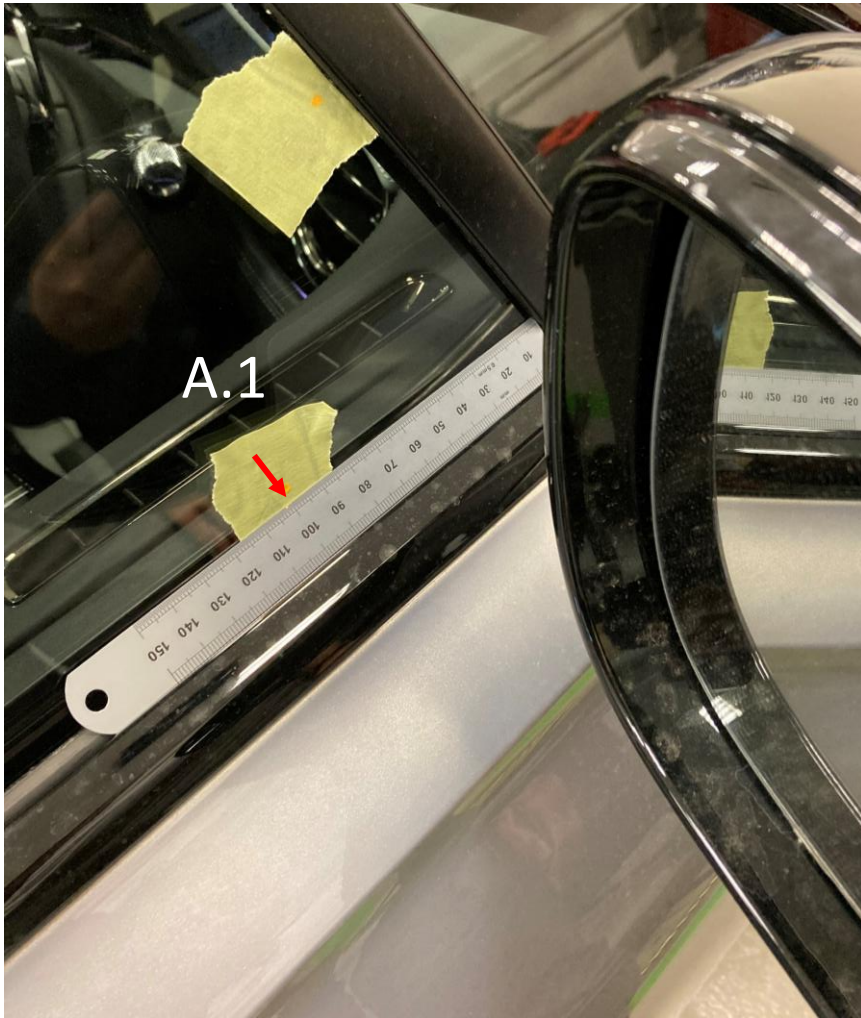
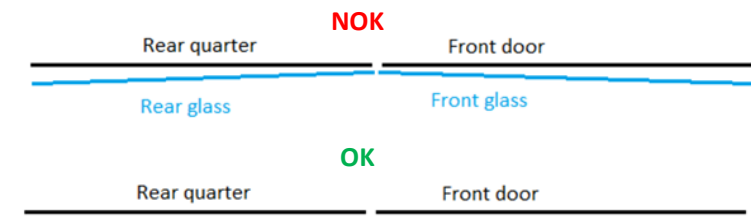
# WAIST SEAL MEASUREMENT POINT A

Mark on tape 100mm from div bar (A.1)

Measure from first lip rubber seal to window glass (A.2)

See image below, for OK and NOK after adjustment/checking

**Repair Group 64 'Slide glass checking and adjusting'**

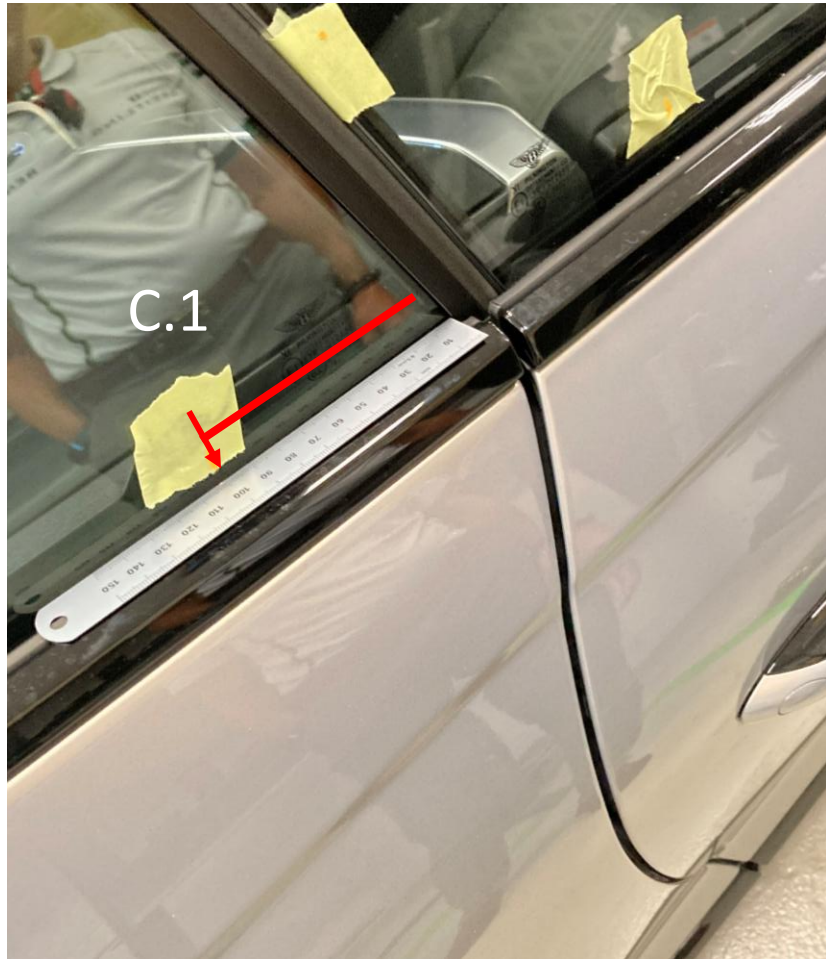
# WAIST SEAL MEASUREMENT POINT C

Mark on tape 100mm from div bar (C.1)

Measure seal to window gap (C.2)

If the measurement is out of specification refer to ElsaPro **Repair Group 64** 'Slide glass checking and adjusting'

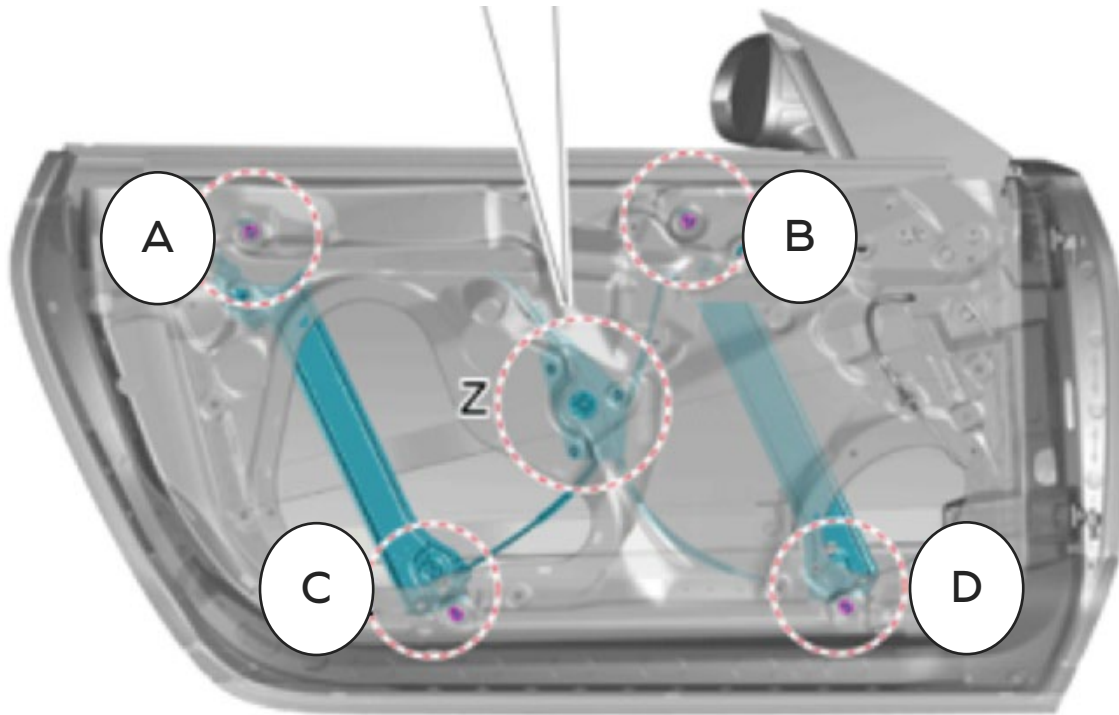
Figure 2

In instances of multiple window drop concerns it has been found that to achieve the glass set specification, some adjusters are being adjusted out of specification.

In some cases, since not all adjusters are visible, there is a possibility that the adjusters can be set to their maximum inboard/outboard and induce excess tension in the regulators and affect the angle the windows enter the seals. There is free play built into the front and rear regulators, therefore as the windows are being held in place by the cant rail/convertible roof seals when closed, this may not be apparent when measuring. However, these extreme adjustments can cause issues with how the windows enter the cant rail/convertible roof seals or how the front and rear glasses interlock with each other, in some cases this can cause the seals to pinch and cause an anti-trap condition leading to window reversal.

D = To reset this adjuster without removing the quarter glass fully screw in clockwise until hard stop, then unscrew 8.5 turns anticlockwise relock the lock nut.

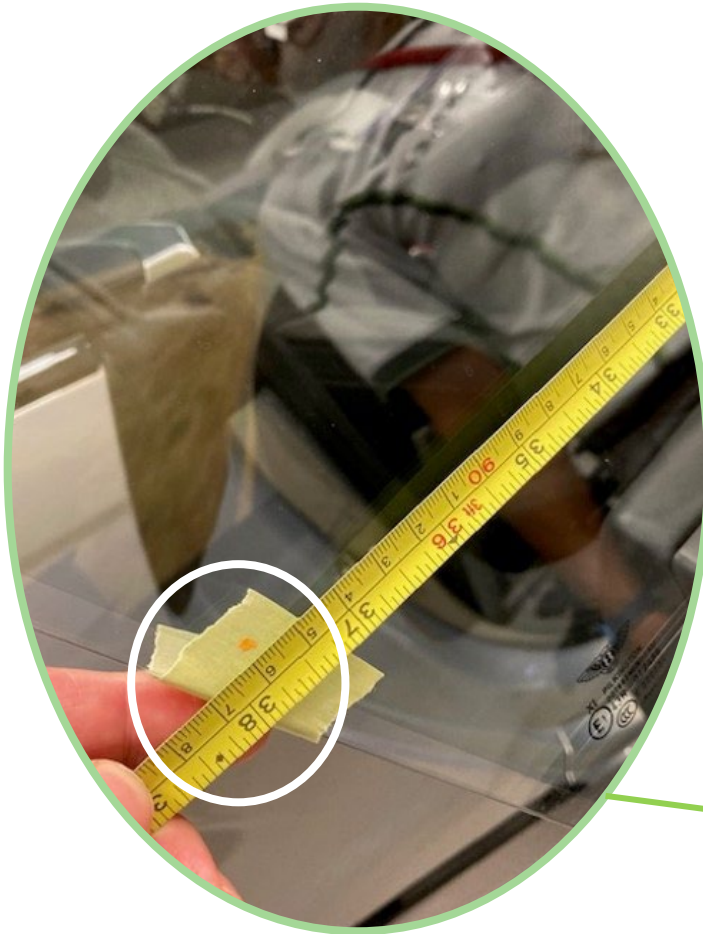
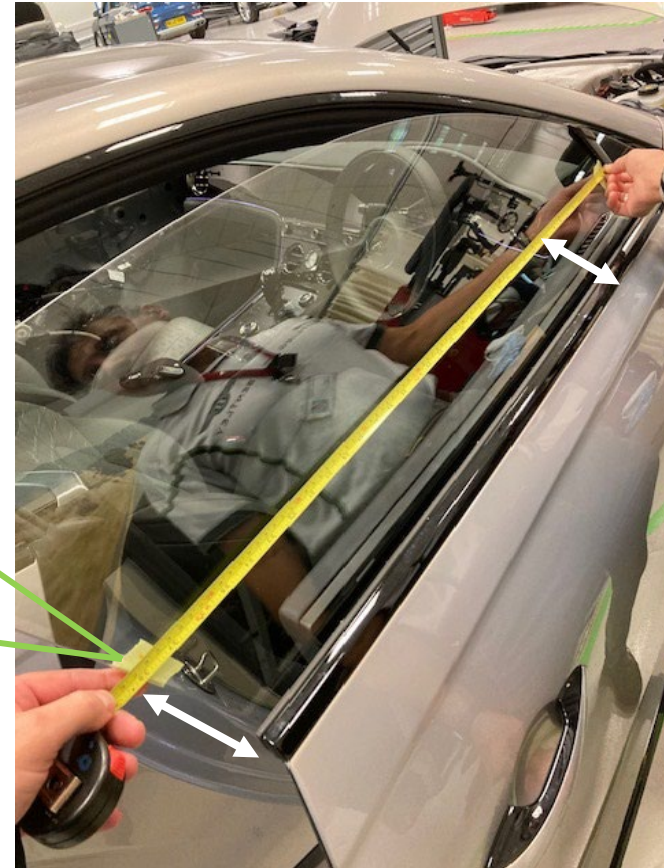
## Measuring from front div bar to rear of the glass

**Specification**  
971mm +2mm

Measure 100mm up from  
the waist rail

If out of specification, refer to the next slide to adjust the glass position
