Technical Service Bulletin

26-EM-012H

PALISADE (LX2)

SUBJECT: OIL LEAK – ENGINE OIL FILTER HOUSING SEAL REPLACEMENT
(WARRANTY EXTENSION Z15)

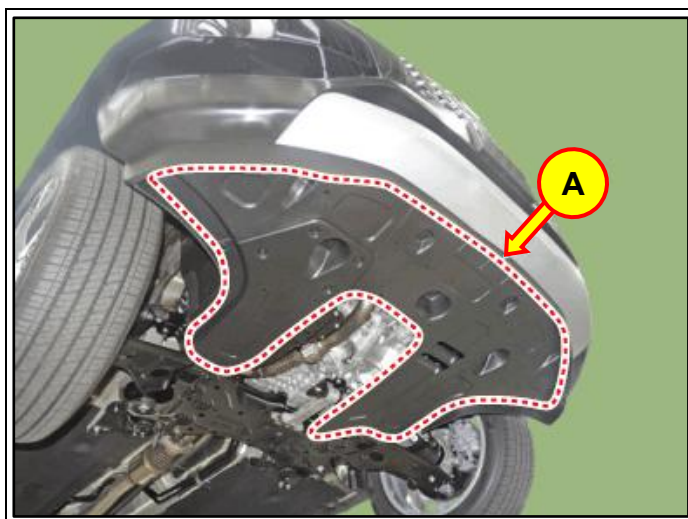
2. Remove the engine room under cover (A) by referring to the shop manual:
 - **Engine Mechanical System > Engine and Transaxle Assembly > Engine Room Under Cover > Repair procedures**
