| <b>HYUNDAI</b><br><b>Technical Service Bulletin</b> | GROUP<br><b>BODY</b> | NUMBER<br><b>26-BD-003H</b> |
| | DATE<br><b>JULY 2026</b> | MODEL(S)<br><b>SANTA CRUZ (NXT)</b> |
| <b>SUBJECT:</b> TONNEAU COVER INSPECTION & REPAIR GUIDE | | |

**This TSB supersedes 25-BD-011H-1 to update the “Tonneau Cover Repair” procedure by adding steps 4 – 6 on pages 10-11 for re-tensioning the tonneau cover (Tonneau Cover Repair).**

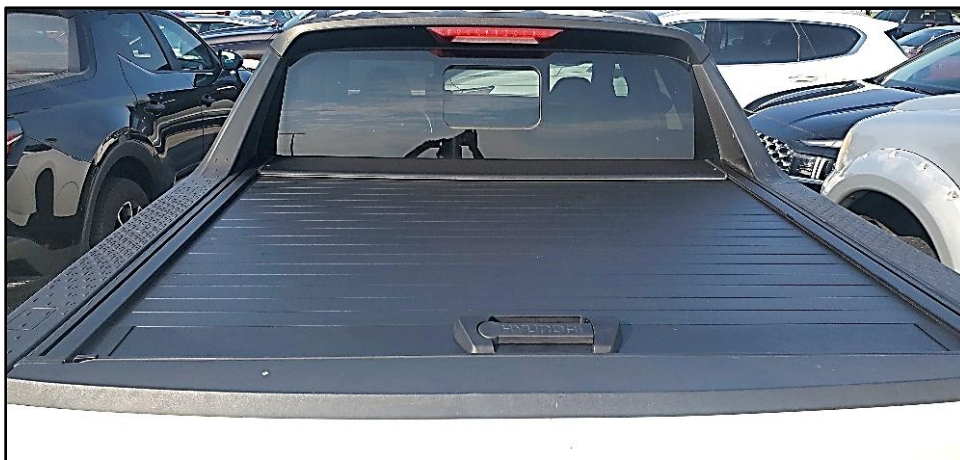
**Description:** Some Santa Cruz (NXT) vehicles may have a tonneau cover that does not latch or unlatch, does not retract properly, and/or has a v-gap that is present when closed. This may be due to a broken or missing clip on the underside of the tonneau cover. This bulletin provides instructions to inspect and, if necessary, repair the tonneau cover function using the Tonneau Cover Repair Kit or by replacing the tonneau handle and latch assembly.

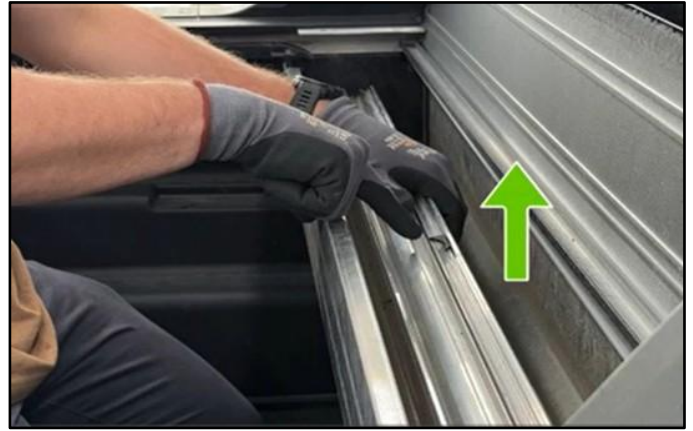
4. Check the tonneau cover for tension:
  - If the tonneau cover does **NOT** have any tension on it (**ALL** three rubber straps [G] are broken), continue to **step 5**.
  - If the tonneau cover has tension on it, proceed to **step 7**.

5. Rotate the axle to position the broken strap pieces in the 12 o'clock position.

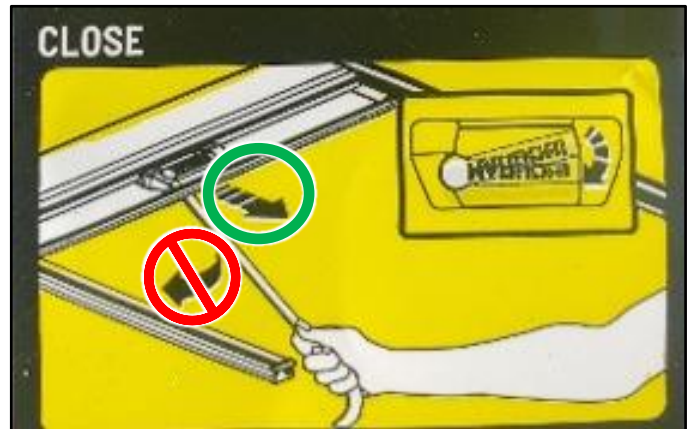
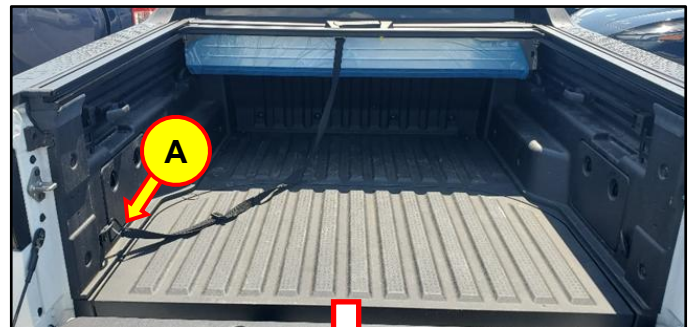
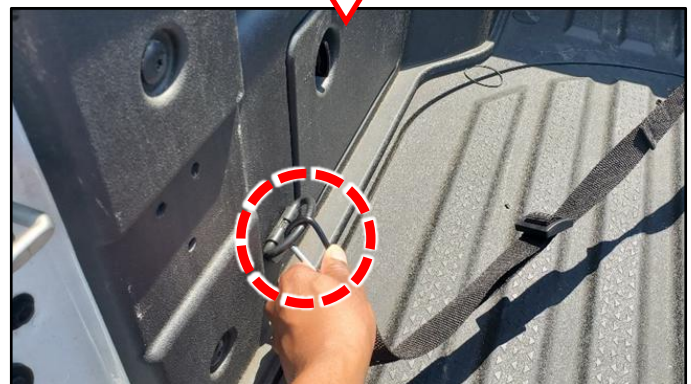
- **ONLY** use the pull strap or center handle to close the tonneau cover.
- The tonneau cover should **ONLY** be closed by pulling from the center.
- Do **NOT** pull from the sides.
- Alignment / retraction problems may occur if the tonneau cover is repeatedly improperly closed.

Do **NOT** slam the tonneau cover closed with excessive force. This may cause damage to the cover.

- Secure the pull strap (A) to either side of the bed when **NOT** in use.
- Pulling the strap to the left will reset the latch center handle position.
