# HYUNDAI

## Technical Service Bulletin

| GROUP<br><b>CAMPAIGN</b> | NUMBER<br><b>26-01-051H</b> |

**SUBJECT:** AC NOT TURNING OFF - ATCU SOFTWARE UPDATE  
(LIMITED COVERAGE CAMPAIGN LA29)

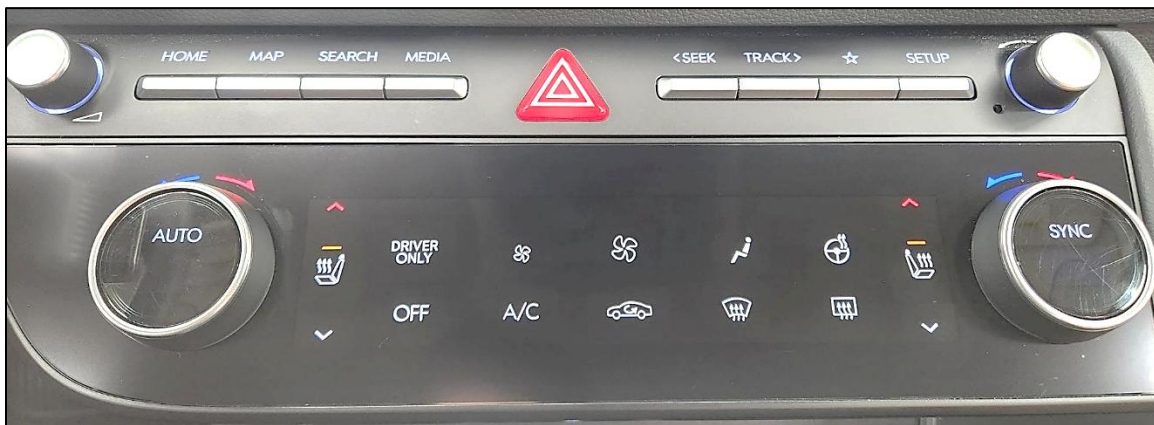
**Description:** Certain Sonata (DN8) vehicles may exhibit intermittent battery discharge condition due to the air conditioning controller not fully powering down after the vehicle is turned off and parked. This bulletin provides the procedure to update the ATCU (Air Temperature Control Unit) software; the revised logic improves controller shutdown to prevent battery drain and corrects a condition where the HVAC control display may appear blank when climate remote start is activated via Bluelink.
