## Technical Service Bulletin (TSB)

### Sunroof Shade Binding

| REFERENCE: | TSB: 23-027-26<br>GROUP: 23 - Body | Date: | July 15, 2026 | REVISION: | — |
| VEHICLES AFFECTED: | 2026 (WL) Jeep Grand Cherokee / Grand Cherokee L<br>This bulletin applies to vehicles built on or after May 04, 2026 (MDH 0504XX) and equipped with a Dual-Pane Panoramic Sunroof (Sales Code GWJ). | | | MARKET APPLICABILITY:<br><div><input checked="" type="checkbox"/> NA<input type="checkbox"/> CH</div> <div><input type="checkbox"/> EE<input type="checkbox"/> IAP</div> <div><input type="checkbox"/> SA<input type="checkbox"/> MEA</div><br><b>NOTE:</b> This bulletin applies to the North America markets. | |

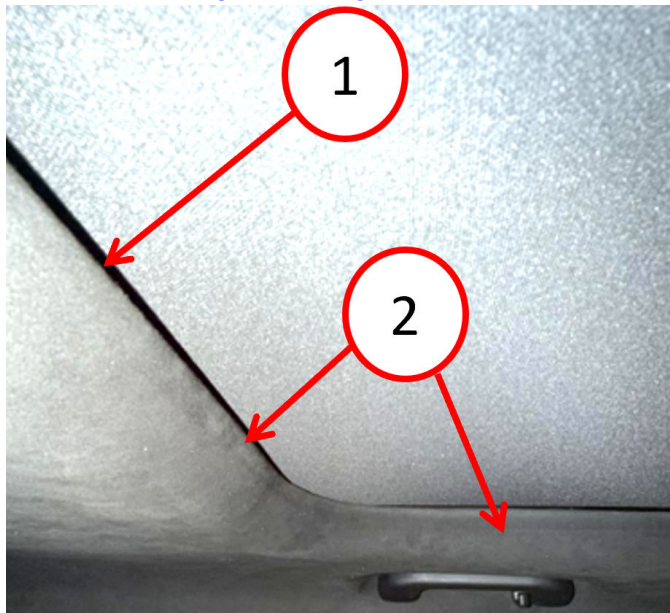
**Fig. 2**

Two Of Four Hook And Loop Fasteners To Release

2. From the rear of the sunroof opening, release the four hook and loop fasteners from around the sunroof opening by pulling down on the headliner [Fig. 2](#) and [Fig. 3](#).

6. Carefully remove the foam pad from the microphone connector and headliner, and relocate the foam pad to behind the microphone [Fig. 5](#).
7. Fasten the headliner to the four hook and loop fasteners [Fig. 2](#) and [Fig. 3](#).
8. Install the trim ring on the dome lamp/Fam Cam interior camera [Fig. 1](#).

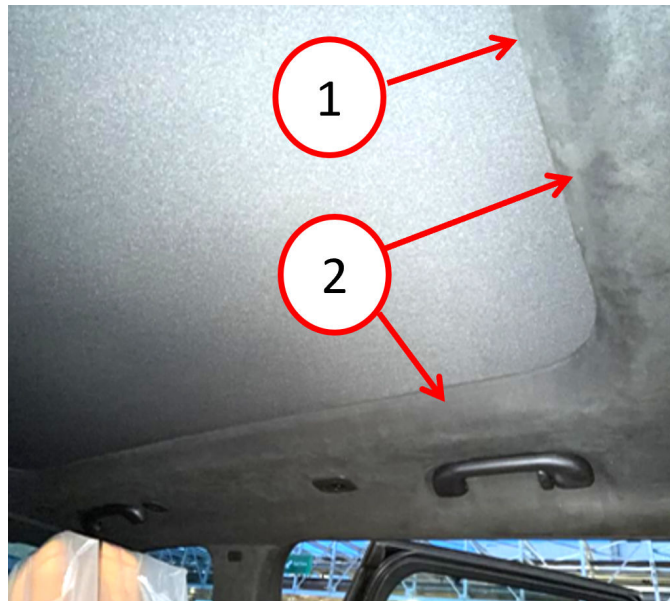
**Fig. 3**

Four Of Four Hook And Loop Fasteners To Release
