**Technical Service Bulletin (TSB)**  
**Sunroof Shade Binding**

| REFERENCE: | TSB: 23-027-26 REV. A<br>GROUP: 23 - Body | Date: | July 17, 2026 | REVISION: | 23-027-26 |
| VEHICLES AFFECTED: | 2026 (WL) Jeep Grand Cherokee / Grand Cherokee L<br>This bulletin applies to vehicles built on or after **May 01, 2026 (MDH 0501XX) and on or before May 08, 2026 (MDH 0508XX)** equipped with a Dual-Pane Panoramic Sunroof (Sales Code GWJ). | | | MARKET APPLICABILITY:<br><div><input checked="" type="checkbox"/> NA<input type="checkbox"/> CH</div> <div><input type="checkbox"/> EE<input type="checkbox"/> IAP</div> <div><input type="checkbox"/> SA<input type="checkbox"/> MEA</div><br><b>NOTE:</b> This bulletin applies to the North America markets. | |

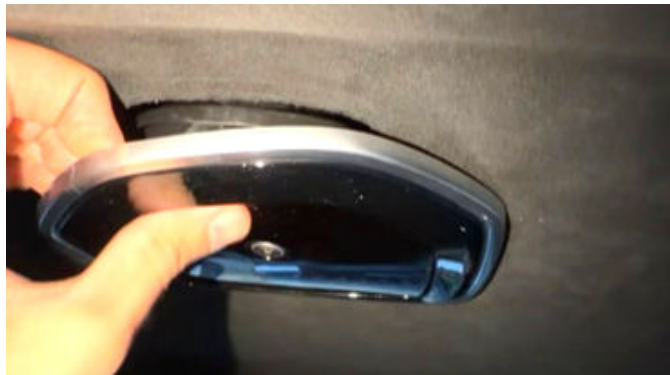
**Fig. 1**

Dome Lamp/Fam Cam Trim Ring

1. Using a trim stick or equivalent, remove the trim ring from the dome lamp/Fam Cam interior camera [Fig. 1](#).

7. Carefully remove the foam pad from the microphone connector and headliner, and relocate the foam pad to behind the microphone [Fig. 5](#).
8. Fasten the headliner to the four hook and loop fasteners [Fig. 2](#) and [Fig. 3](#).
9. \*\*Install the second row grab handles. Refer to the detailed service procedures listed in DealerCONNECT> Service Library under: 23 - Body / Interior / Handle, Grab / Installation.\*\*
10. Install the trim ring on the dome lamp/Fam Cam interior camera [Fig. 1](#).

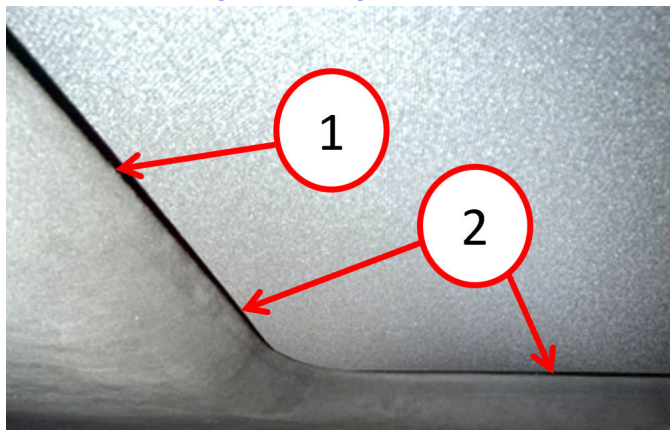
**Fig. 2**

Two Of Four Hook And Loop Fasteners To Release

2. \*\*Remove the second row grab handles. Refer to the detailed service procedures listed in DealerCONNECT> Service Library under: 23 - Body / Interior / Handle, Grab / Removal.\*\*
3. From the rear of the sunroof opening, release the four hook and loop fasteners from around the sunroof opening by pulling down on the headliner [Fig. 2](#) and [Fig. 3](#).

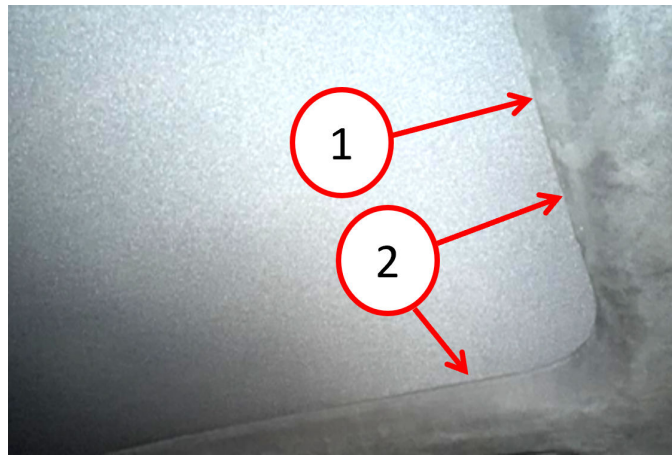
**Fig. 3**

Four Of Four Hook And Loop Fasteners To Release
