Service Campaign ID: 76 – 02 Trimark PTL Doors

Issued Date: July 1, 2026

# Technical Service Bulletin

## TSB102

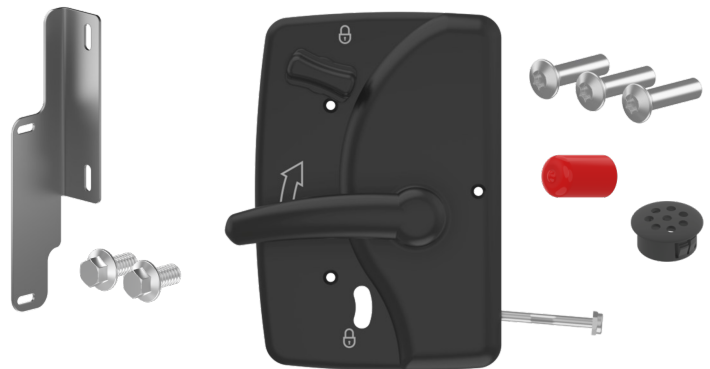
- Technical Service Bulletin
- L Bracket & 2 Fasteners
- Red Vinyl Cap (provided as spare)
- Inside Handle Assembly
- 3 Torx Head Screws (provided as spare)
- Plastic Cap
