## Technical Service Bulletin

Transaction No.: **2069594/3**

60 Sloshing noises from roof area when vehicle is moving, water under front trim

Release date: Jul 27, 2026

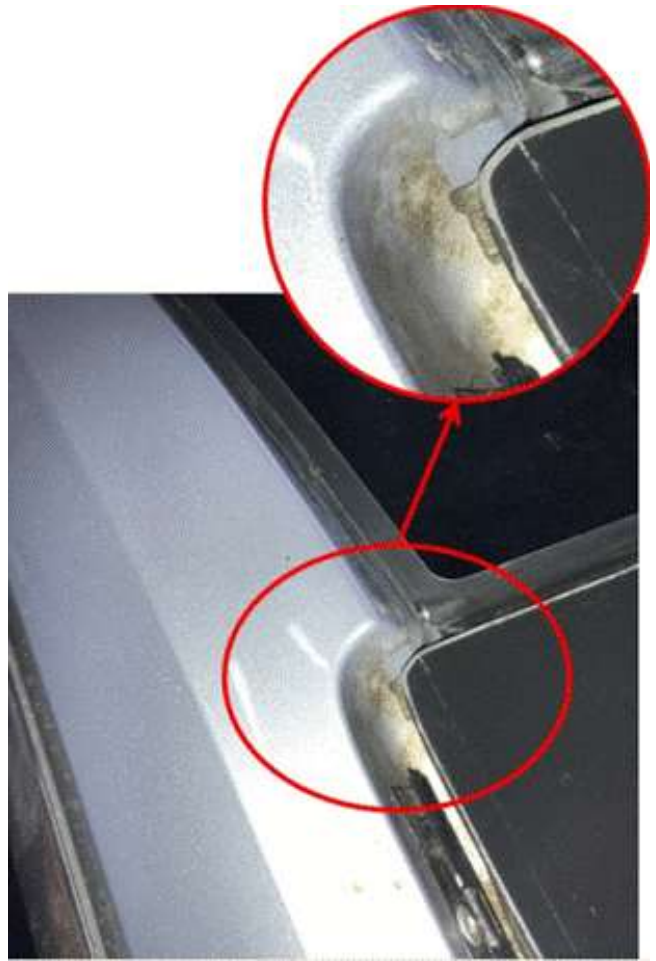
**Figure 9.** *Dirt removed.*

6. Now take a pneumatic gun and loosen the dirt. **The pneumatic gun must also be held pointed upwards so that the dirt under the front trim is also loosened.** (Figures 8 and 9).

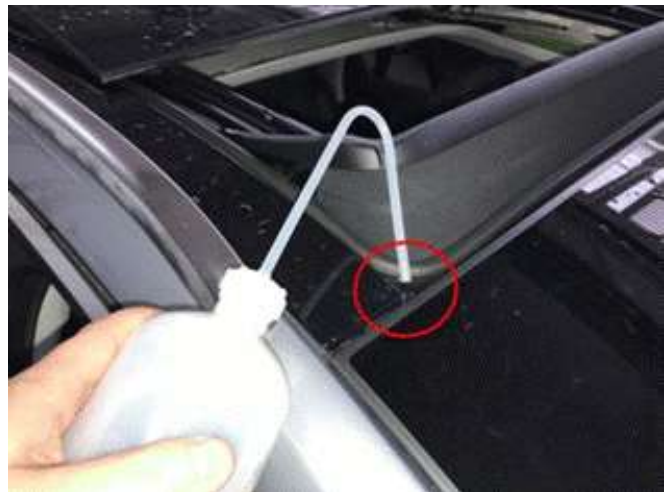
**Figure 10.** *Rinsing the drainage channels.*

7. The sunroof frame area must then be cleaned thoroughly from above with water and detergent. (Figures 10, 11 and 12).

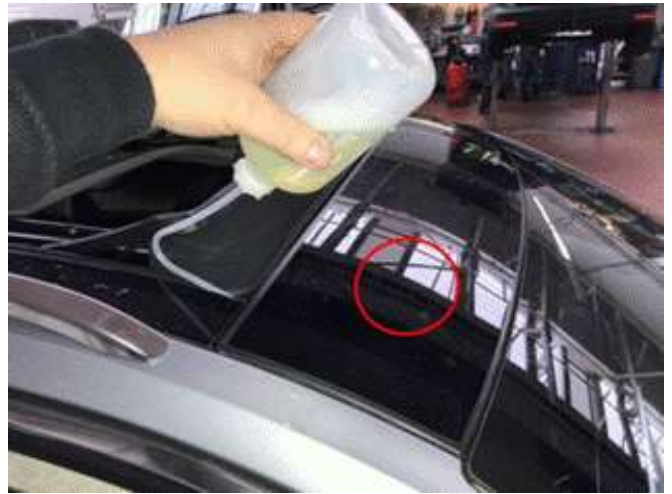
**Figure 11.** Rinsing the drainage channels.

8. If necessary, repeat the cleaning procedure multiple times until no more dirt particles are visible.

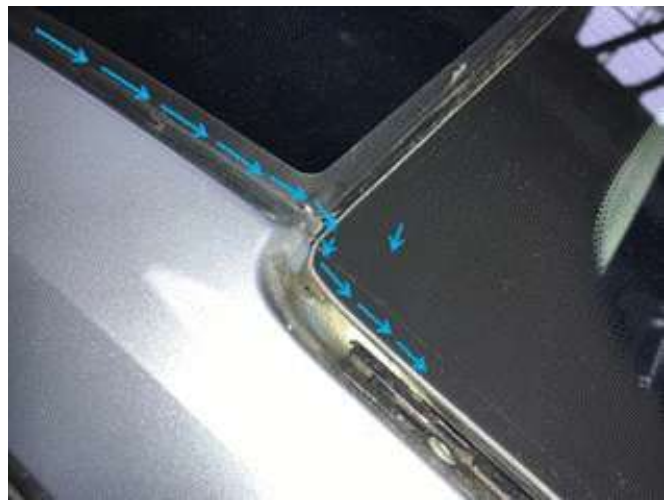
**Figure 12.** Drainage channels rinsed.

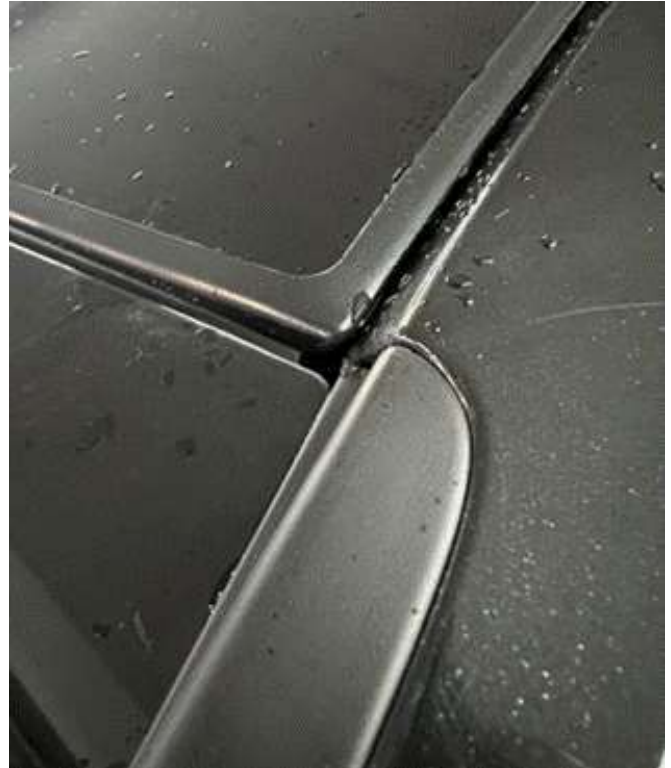
**Figure 15.** Water deflector reinstalled.

10. Finally, fit the water deflector on the A-pillar again. (Figure 15).
