Mitsubishi Motors North America, Inc.

TECHNICAL SERVICE BULLETIN

**HOOD FLUTTER  
MY 2022 OUTLANDER**

No: TSB-26-42A-002

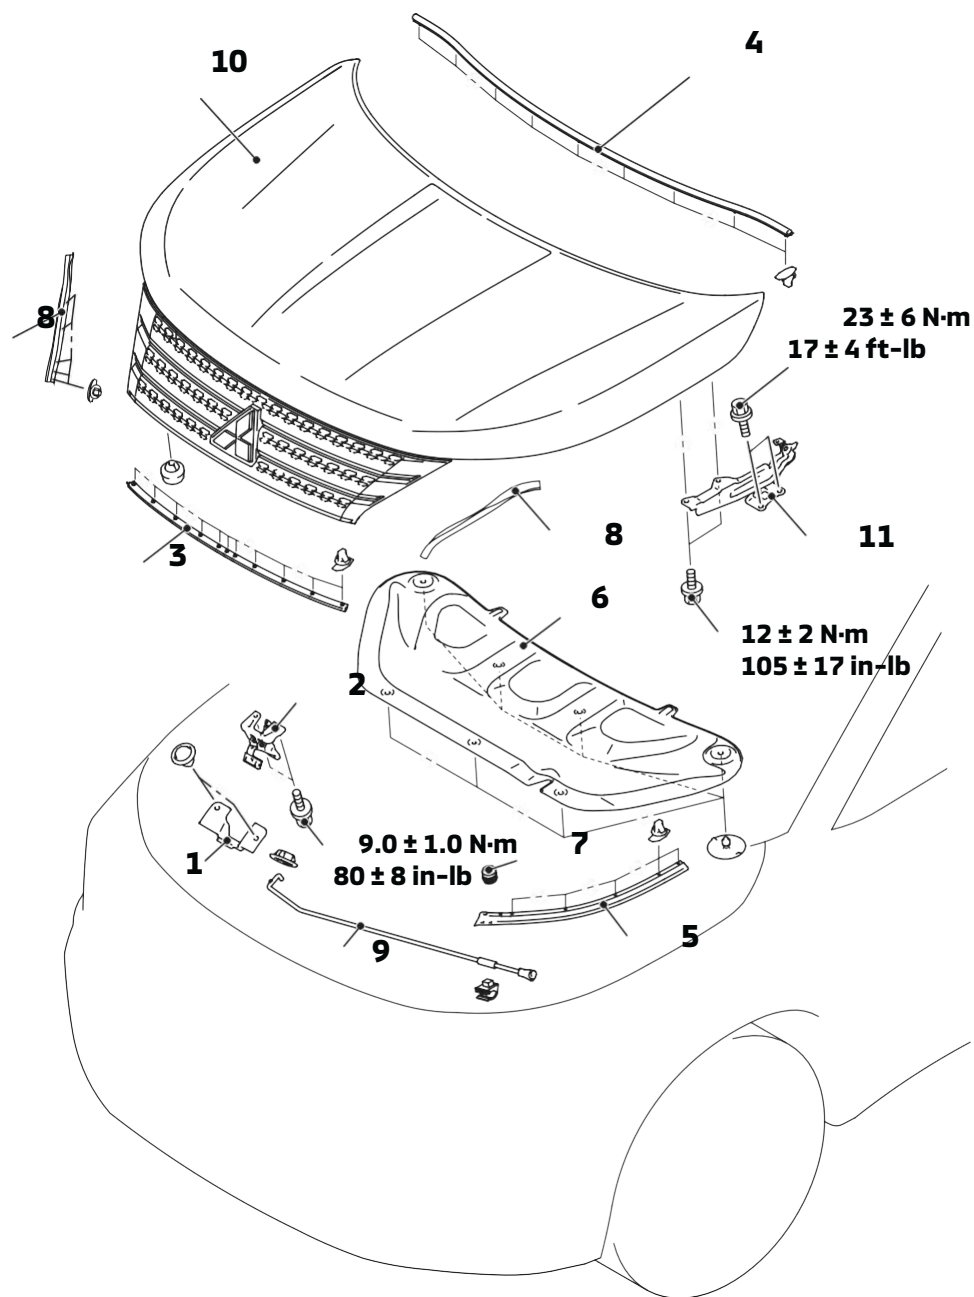
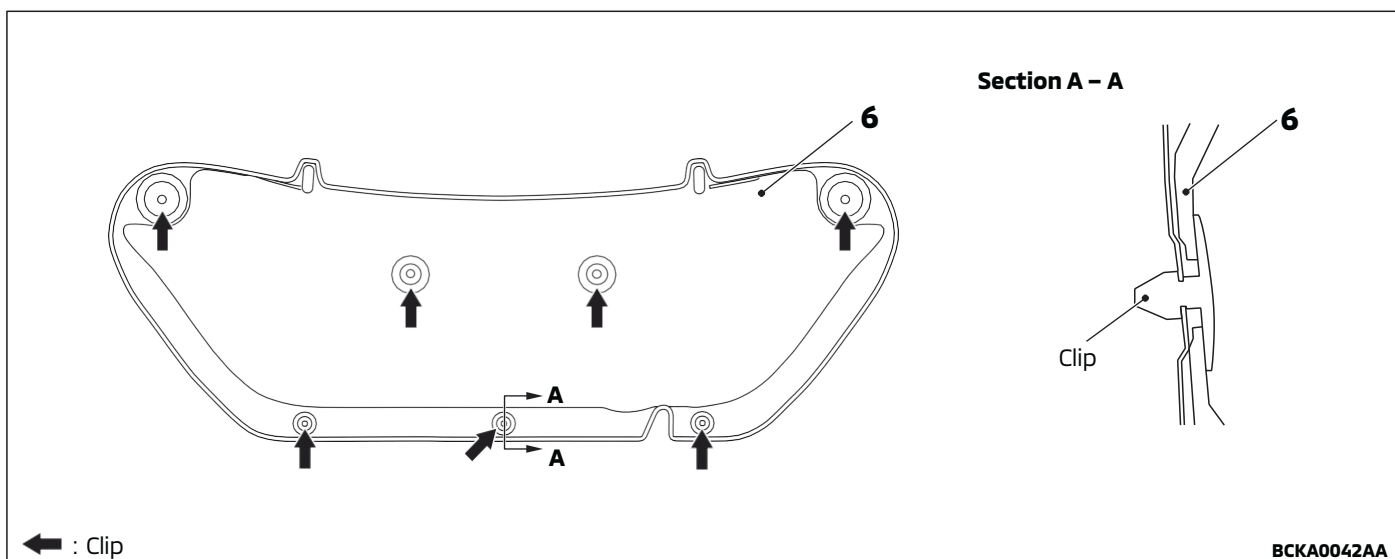
### REMOVAL AND INSTALLATION

Hoods of certain 2022 Mitsubishi Outlander vehicles are defective because they flutter and bounce while driving.

Insufficient hood reinforcement

All vehicles equipped with a NON REINFORCED hood will require the engine hood to be replaced with the updated reinforced hood design.
