## Technical product information

| <b>Topic</b> | Window Drop Glass Operation Continental GT/GTC 19-24MY |
| <b>Transaction No.</b> | 2080375/4 |

Window Drop Glass Operation | Continental GT/GTC |19-24MY

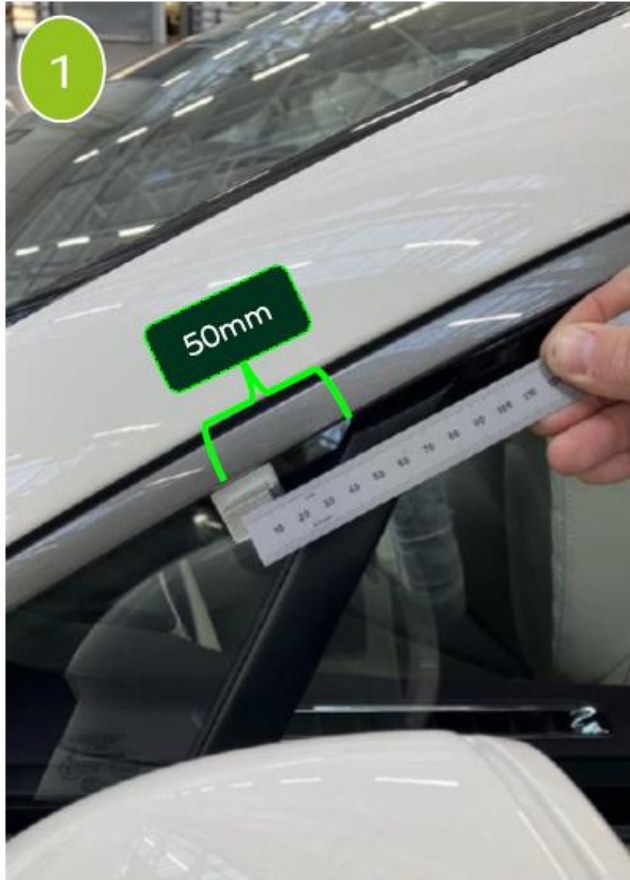
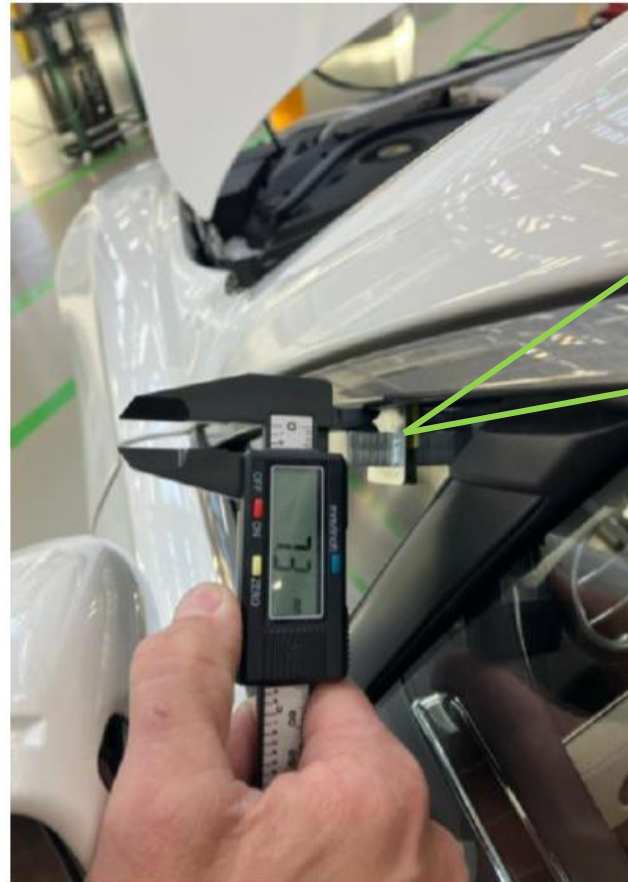
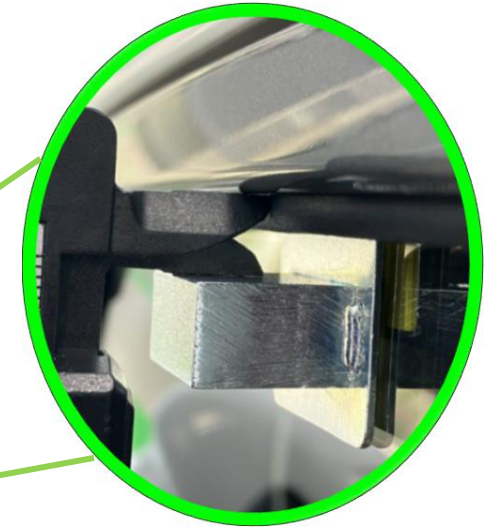
# INTERLOCK POINT 1

Place block 50mm in front of front div bar

Record measurement for all interlock points

From block to bright ware for all interlock points

**Specification**  
7.5mm  $\pm$  1mm  
(Interlock Tool WT10549/1)  
If the measurement is out of specification refer to ElsaPro  
**Repair Group 64 'Front door quarter glass – To adjust'**

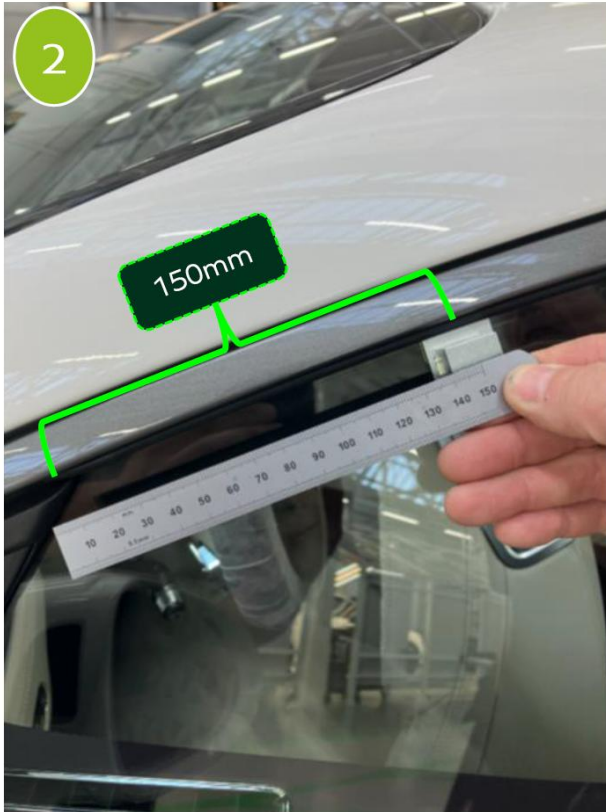
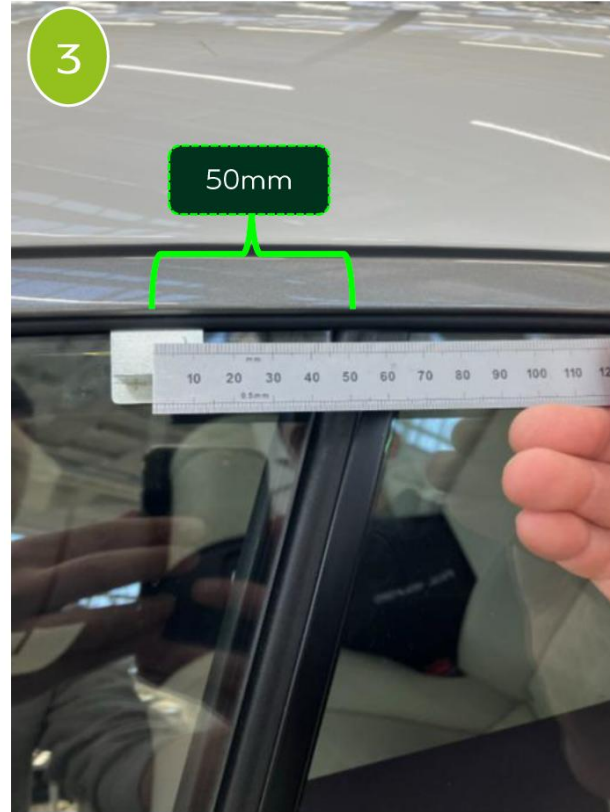
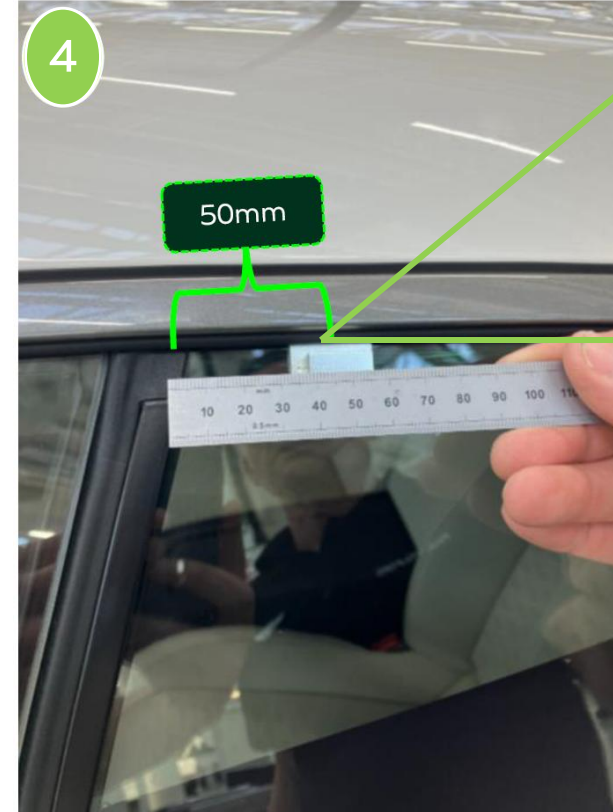
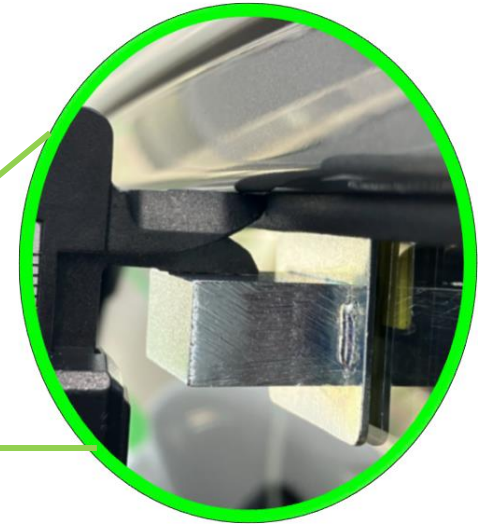
# INTERLOCK POINTS 2, 3, 4

Place block 150mm  
behind corner of  
front div bar

Place block 50mm  
in front of rear div  
bar

Place block 50mm  
to rear of rear div  
bar

**Specification**  
8mm ± 1mm  
(Interlock Tool WT10549)

If the measurement is  
out of specification  
refer to ElsaPro

**Repair Group 64 'Slide  
glass checking and  
adjusting'**

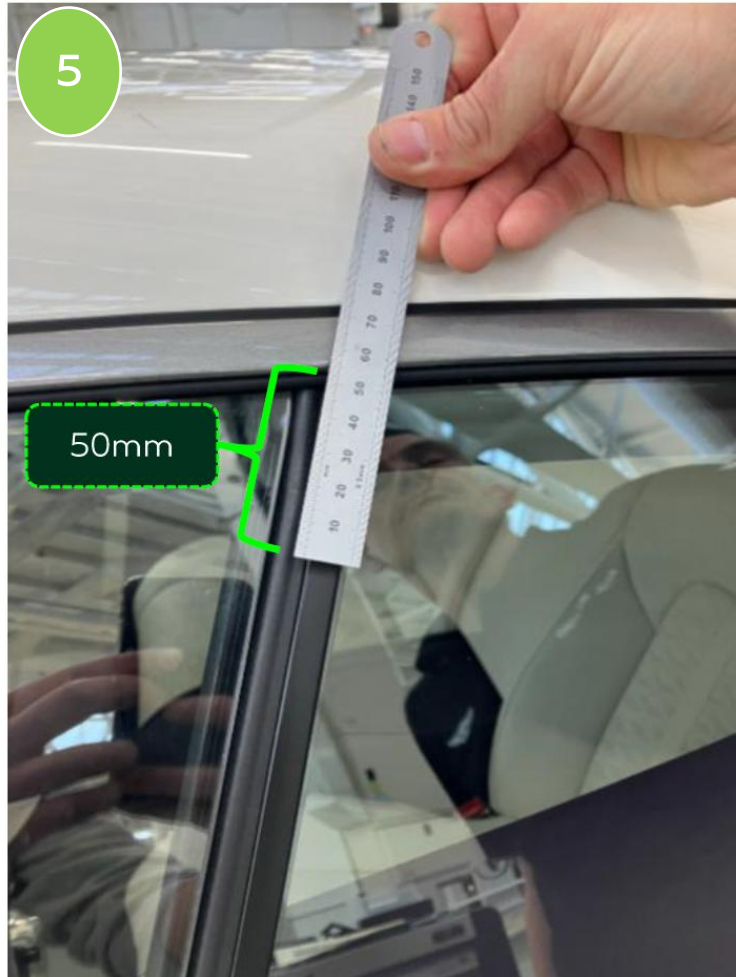
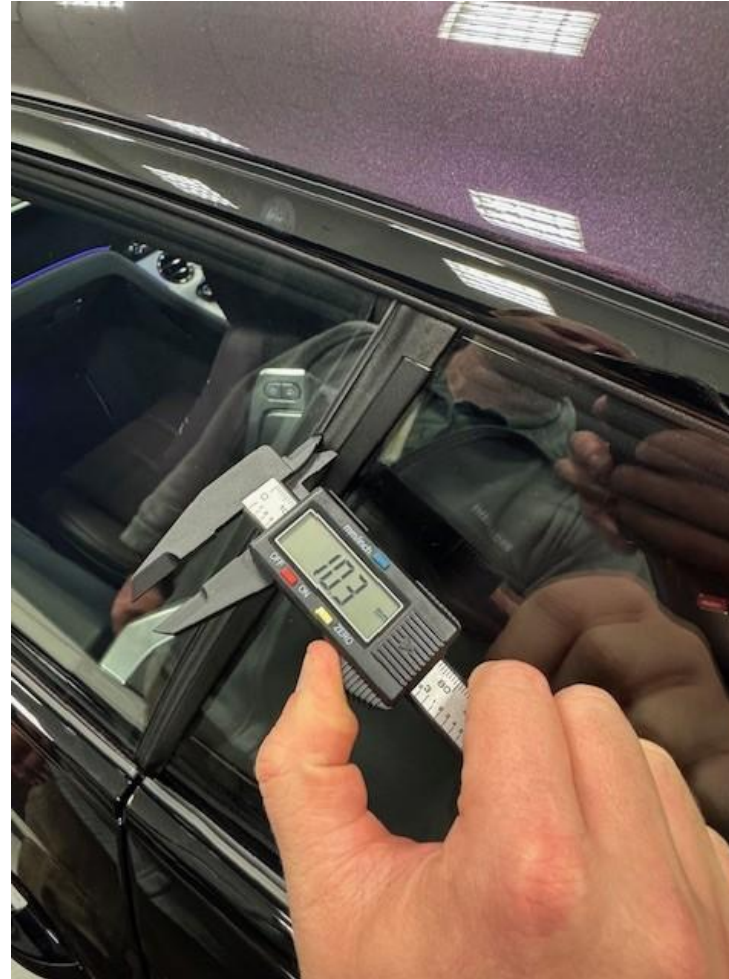
# INTERLOCK POINT 5

50mm from seal

Record measurement

**Repair Group 64 'Slide  
glass checking and  
adjusting'**

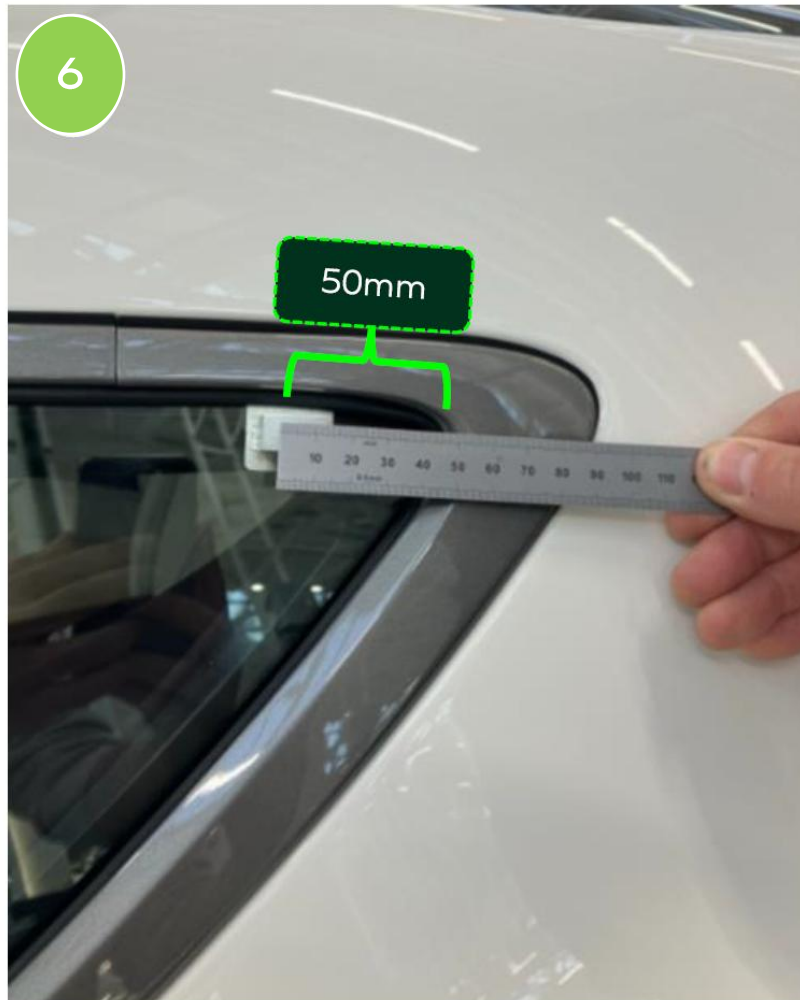
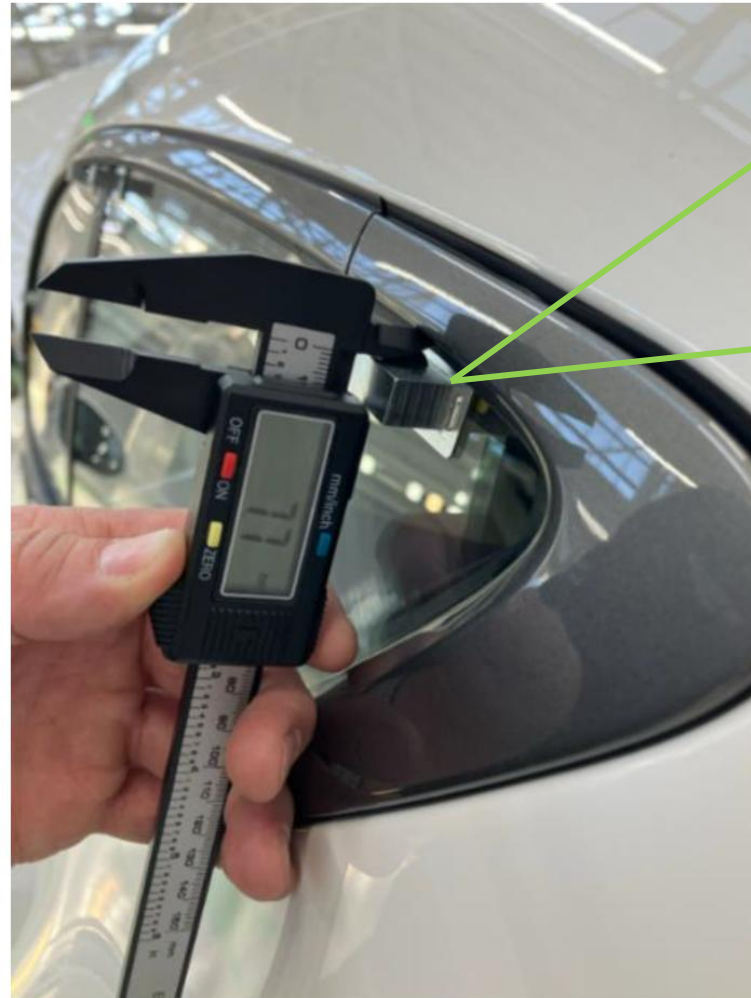
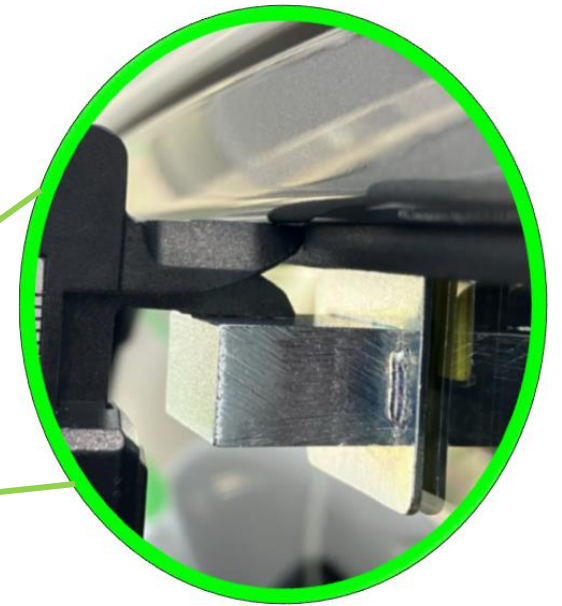
# INTERLOCK POINT 6

Place block 50mm from corner point of bright ware

Record measurement for all interlock points

**Specification**  
8mm  $\pm$  1mm  
(Interlock Tool WT10549/1)

If the measurement is out of specification refer to ElsaPro

**Repair Group 64 'Slide glass checking and adjusting'**

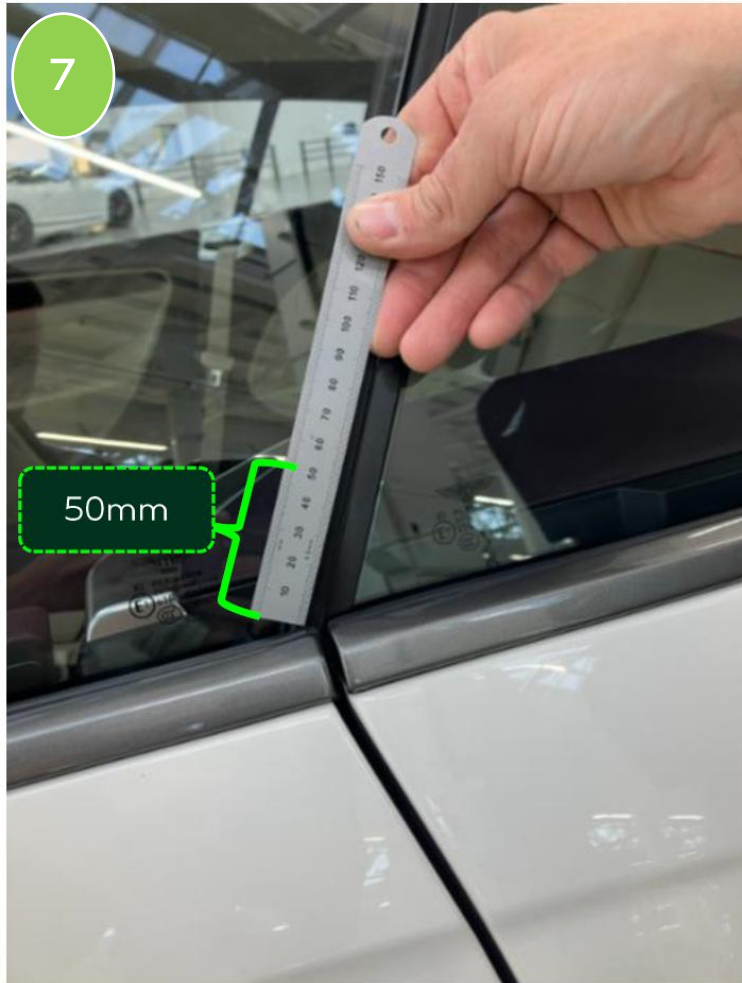
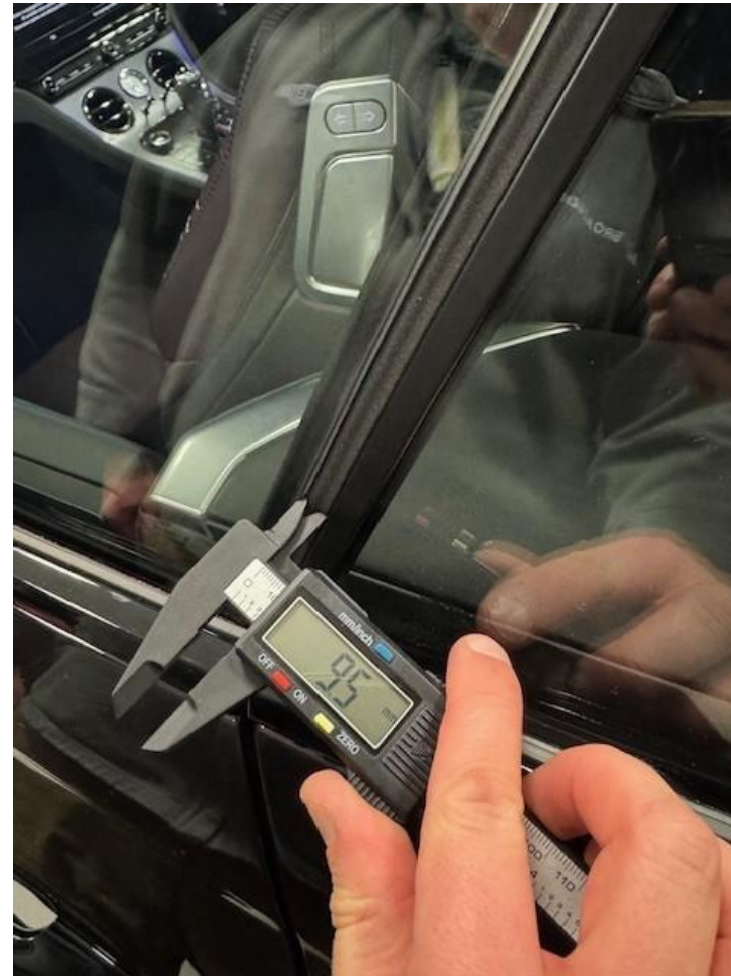
# INTERLOCK POINT 7

50mm from seal

Record measurement

**Repair Group 64 'Slide  
glass checking and  
adjusting'**

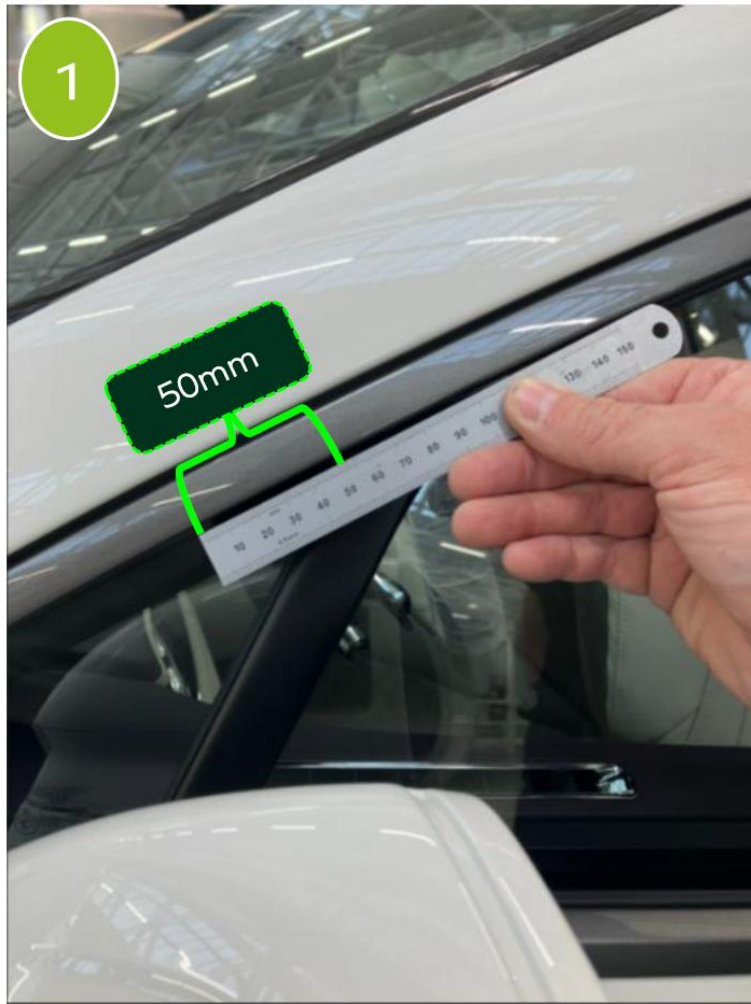
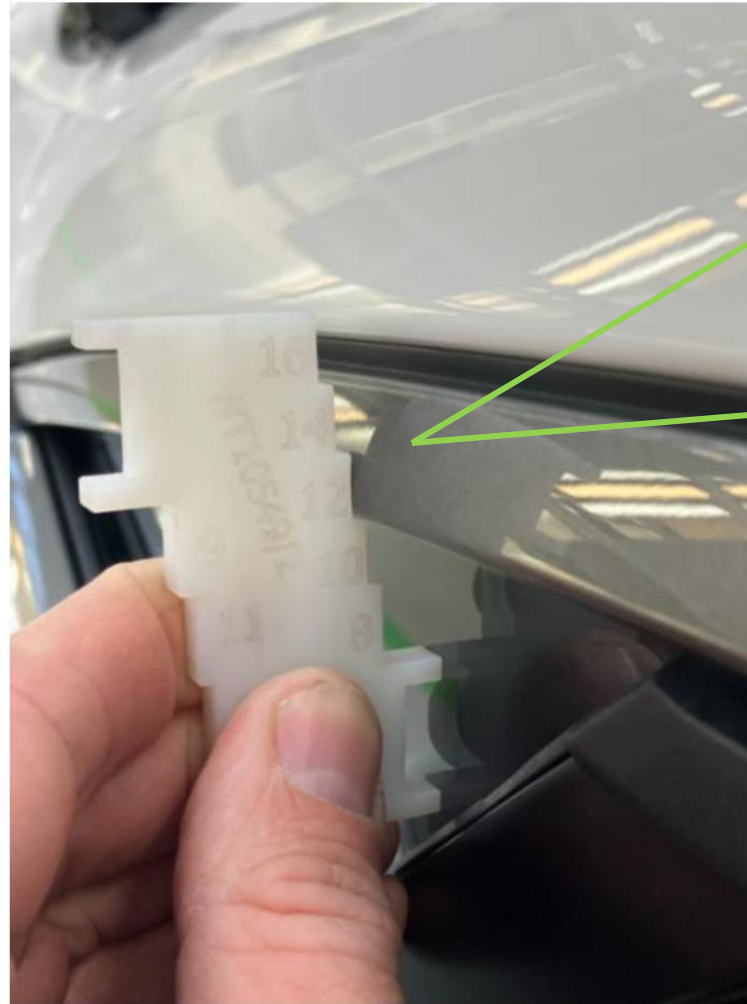
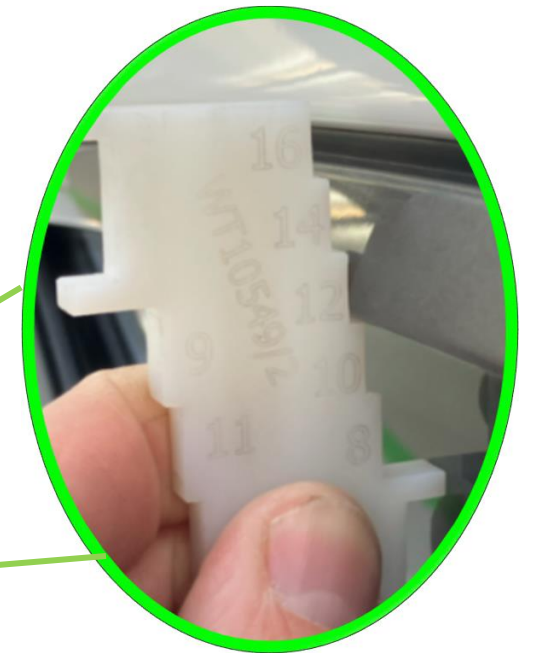
# PROFILE POINT 1

50mm in front of front div  
bar

Flat against glass to  
brightware

**Specification**  
10mm  $\pm$  1mm  
(Profile Tool WT10549/2)

If the measurement is  
out of specification refer  
to ElsaPro

**Repair Group 64 'Slide  
glass checking and  
adjusting'**

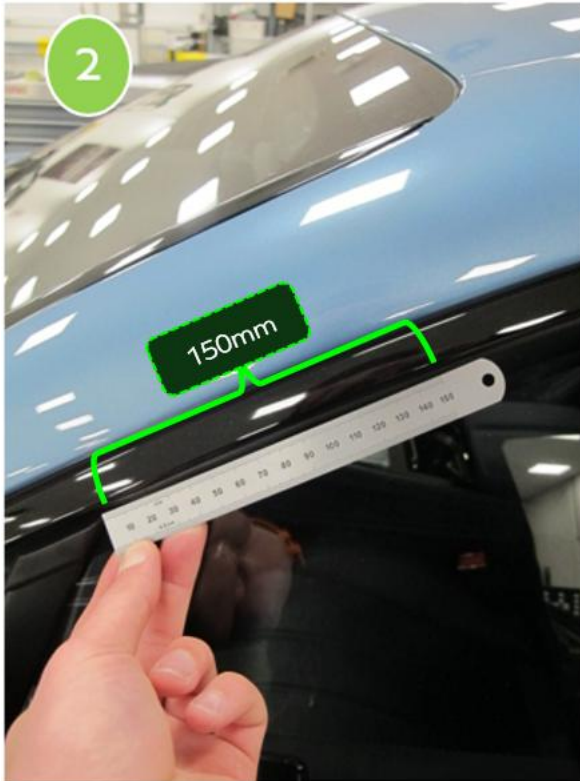
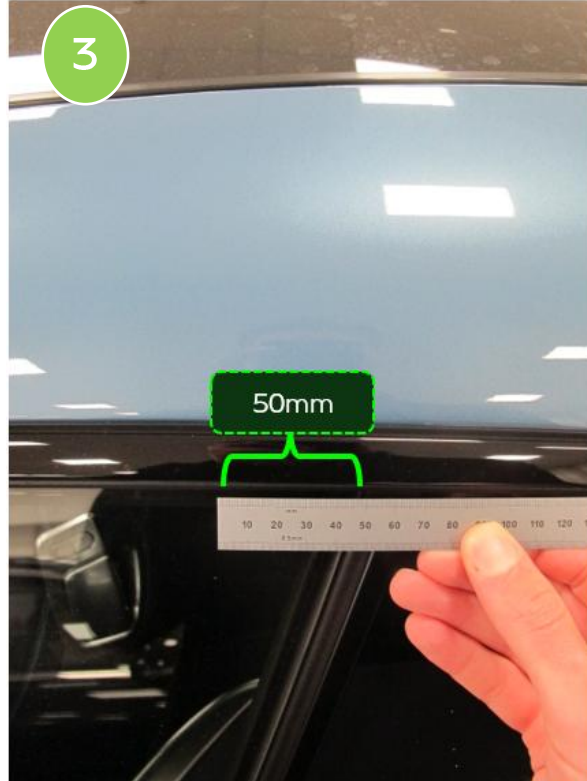
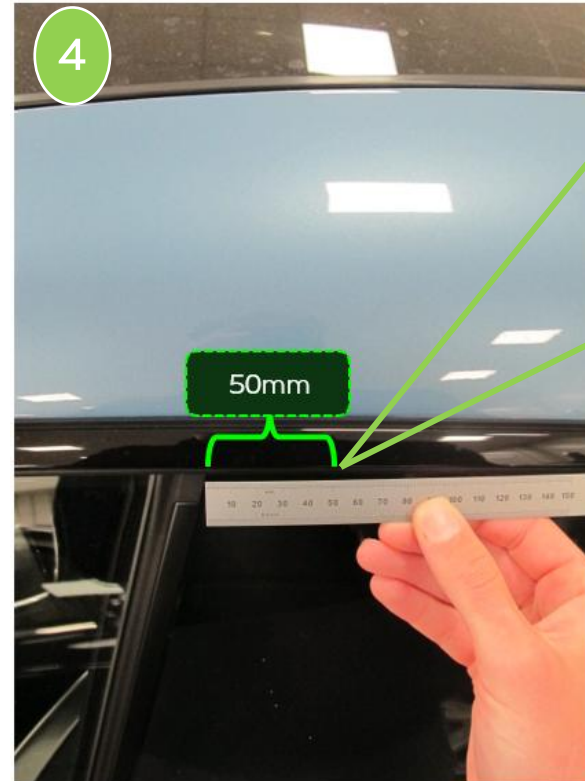
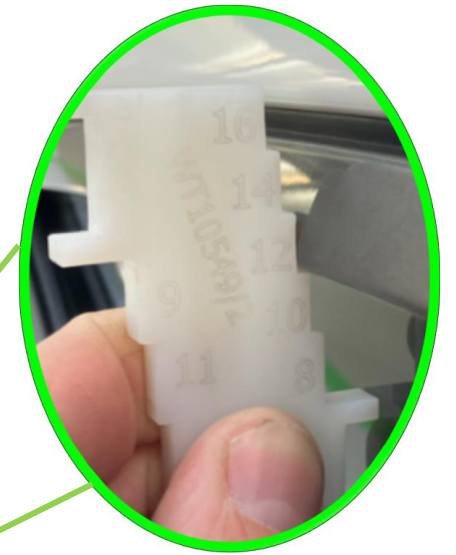
# PROFILE POINT 2, 3, 4

150mm behind front  
div bar

50mm in front of  
rear div bar

50mm behind  
rear div bar

Flat against glass to  
brightware

**Repair Group 64 'Slide  
glass checking and  
adjusting'**

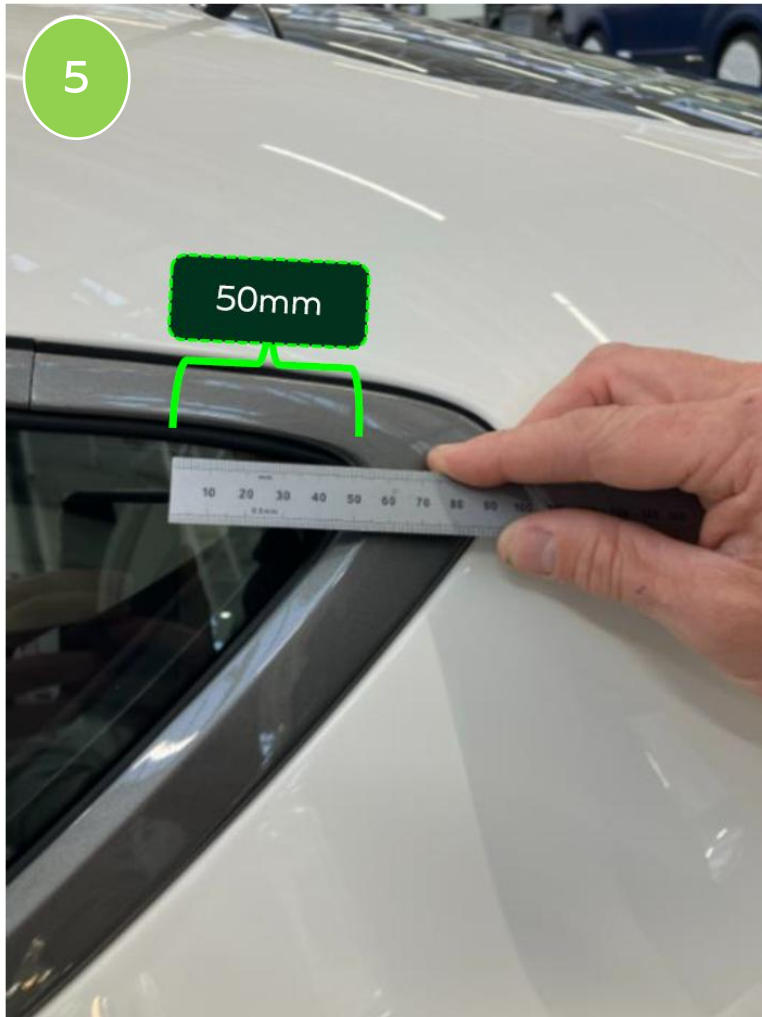
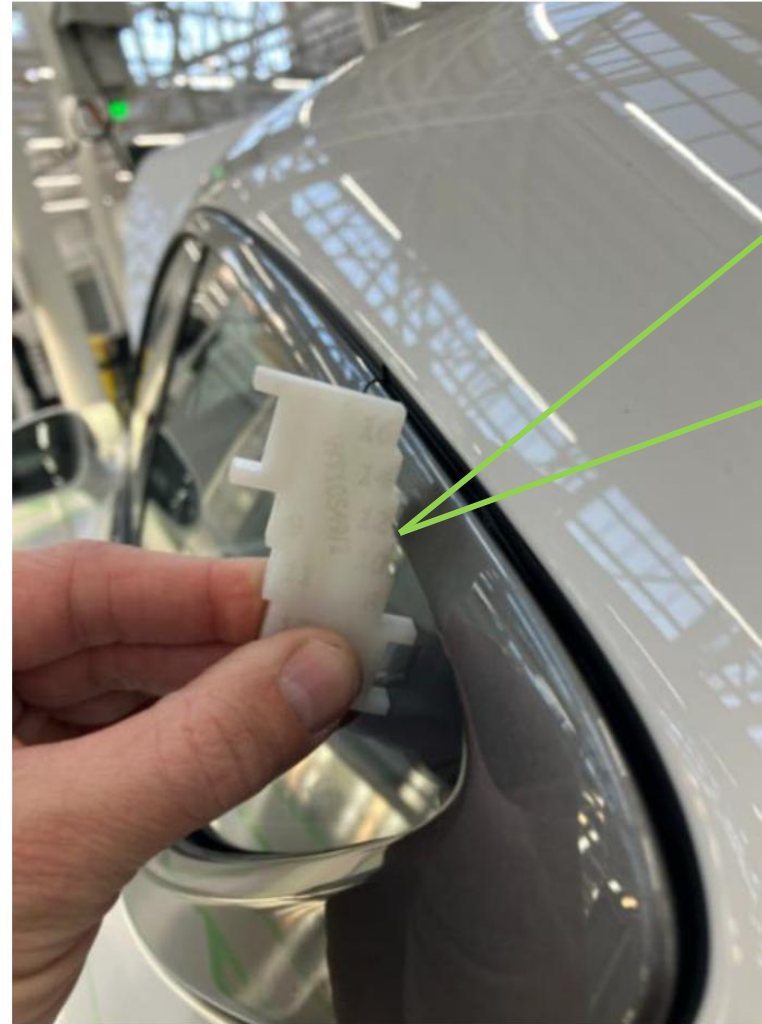
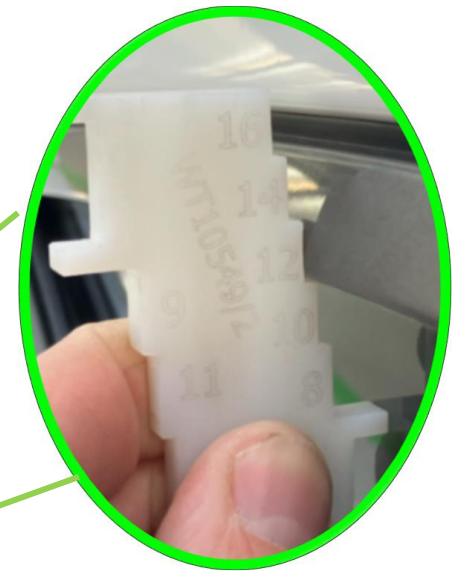
# PROFILE POINT 5

50mm from corner  
point of bright ware

Flat against glass to  
brightware

**Specification**  
10mm  $\pm$  2mm  
(Profile Tool WT10549/2)

**Repair Group 64 'Slide glass  
checking and adjusting'**

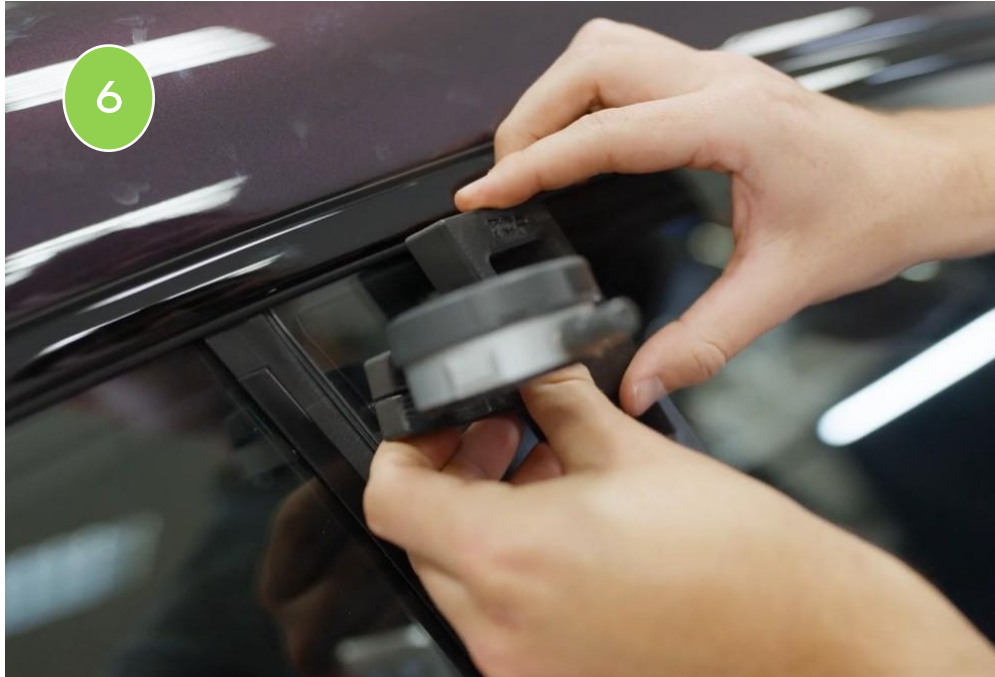
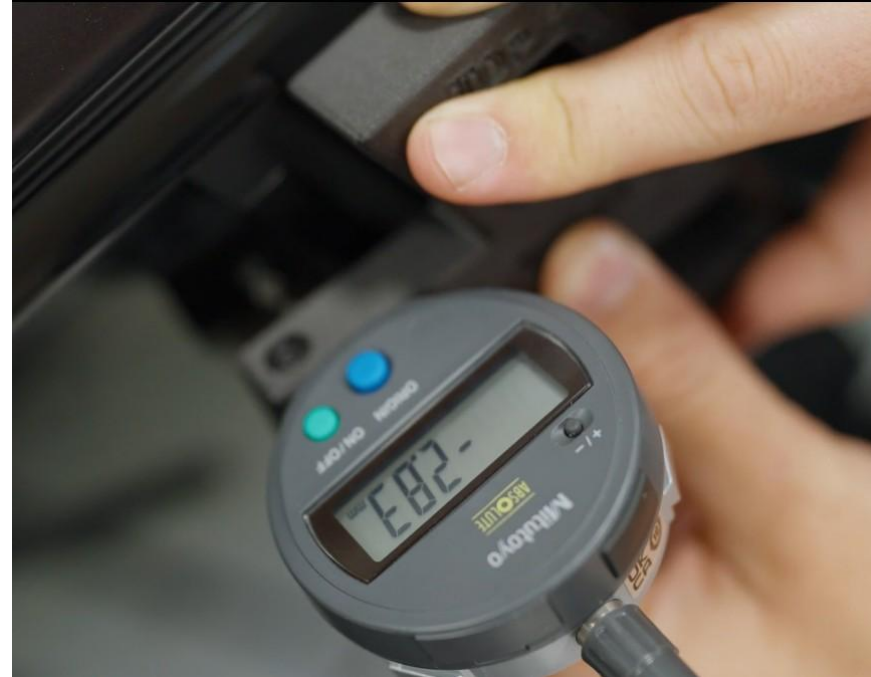
# PROFILE POINT 6 (DIGITAL DTI GAUGE - LATEST TOOL)

Align and position the tool on the front window so that its contact face rests flat against the upper bright ware trim, zero the tool.

Then slide it along the surface until it makes full, even contact with the rear glass.  
Record the measurement.

**Specification**  
0mm +0 / -3mm

**Repair Group 64**  
**'Slide glass checking and adjusting'**

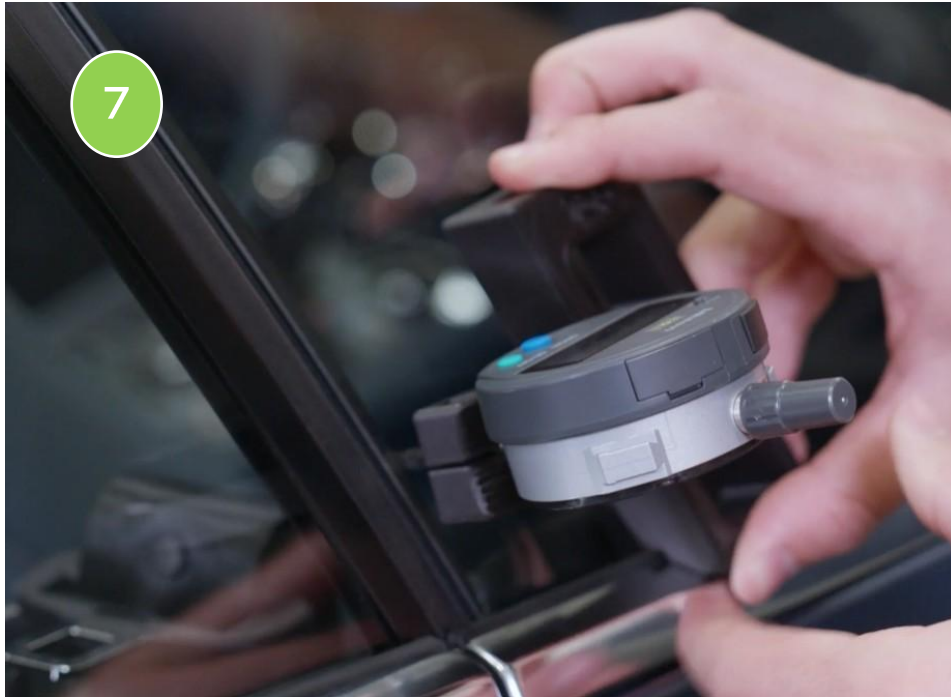
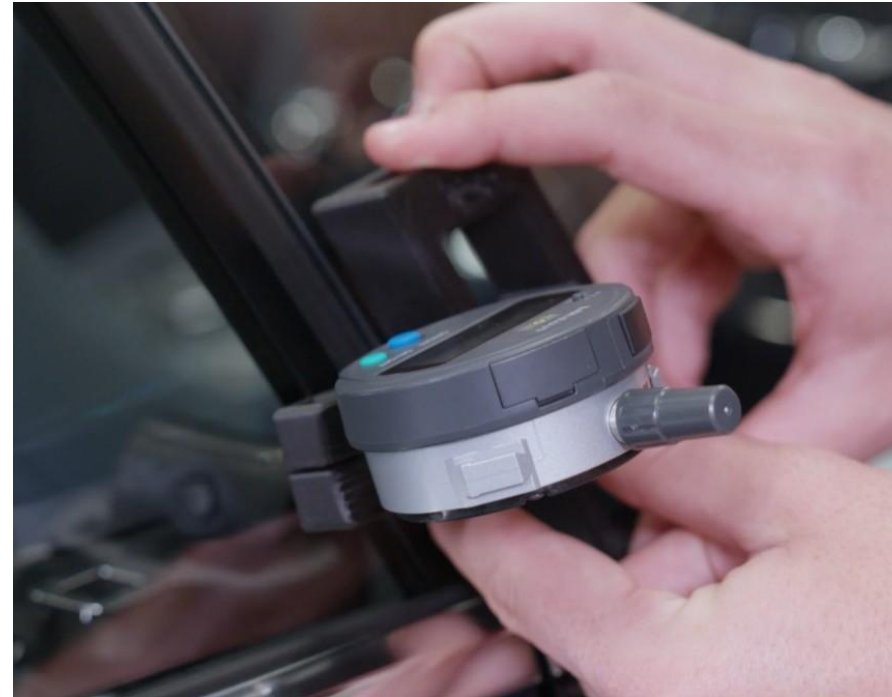
# PROFILE POINT 7 (DIGITAL DTI GAUGE - LATEST TOOL)

Align and position the tool on the front window so that its contact face rests flat against the lower bright ware trim, zero the tool.

Then slide it along the surface until it makes full, even contact with the rear glass.  
Record the measurement.

**Specification**  
0mm +0 / -3mm

**Repair Group 64**  
**'Slide glass checking and adjusting'**

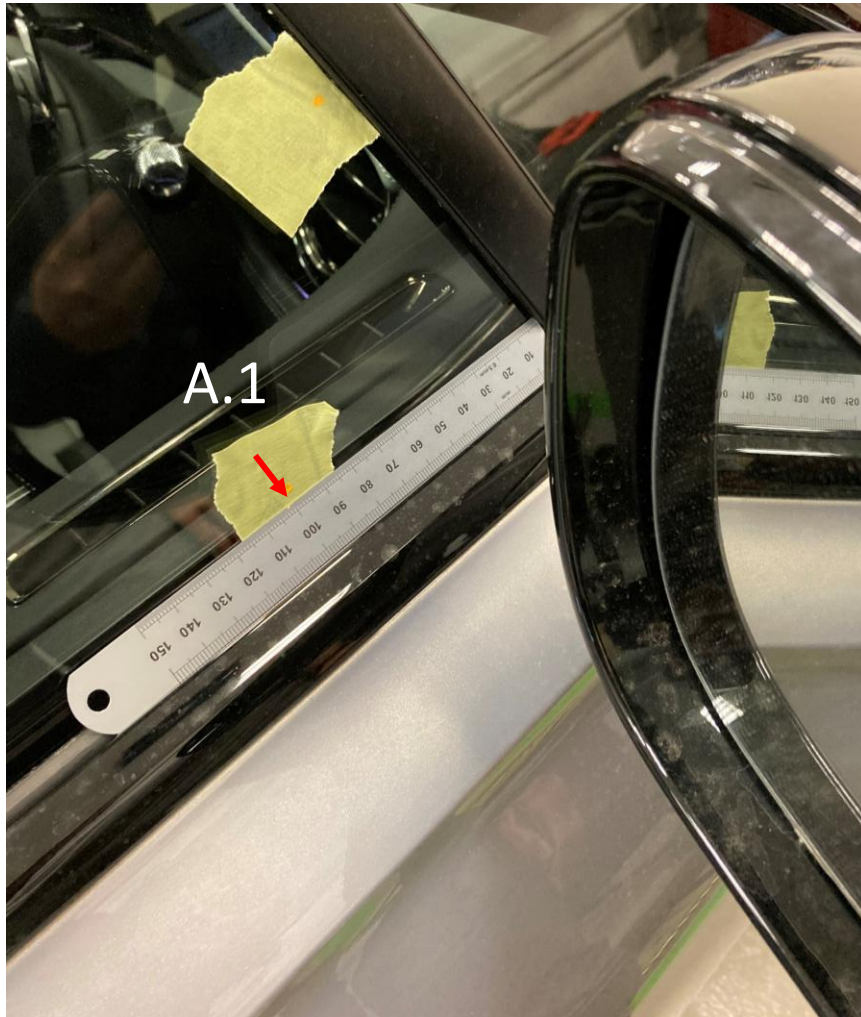
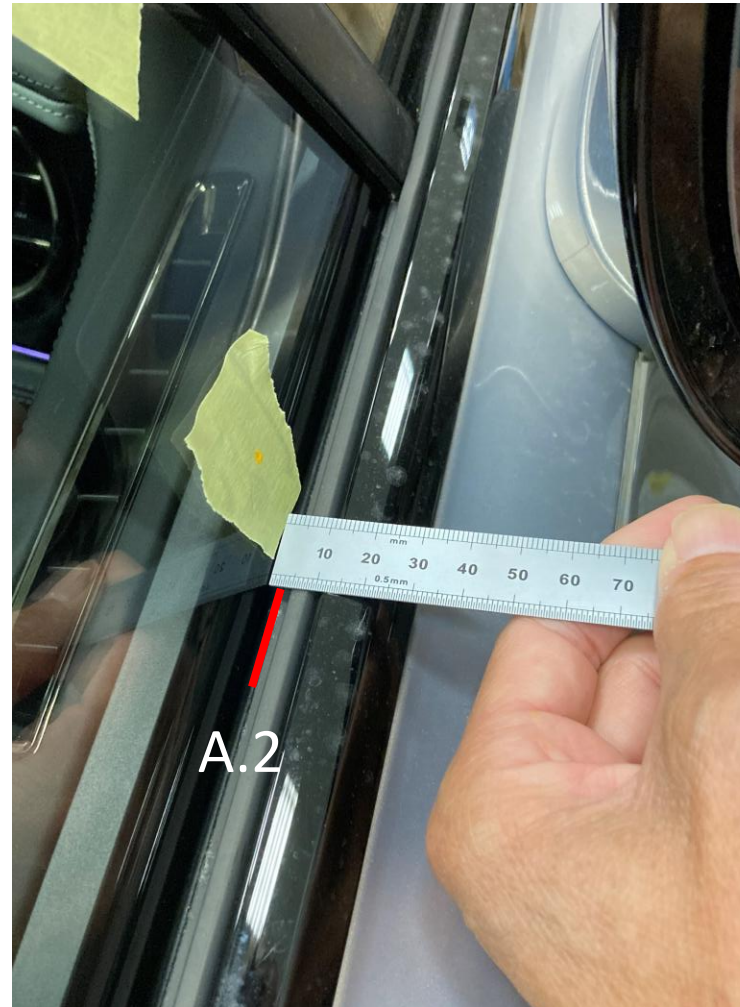
# WAIST SEAL MEASUREMENT POINT A

Mark on tape 100mm  
from div bar (A.1)

Measure from first lip rubber  
seal to window glass (A.2)

**Repair Group 64 'Slide  
glass checking and  
adjusting'**

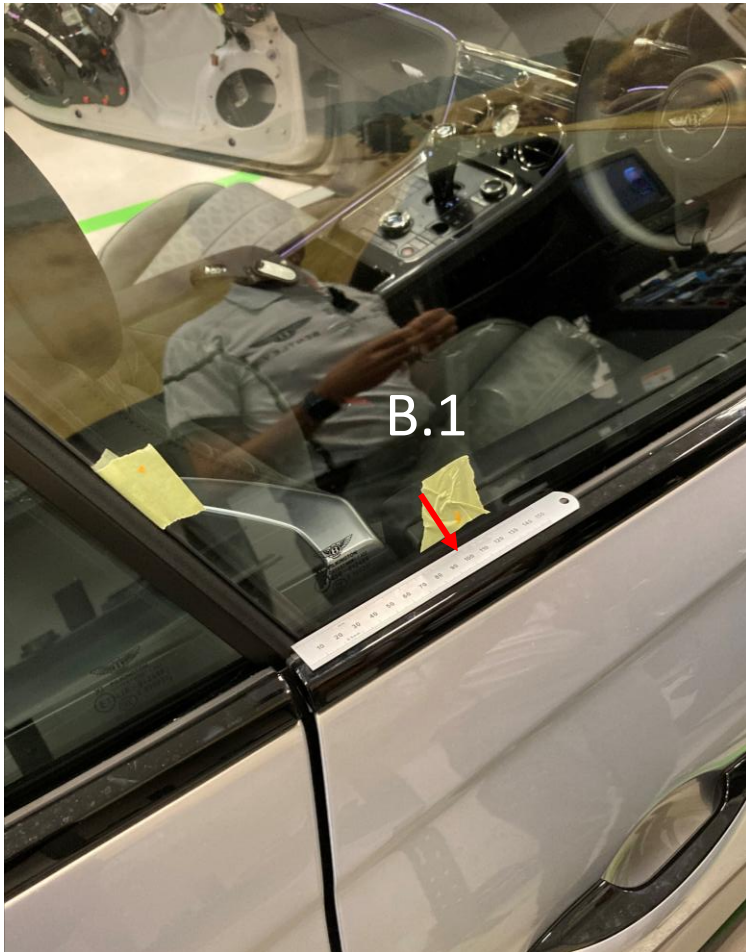
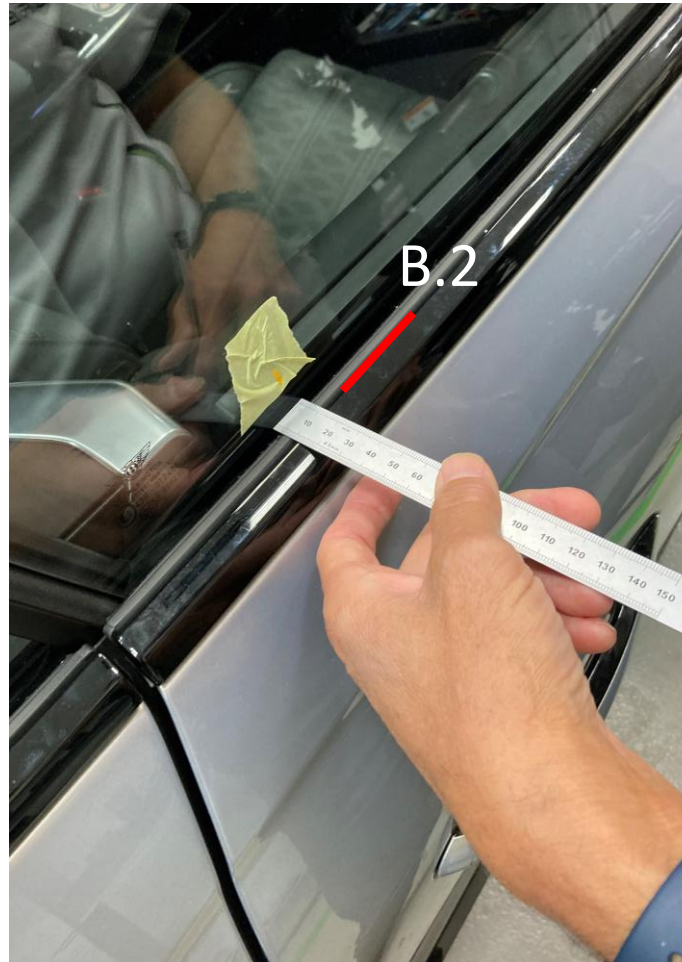
# WAIST SEAL MEASUREMENT POINT B

Mark on tape 100mm from div bar (B.1)

Measure from first lip rubber seal to window glass (B.2)

**Repair Group 64 'Slide glass checking and adjusting'**

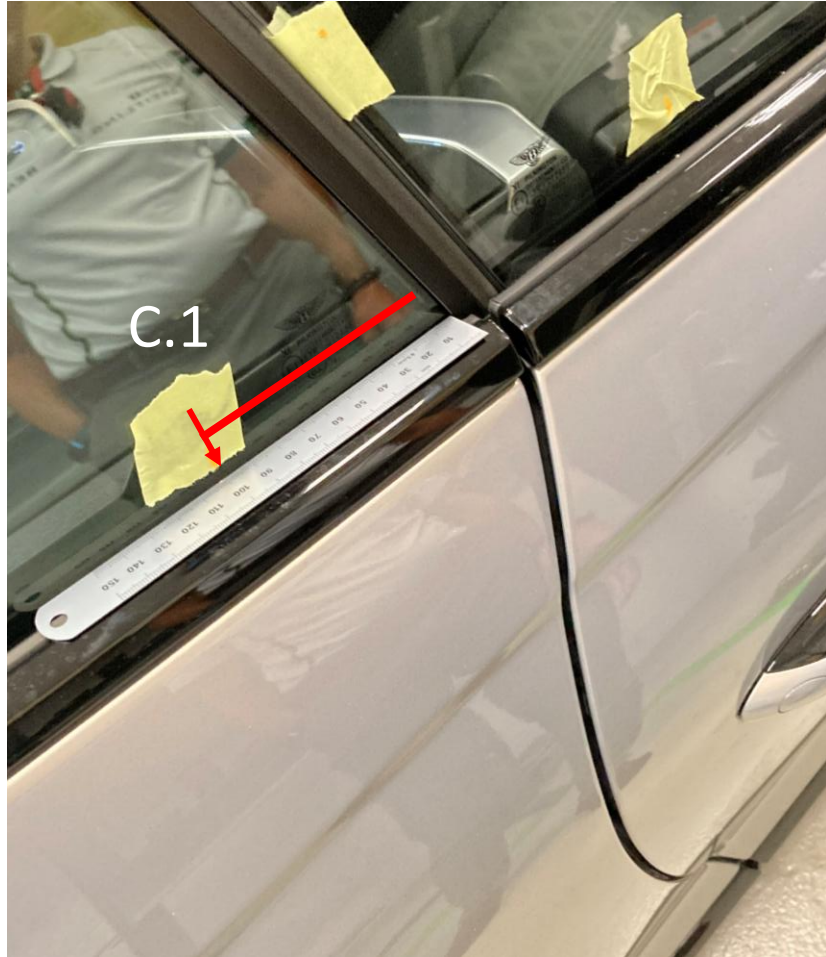
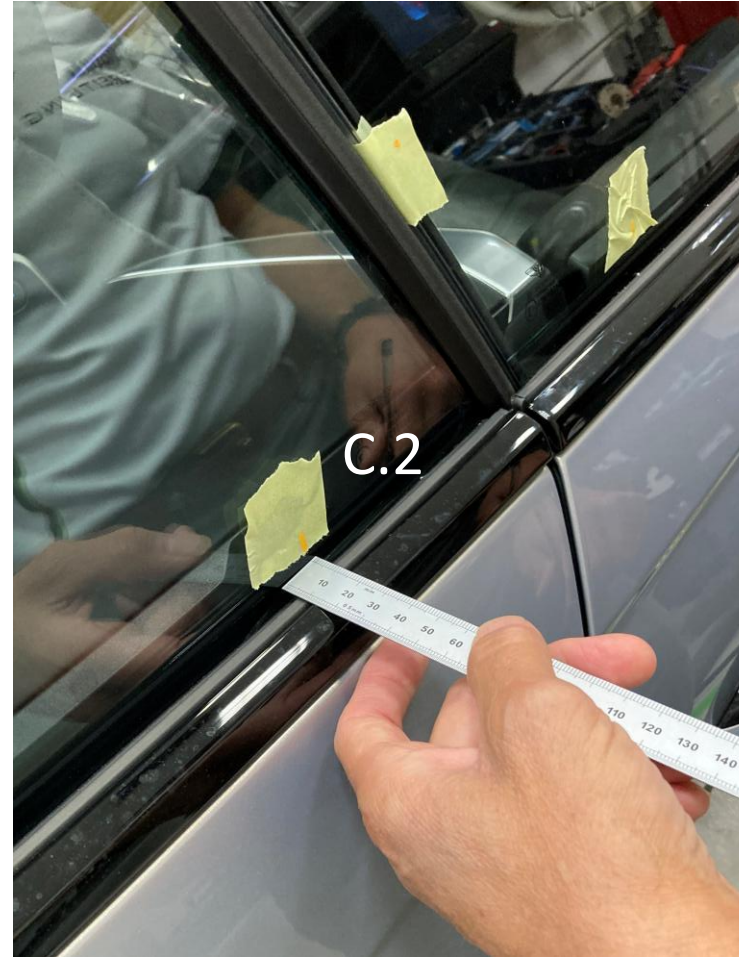
# WAIST SEAL MEASUREMENT POINT C

Mark on tape 100mm  
from div bar (C.1)

Measure seal to  
window gap (C.2)

**Repair Group 64 'Slide glass  
checking and adjusting'**

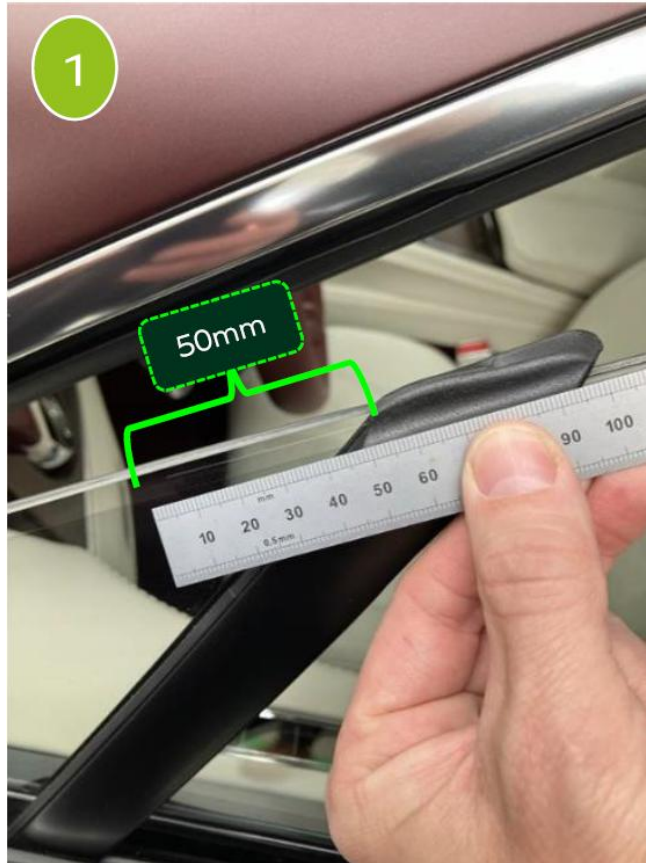
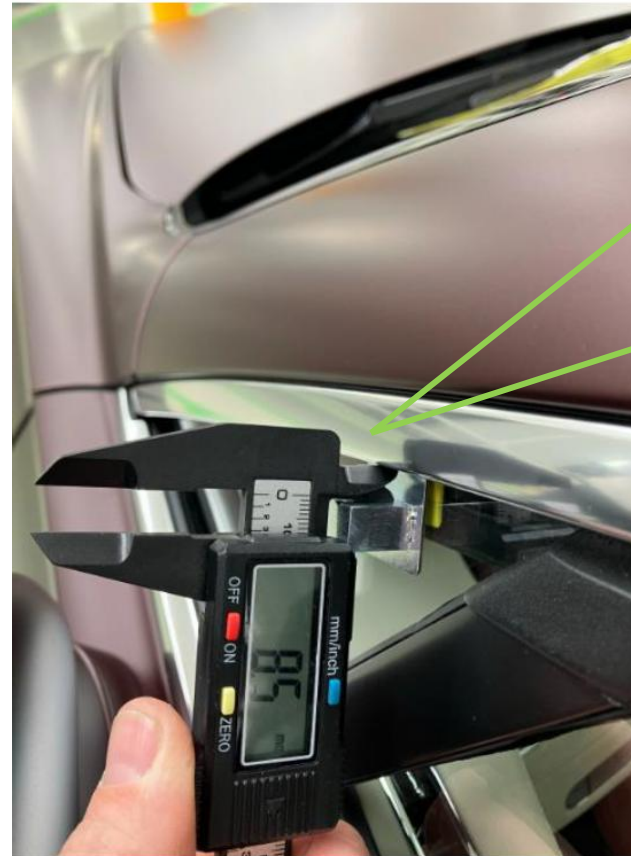
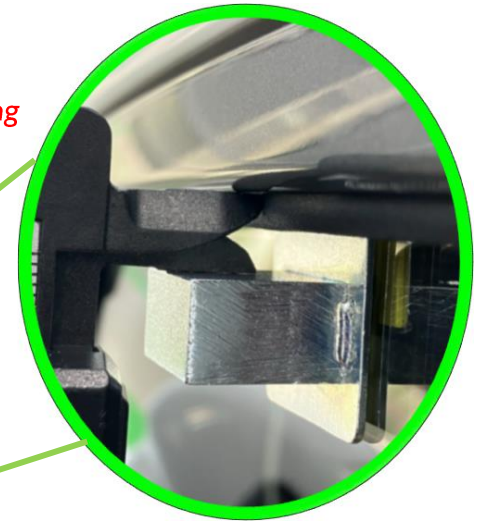
# INTERLOCK POINT 1

Place block 50mm in front of front div bar

Record measurement for all interlock points

From block to bright ware for all interlock points

7.5mm  $\pm$  1mm

**Repair Group 64 'Front door quarter glass – To adjust'**
