## Technical product information

| <b>Topic</b> | Window Drop Glass Operation Continental GT/GTC 19-24MY |
| <b>Transaction No.</b> | 2080375/4 |

Window Drop Glass Operation | Continental GT/GTC |19-24MY

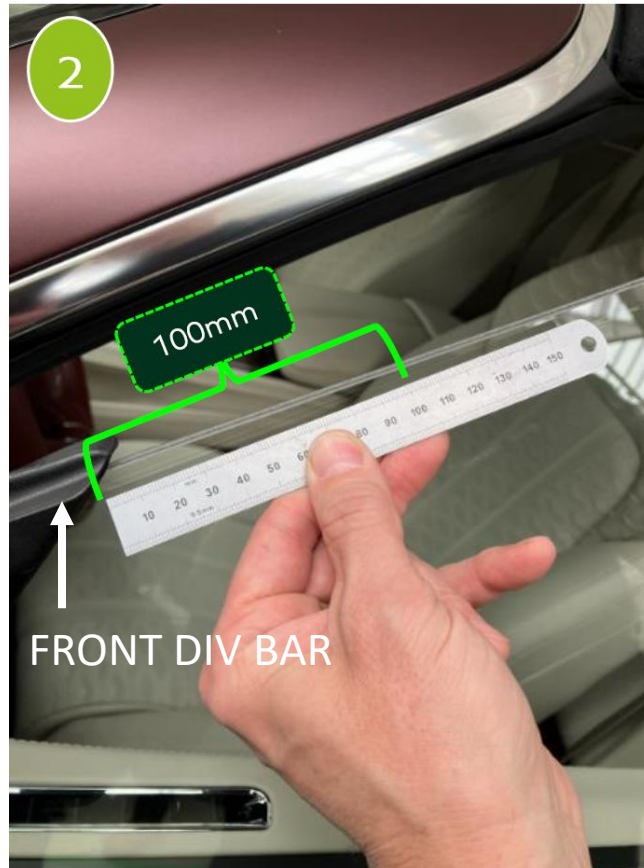
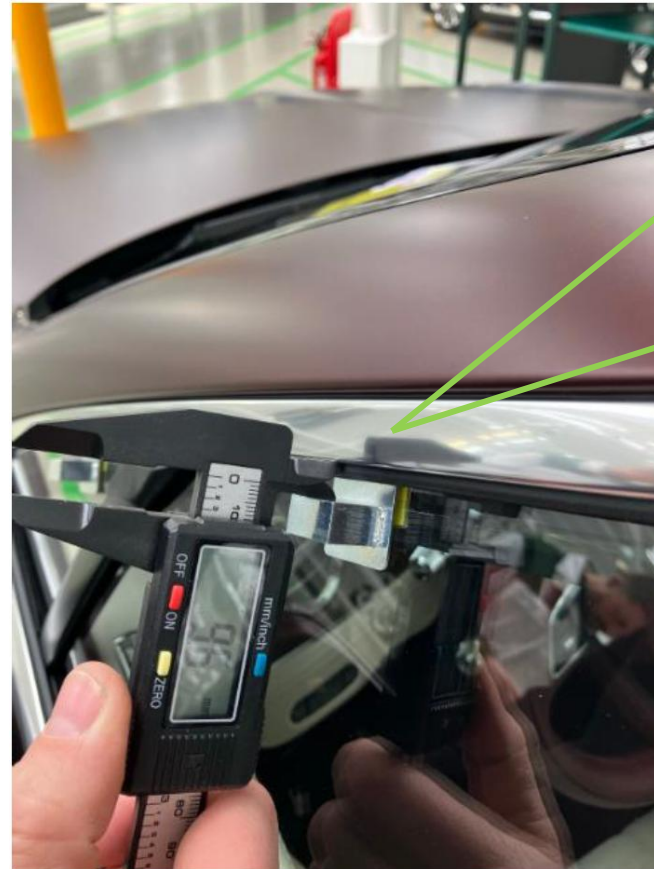
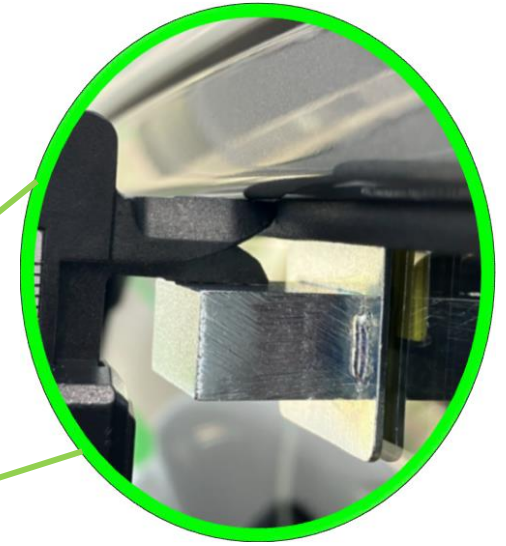
# INTERLOCK POINT 2

Place block 100mm in front of front div bar

Record measurement for all interlock points

From block to bright ware for all interlock points

**Repair Group 64 'Front door quarter glass – To adjust'**

*If the specification for interlock points 2, 3 or 4 cannot be achieved through normal adjustment, refer to page 6 of the glass reset procedure.*

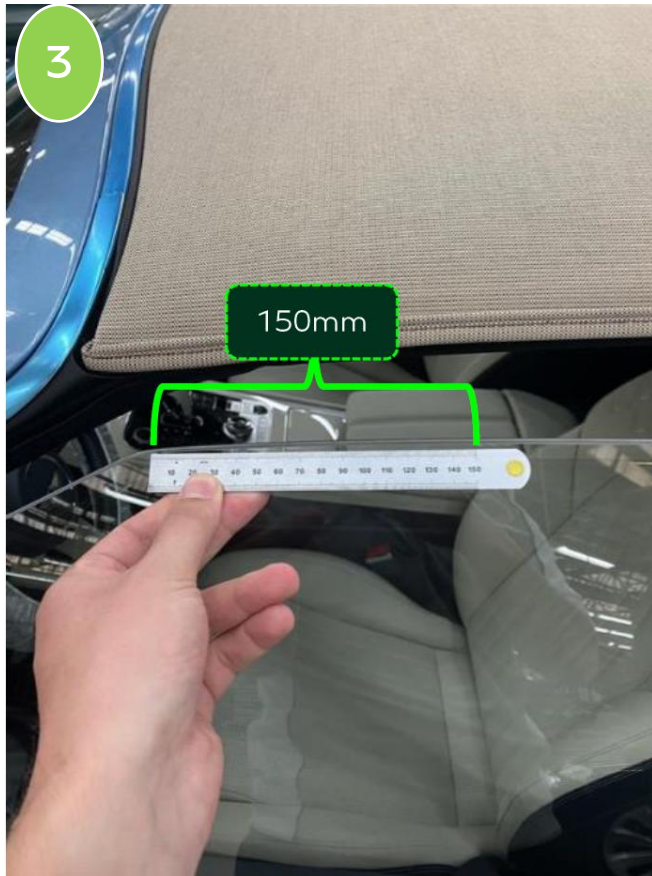
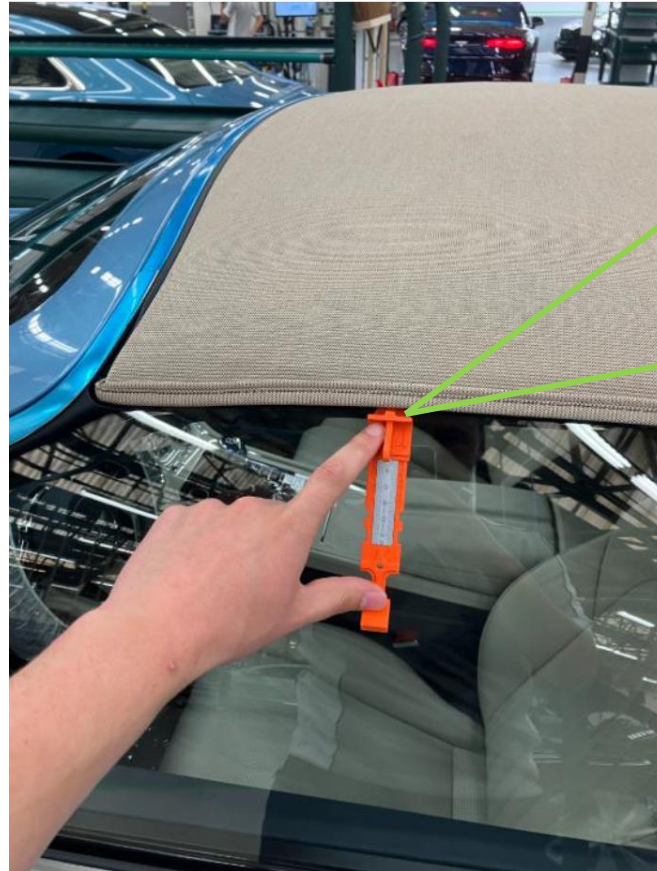
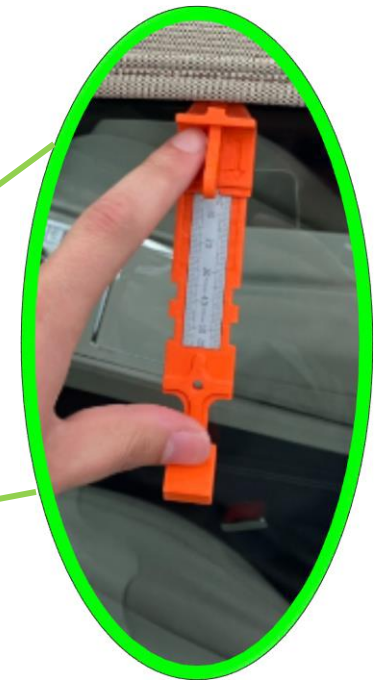
# INTERLOCK POINT 3

150mm from front corner of window glass as shown

**Specification**  
7mm ± 1mm  
(Interlock Tool WT10554)

If the measurement is out of specification refer to ElsaPro Repair Group 64 'Front door quarter glass – To adjust'

*If the specification for interlock points 2, 3 or 4 cannot be achieved through normal adjustment, refer to page 6 of the glass reset procedure.*

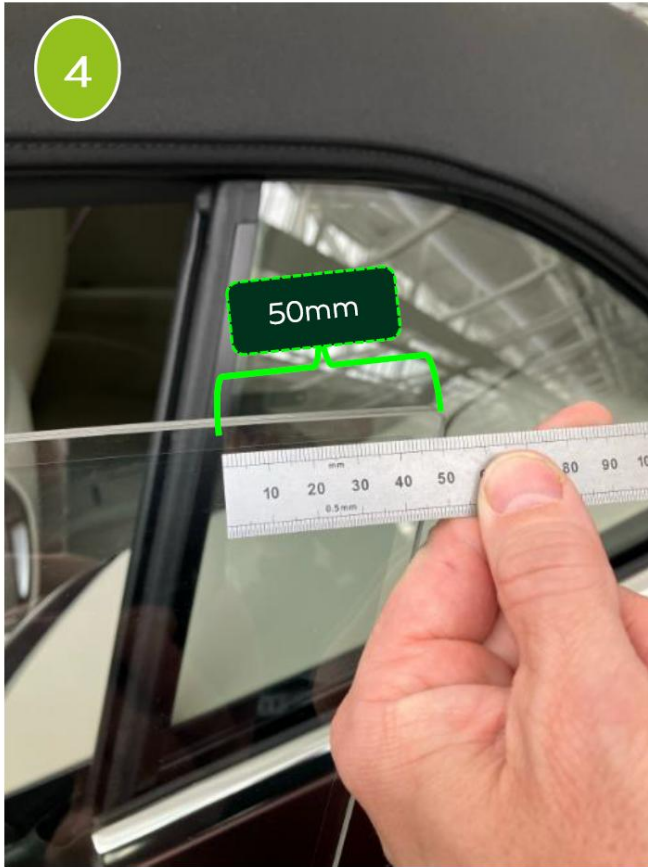
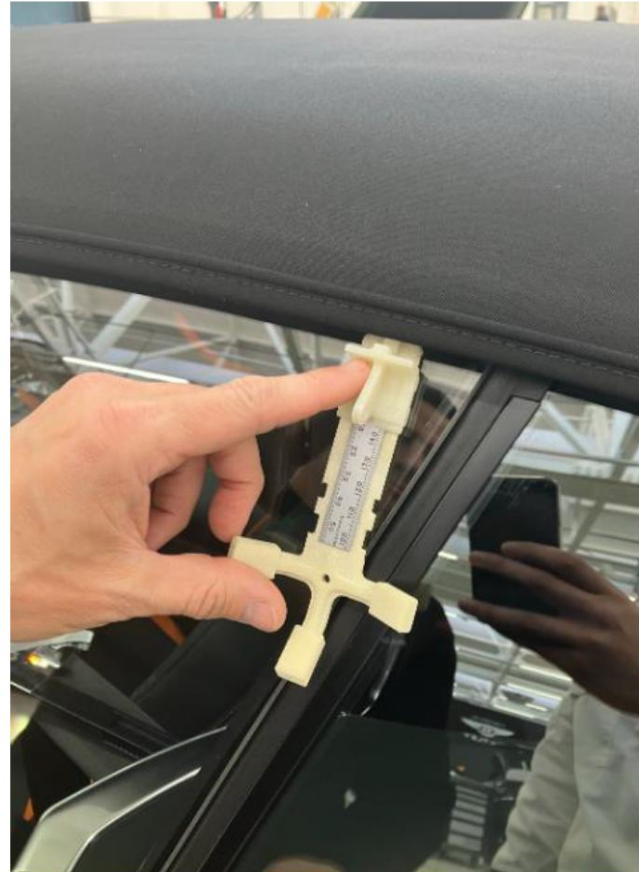
# INTERLOCK POINT 4

50mm from rear edge of the front door glass as shown

**Specification**  
8.5mm  $\pm$  1mm  
(Interlock Tool WT10554)

If the measurement is out of specification refer to ElsaPro Repair Group 64 'Front door quarter glass – To adjust'

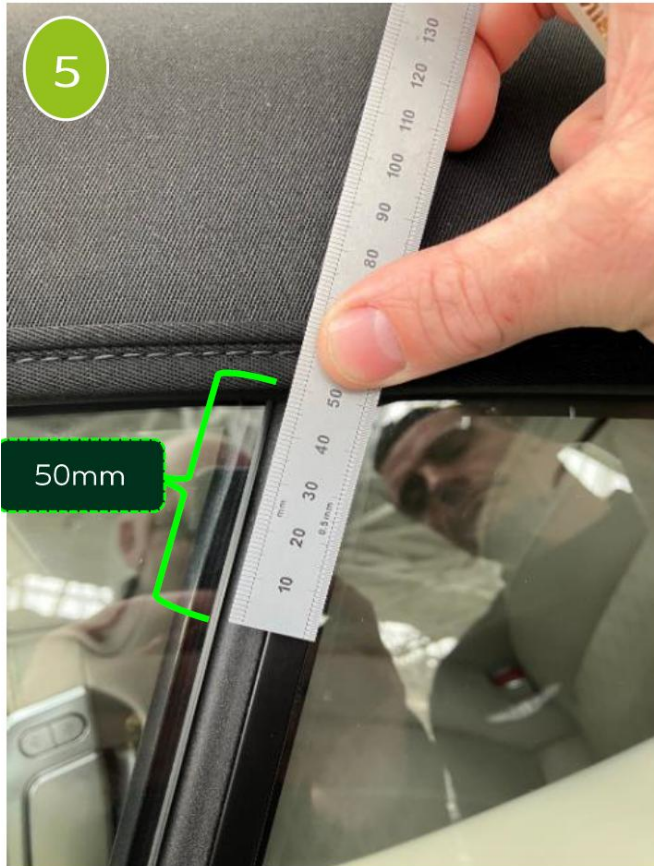
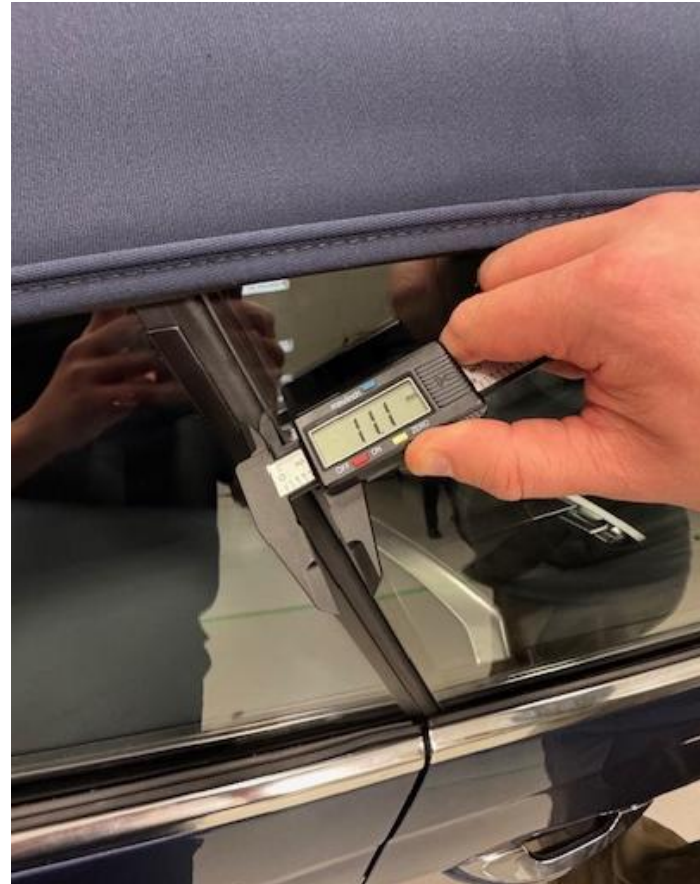
# INTERLOCK POINT 5 ROOF UP

50mm from corner

**Specification**  
11mm  $\pm$  1mm  
(Ruler/vernier)

If the measurement is out of specification refer to ElsaPro Repair Group 64 'Front door quarter glass – To adjust'

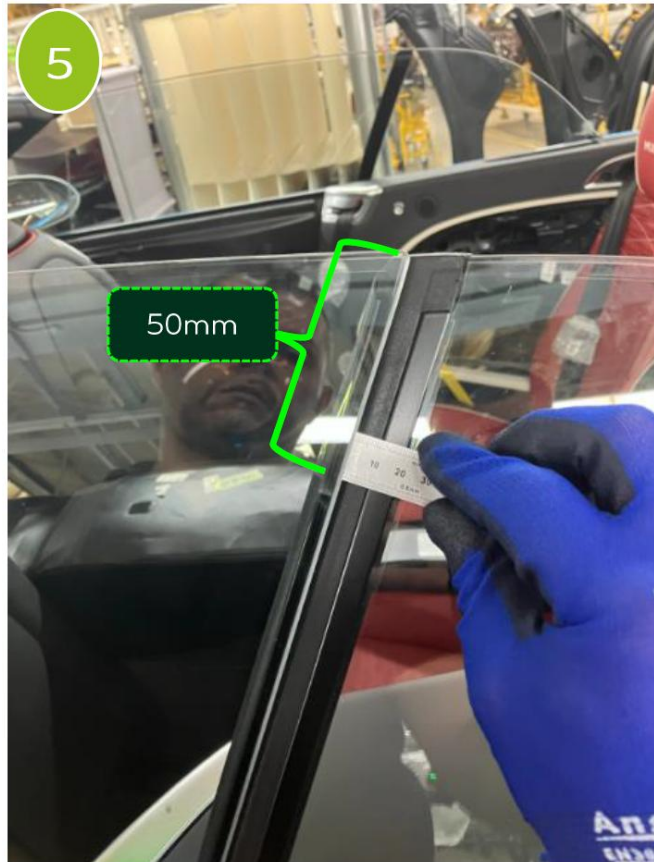
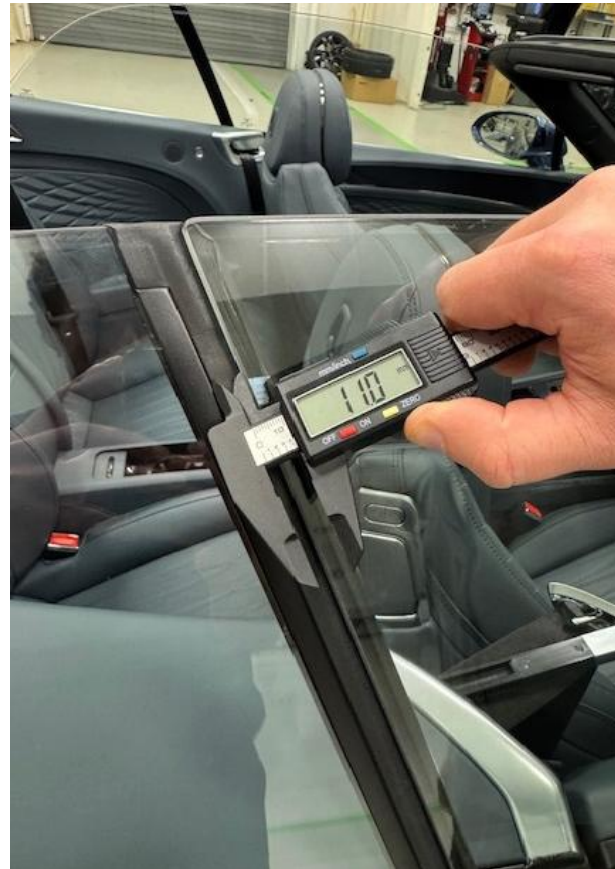
# INTERLOCK POINT 5 ROOF DOWN

Take measurement  
50mm from top of glass

**Specification**  
11mm  $\pm$  1mm  
(Ruler/vernier)

If the measurement is out of  
specification refer to ElsaPro  
**Repair Group 64 'Front door  
quarter glass – To adjust'**

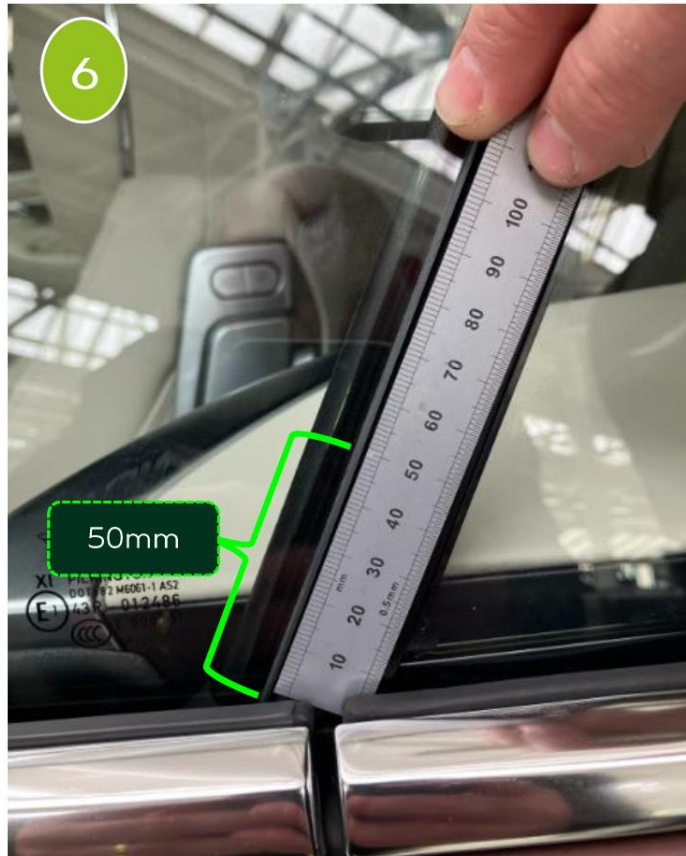
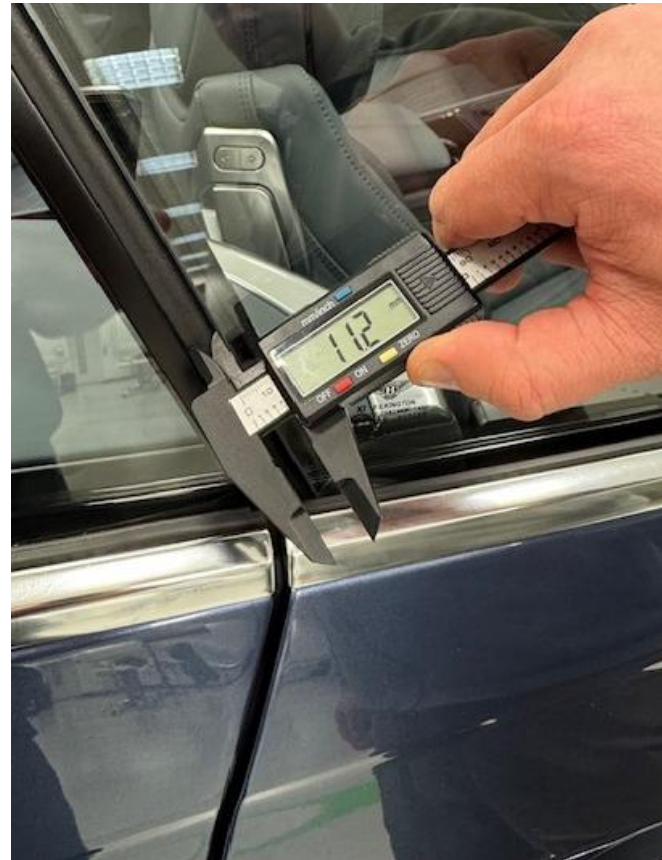
# INTERLOCK POINT 6 ROOF UP & DOWN

50mm from corner

**Specification**  
11mm  $\pm$  1mm  
(Ruler/vernier)

If the measurement is out of specification refer to ElsaPro Repair Group 64 'Front door quarter glass – To adjust'

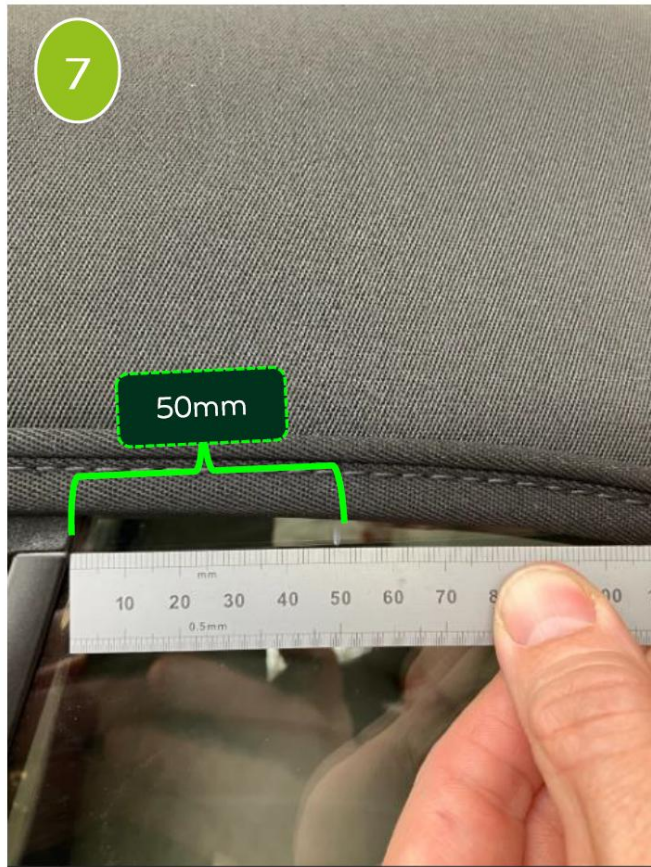
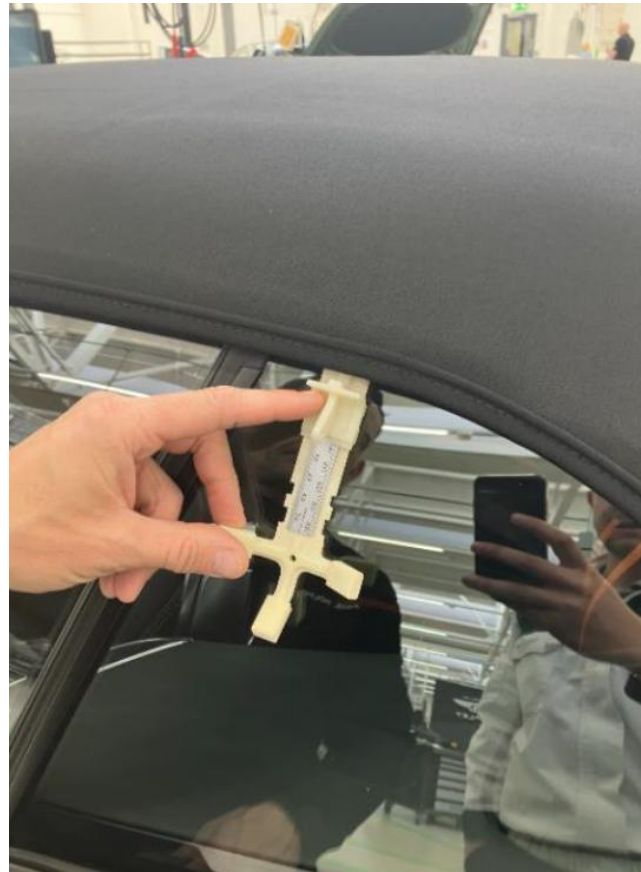
# INTERLOCK POINT 7

50mm behind rear div bar

**Specification**  
8.5mm  $\pm$  1mm  
(Interlock Tool WT10554)

1. Hook onto glass with door open at measured point
2. Close door and allow glass to close
3. Lightly push gauge to top and take measurement at indicated point. Do not deform the seal.

If the measurement is out of specification refer to ElsaPro Repair Group 64 'Front door quarter glass – To adjust'

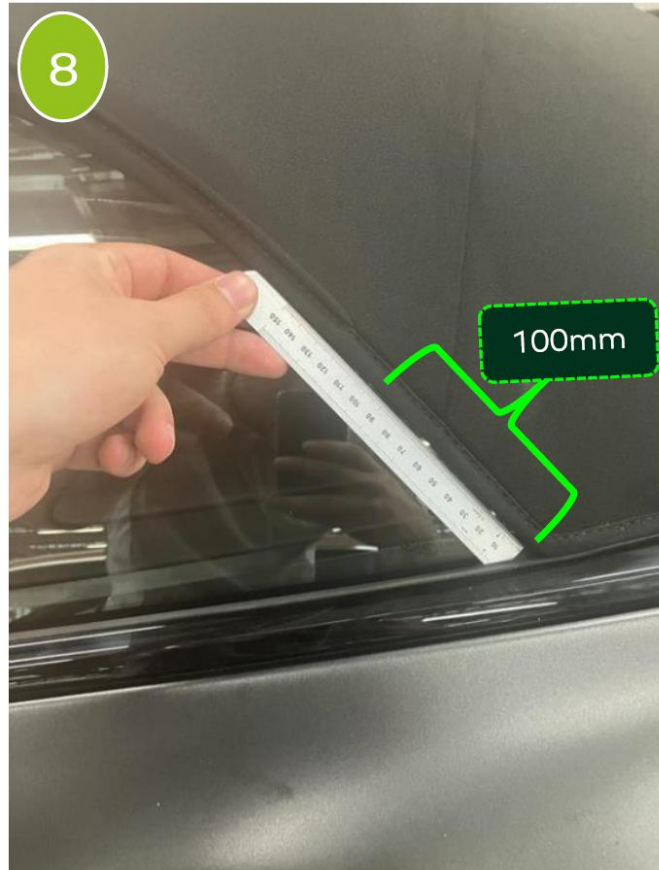
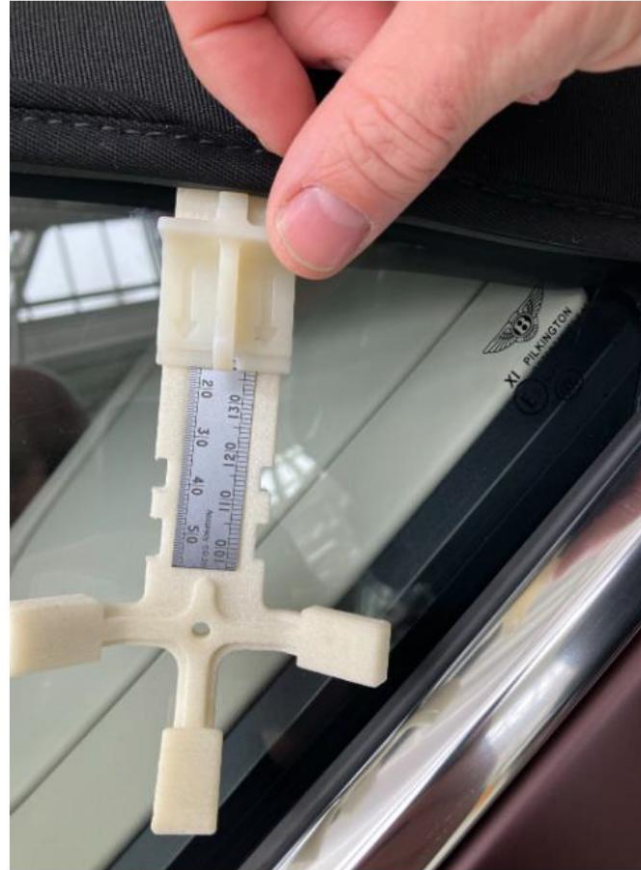
# INTERLOCK POINT 8

100mm from corner

**Specification**  
8.5mm – 16mm  
(Interlock Tool WT10554)

1. Hook onto glass with door open at measured point
2. Close door and allow glass to close
3. Lightly push gauge to top and take measurement at indicated point. Do not deform the seal.

If the measurement is out of specification refer to ElsaPro Repair Group 64 'Front door quarter glass – To adjust'

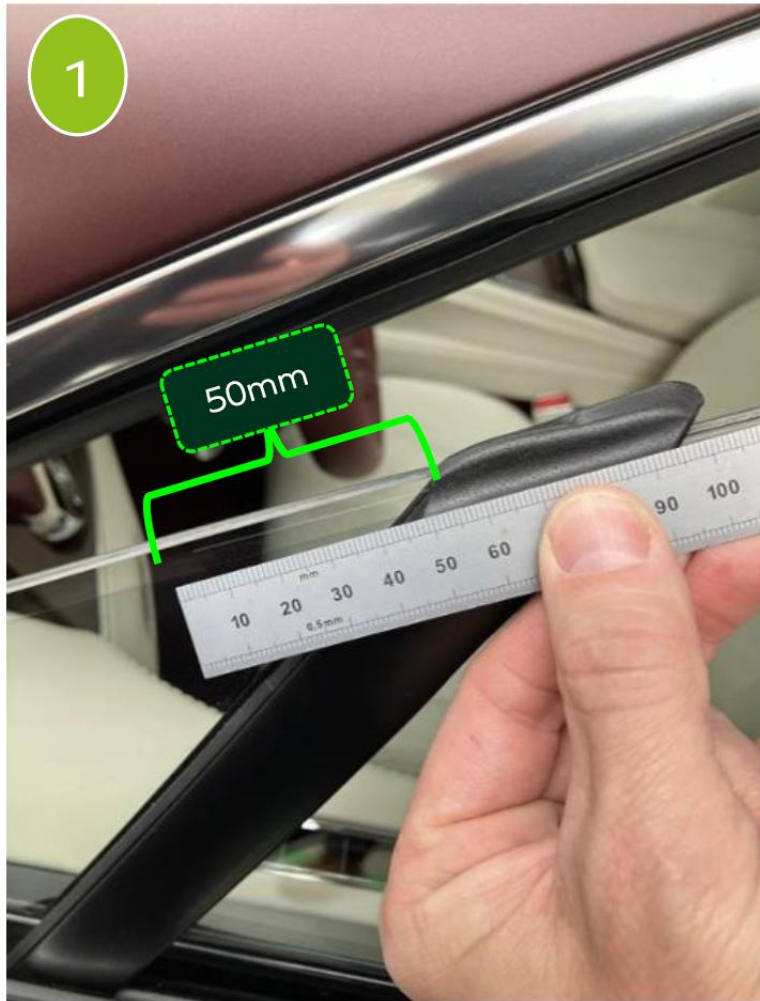
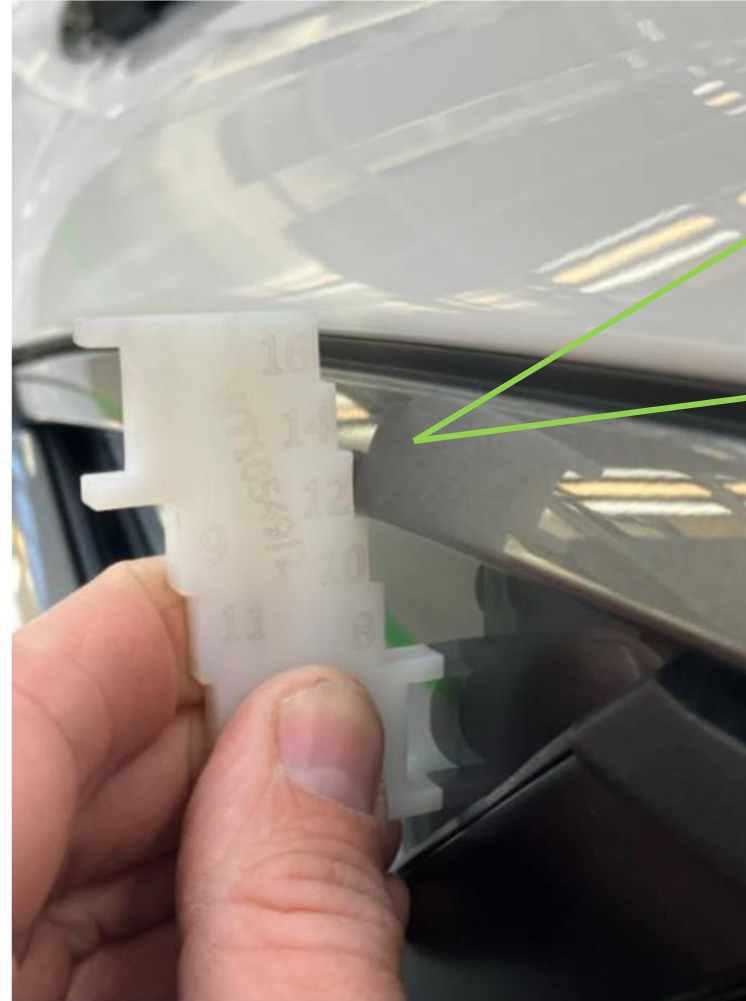
# PROFILE POINT 1

50mm in front of front div  
bar

**Specification**  
10mm  $\pm$  1mm  
(Profile Tool WT10549/2)

Flat against glass to  
brightware

If the measurement is out of  
specification refer to ElsaPro  
**Repair Group 64 'Slide glass  
checking and adjusting'**

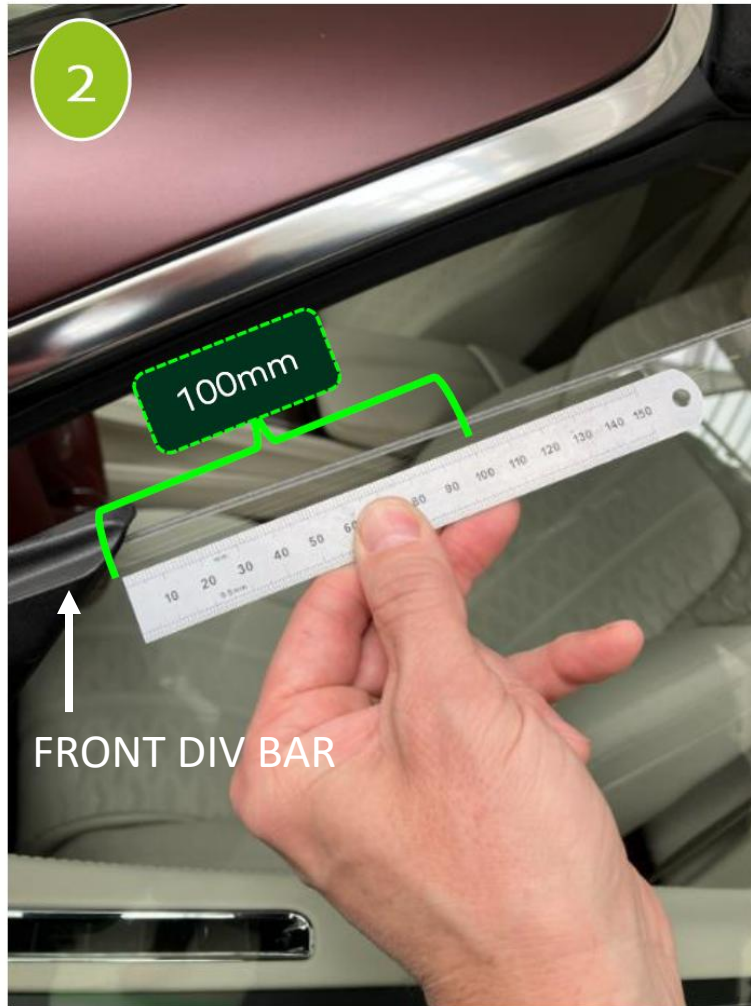
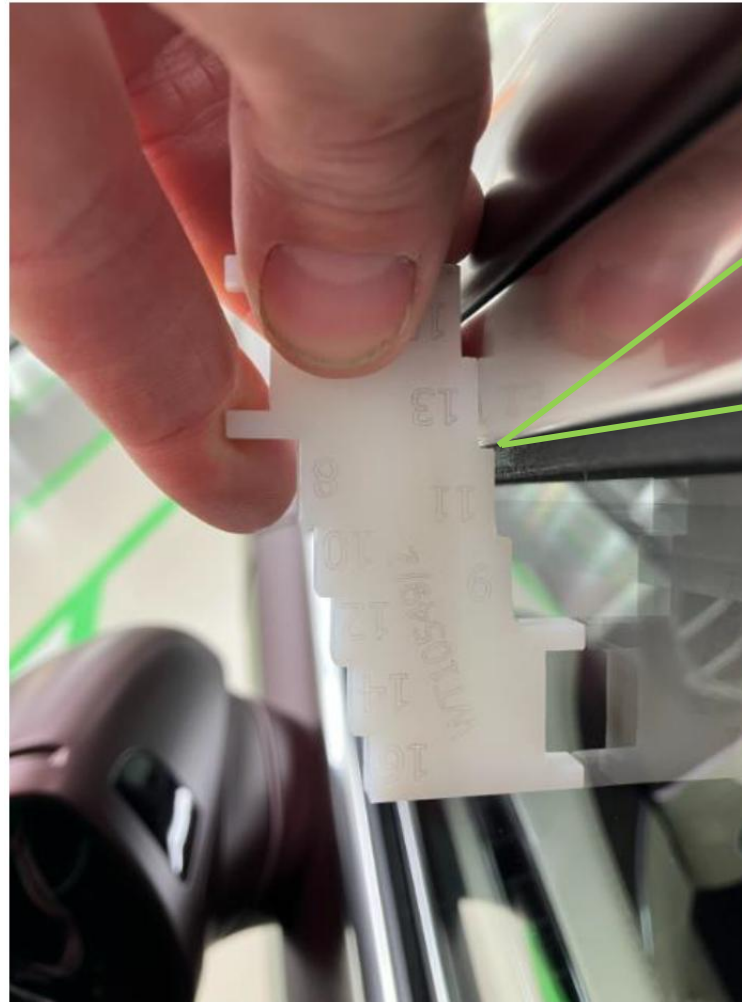
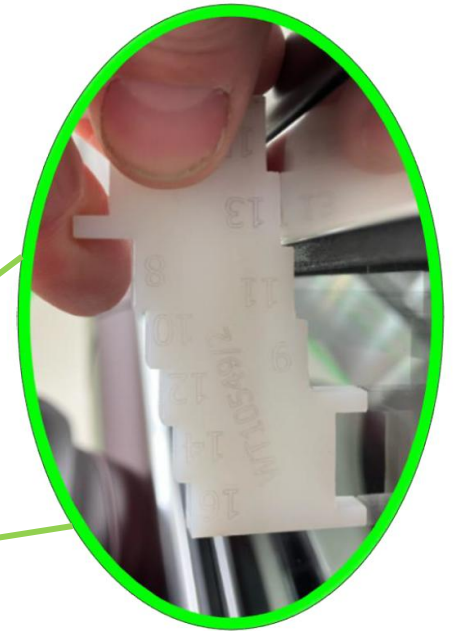
# PROFILE POINT 2

Place block 100mm in front  
of front div bar

Flat against glass to  
brightware

**Specification**  
14mm  $\pm$  2mm  
(Profile Tool WT10549/2)

If the measurement is out of  
specification refer to ElsaPro  
**Repair Group 64 'Slide glass  
checking and adjusting'**

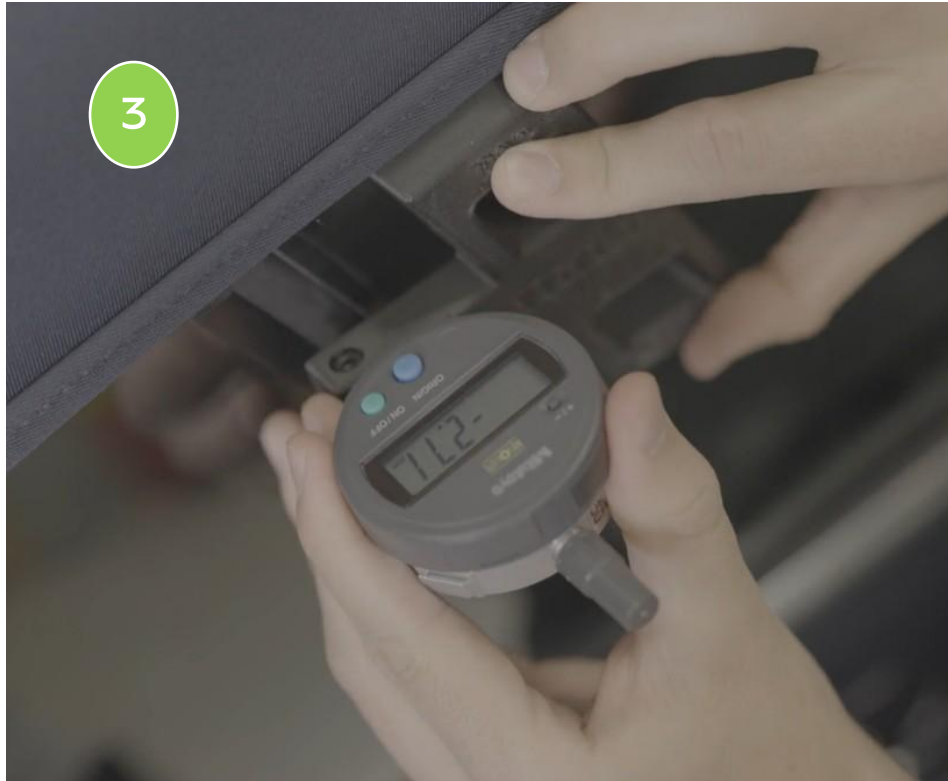
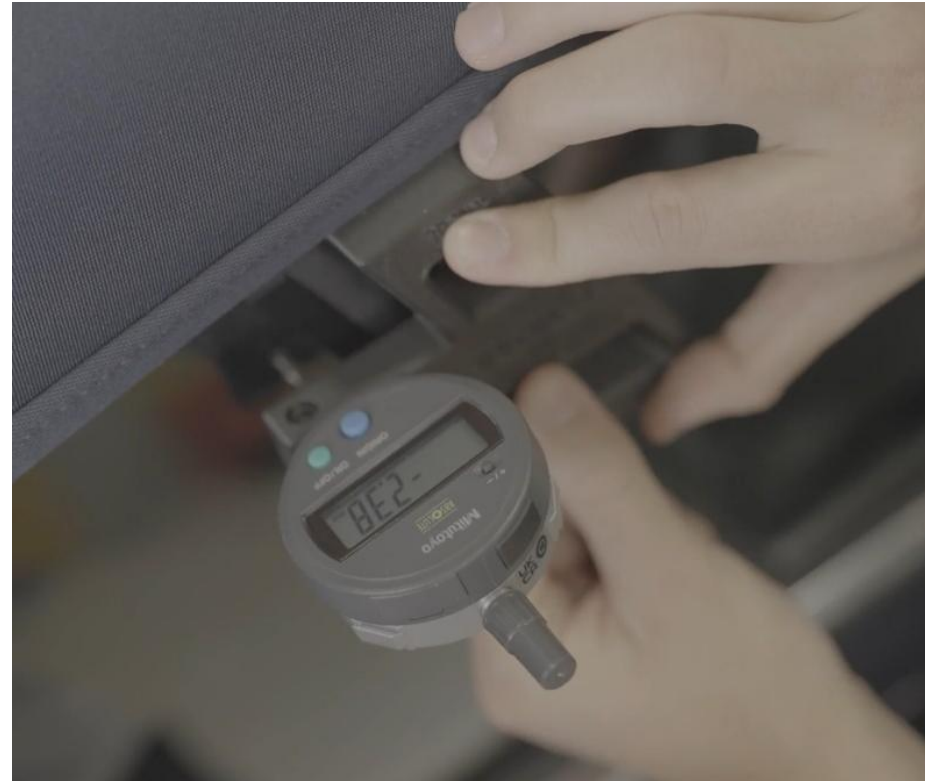
# PROFILE POINT 3 ROOF UP (DIGITAL DTI GAUGE - LATEST TOOL)

Align and position the tool on the front window so that its contact face rests flat against the roof trim, zero the tool.

Then slide it along the surface until it makes full, even contact with the rear glass. Record the measurement.

**Specification**  
0mm +0 / -3mm

**Repair Group 64**  
**'Slide glass checking and adjusting'**

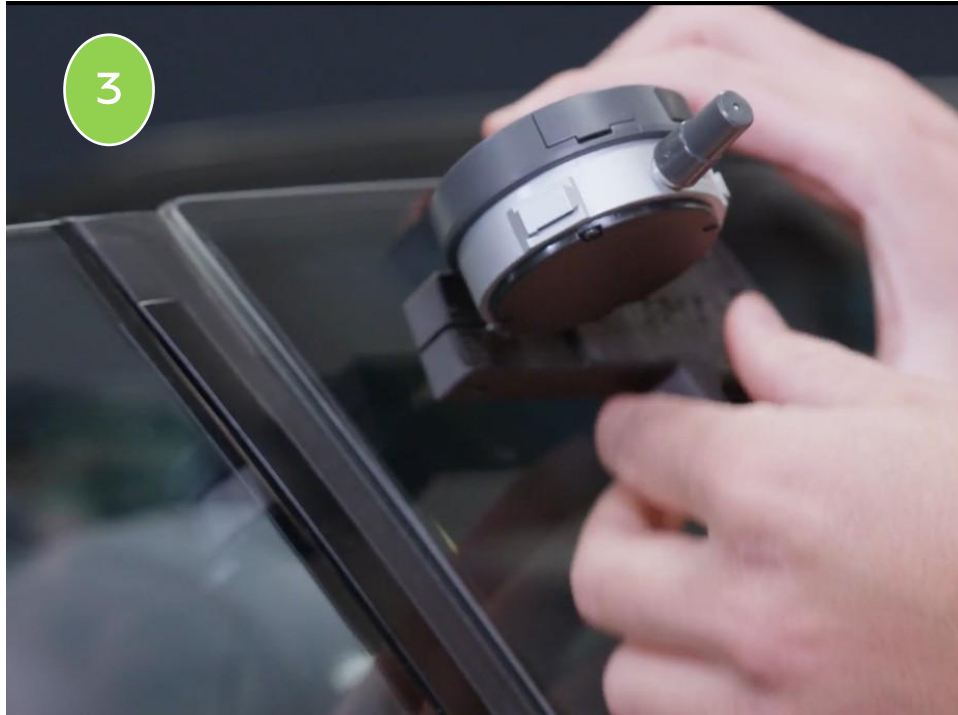
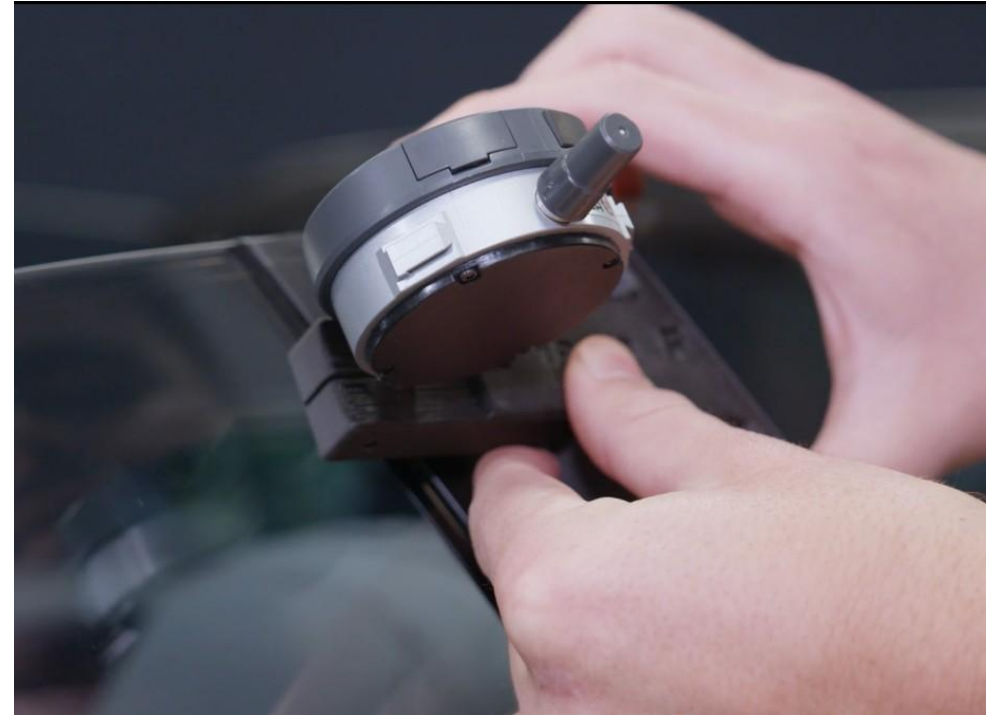
## PROFILE POINT 3 ROOF DOWN (DIGITAL DTI GAUGE - LATEST TOOL)

Align and place the tool on the front window, ensuring the contact face sits level with the top of the glass, zero the tool.

Then slide it along the surface until it makes full, even contact with the rear glass.  
Record the measurement.

**Specification**  
0mm +0 / -3.5mm

**Repair Group**  
**64 'Slide glass**  
**checking and**  
**adjusting'**

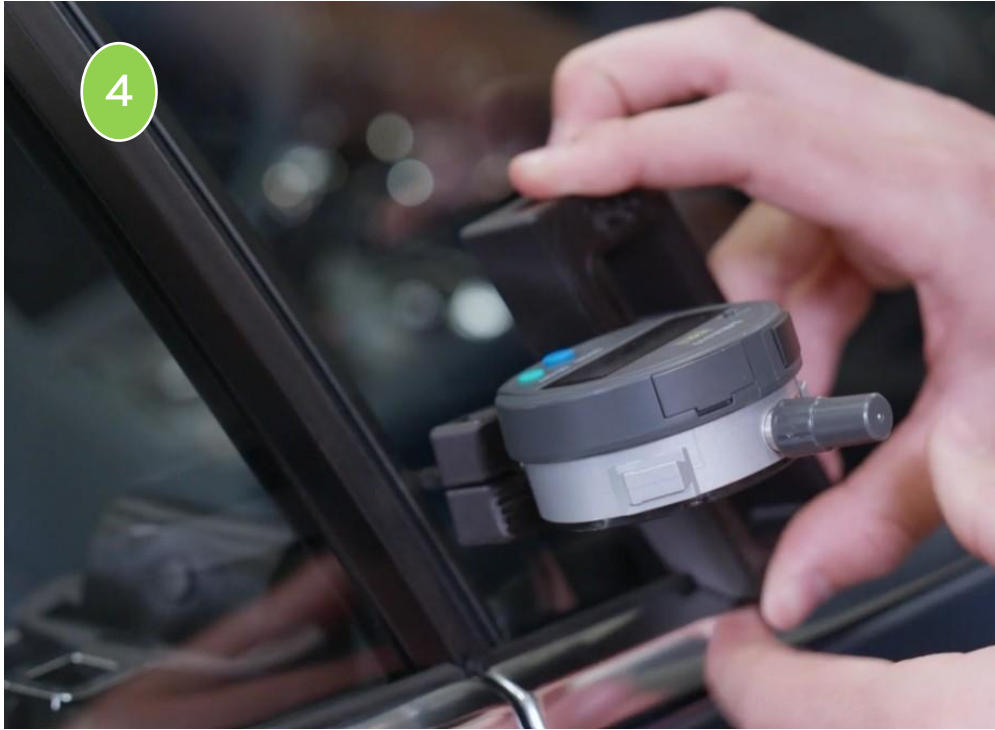
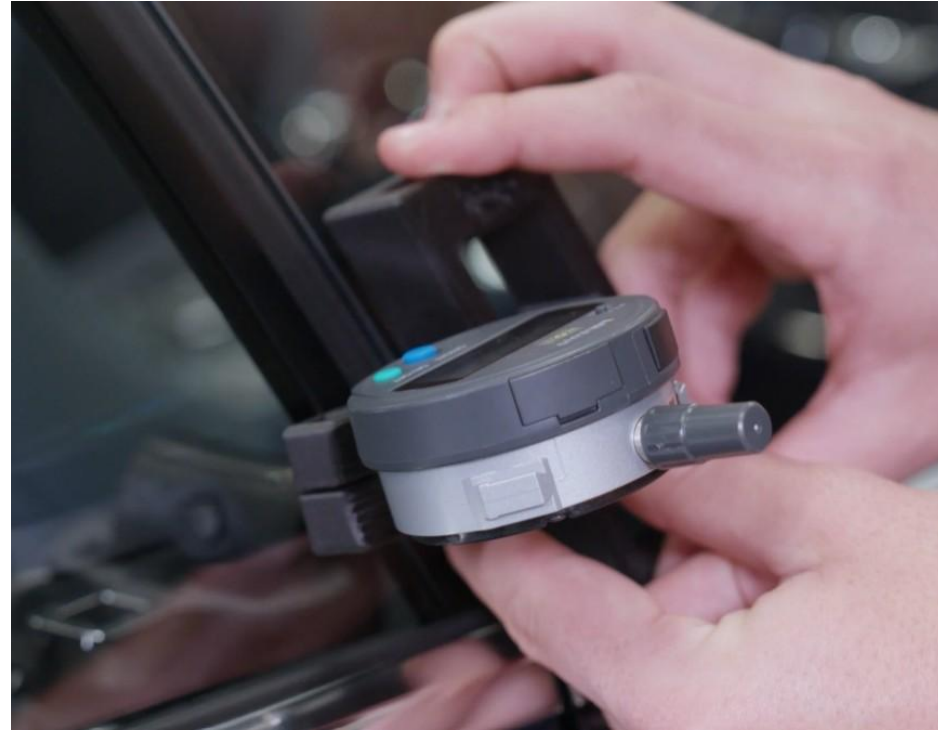
## PROFILE POINT 4 ROOF UP (DIGITAL DTI GAUGE - LATEST TOOL)

Align and position the tool on the front window so that its contact face rests flat against the lower bright ware trim, zero the tool.

Then slide it along the surface until it makes full, even contact with the rear glass.  
Record the measurement.

**Specification**  
0mm +0 / -3mm

**Repair Group 64**  
**'Slide glass**  
**checking and**  
**adjusting'**

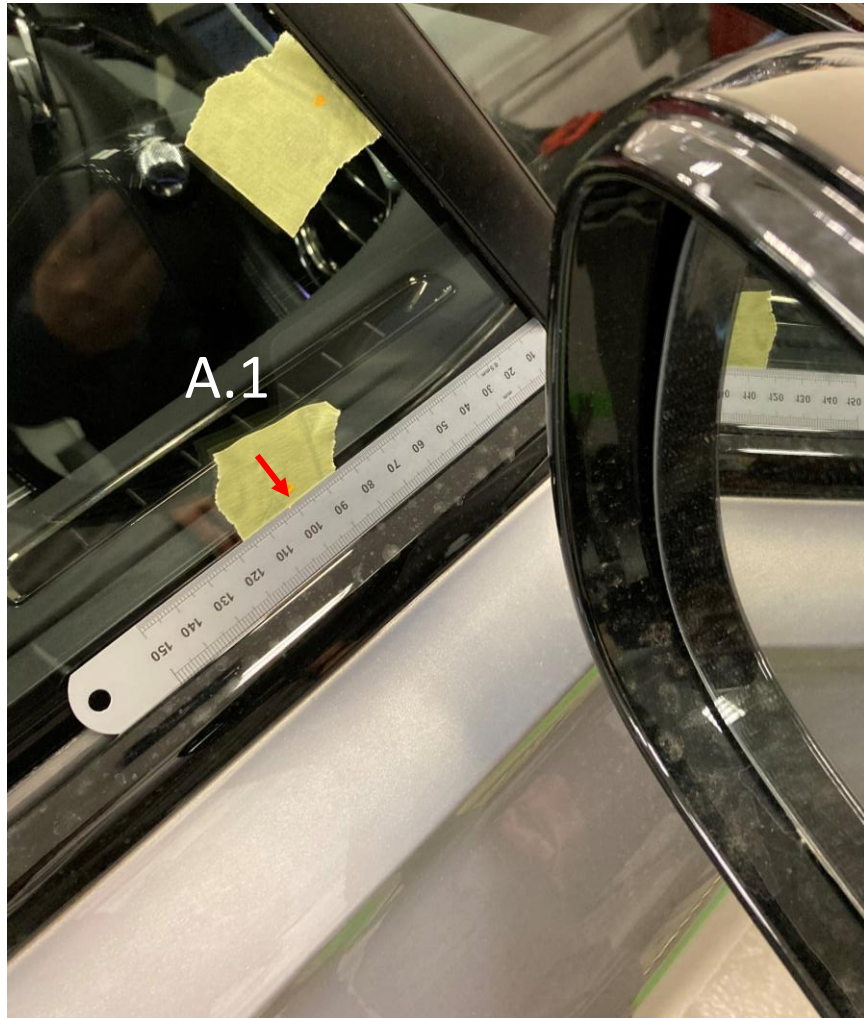
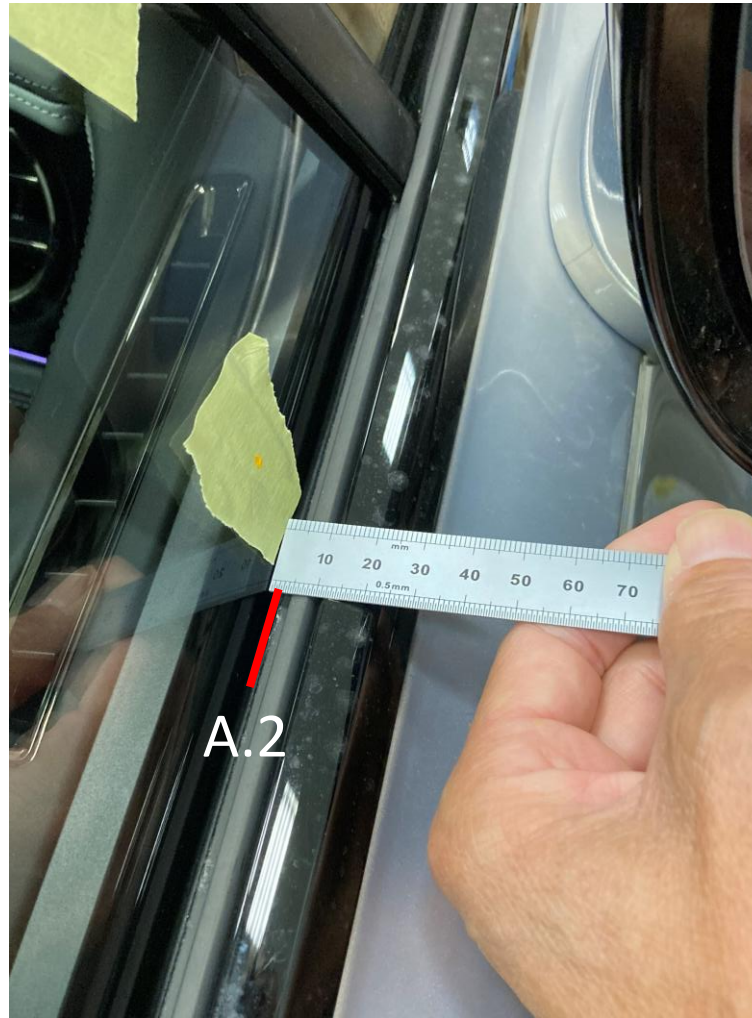
# WAIST SEAL MEASUREMENT POINT A

Mark on tape 100mm from div bar (A.1)

Measure from first lip rubber seal to window glass (A.2)

**Repair Group 64 'Slide glass checking and adjusting'**

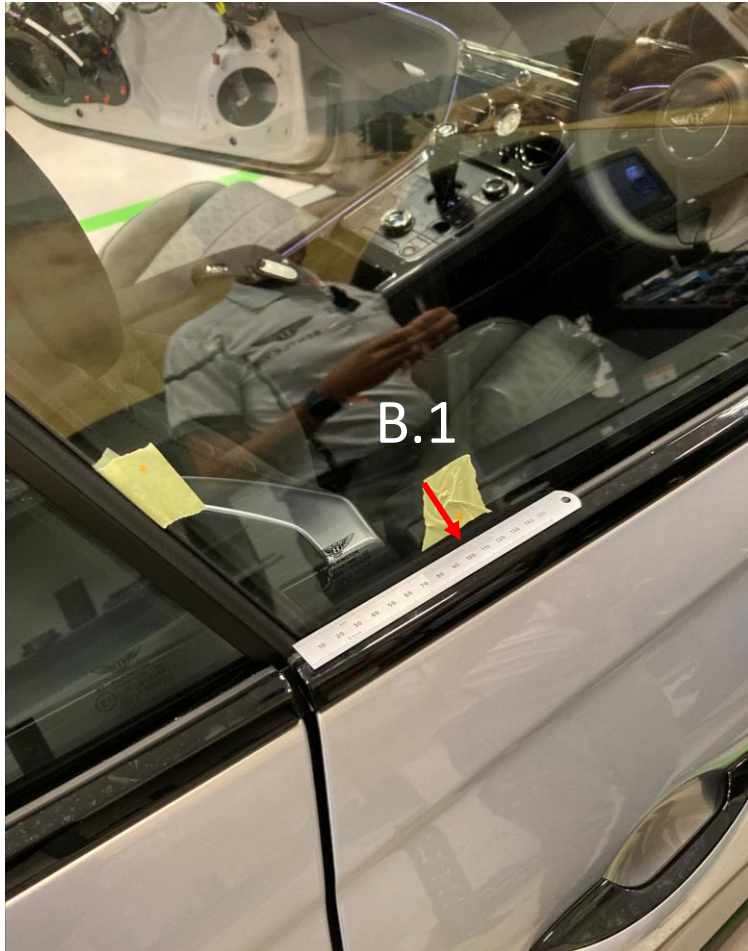
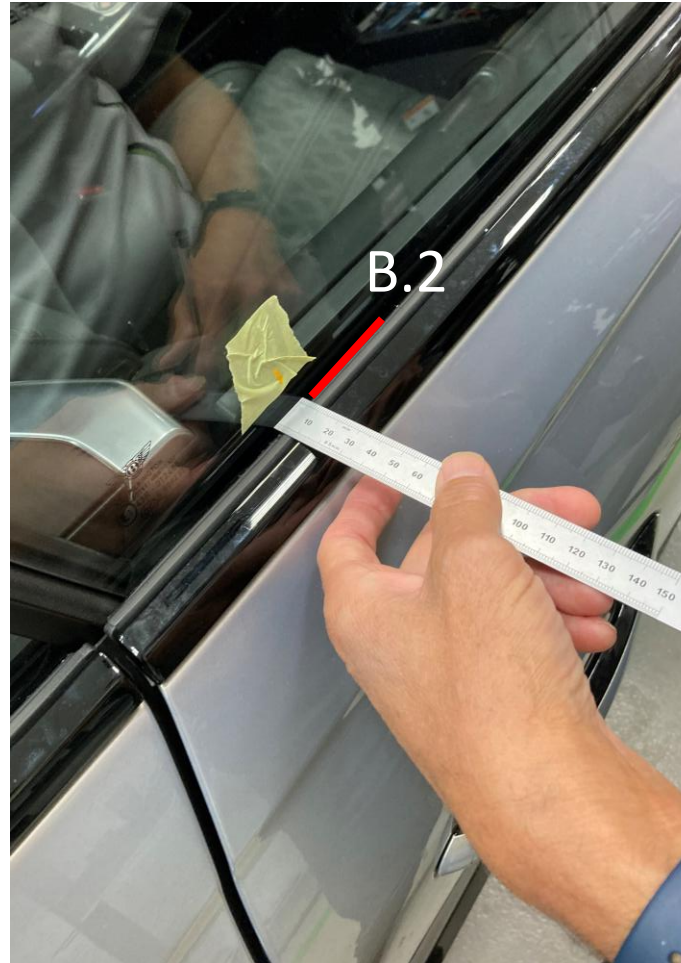
# WAIST SEAL MEASUREMENT POINT B

Mark on tape 100mm from  
div bar (B.1)

Measure from first lip  
rubber seal to window glass  
(B.2)

**Repair Group 64 'Slide glass  
checking and adjusting'**

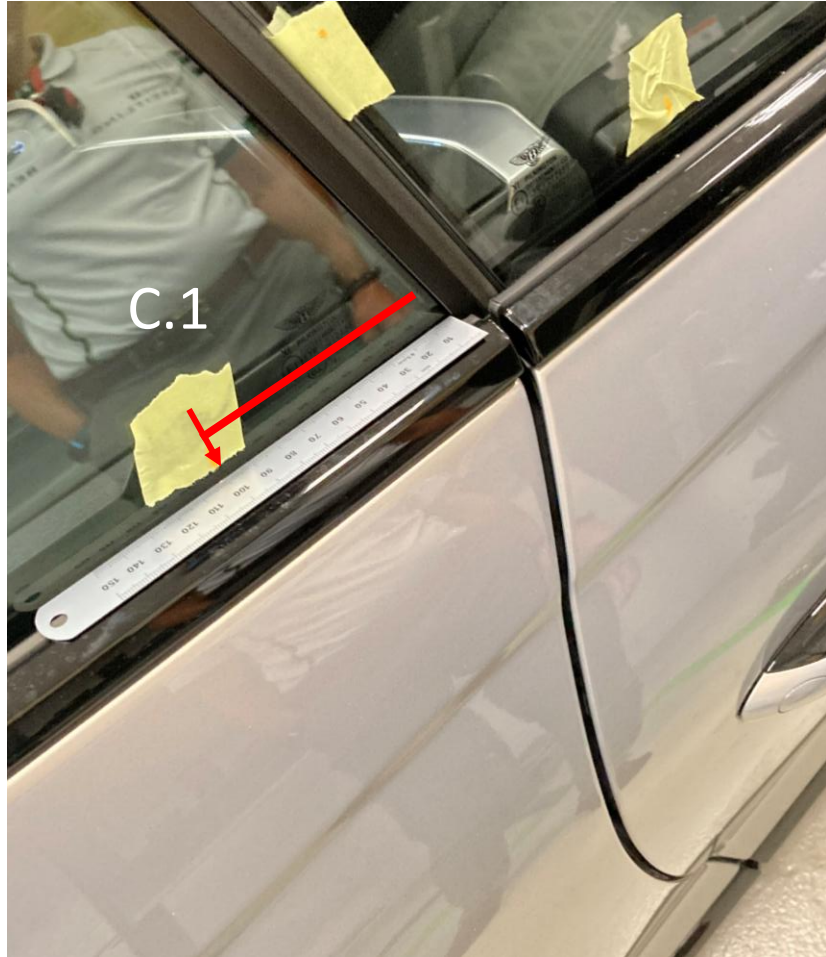
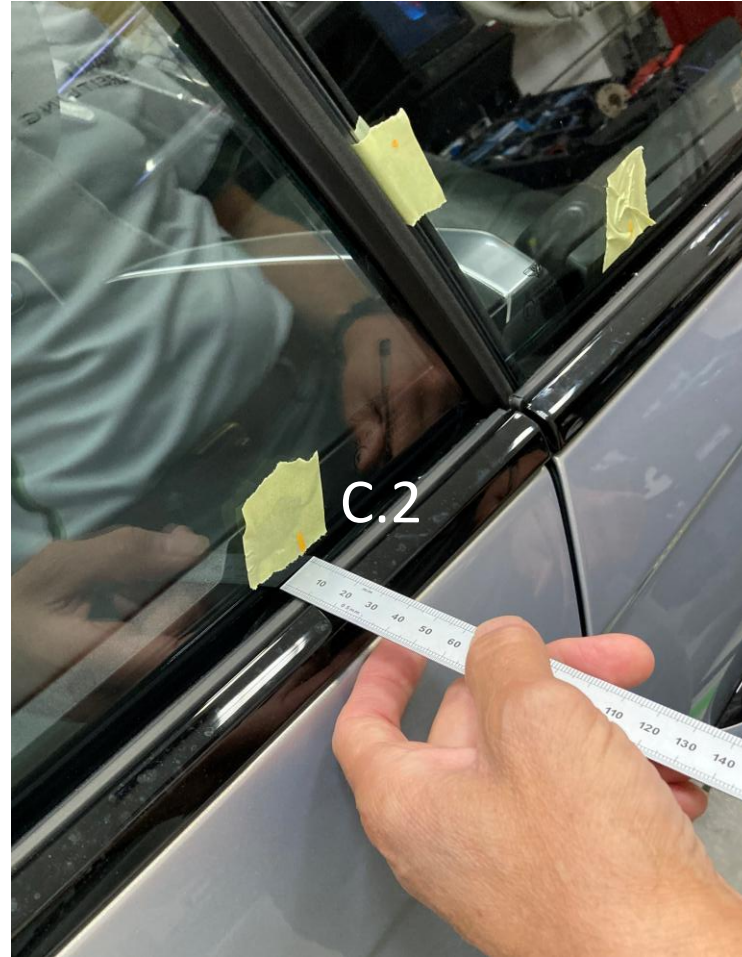
# WAIST SEAL MEASUREMENT POINT C

Mark on tape 100mm  
from div bar (C.1)

Measure seal to  
window gap (C.2)

If the measurement is out  
of specification refer to  
ElsaPro **Repair Group 64**  
**'Slide glass checking and  
adjusting'**
