## Technical product information

| <b>Topic</b> | Window Drop Glass Operation Continental GT/GTC 19-24MY |
| <b>Transaction No.</b> | 2080375/4 |

Window Drop Glass Operation | Continental GT/GTC |19-24MY

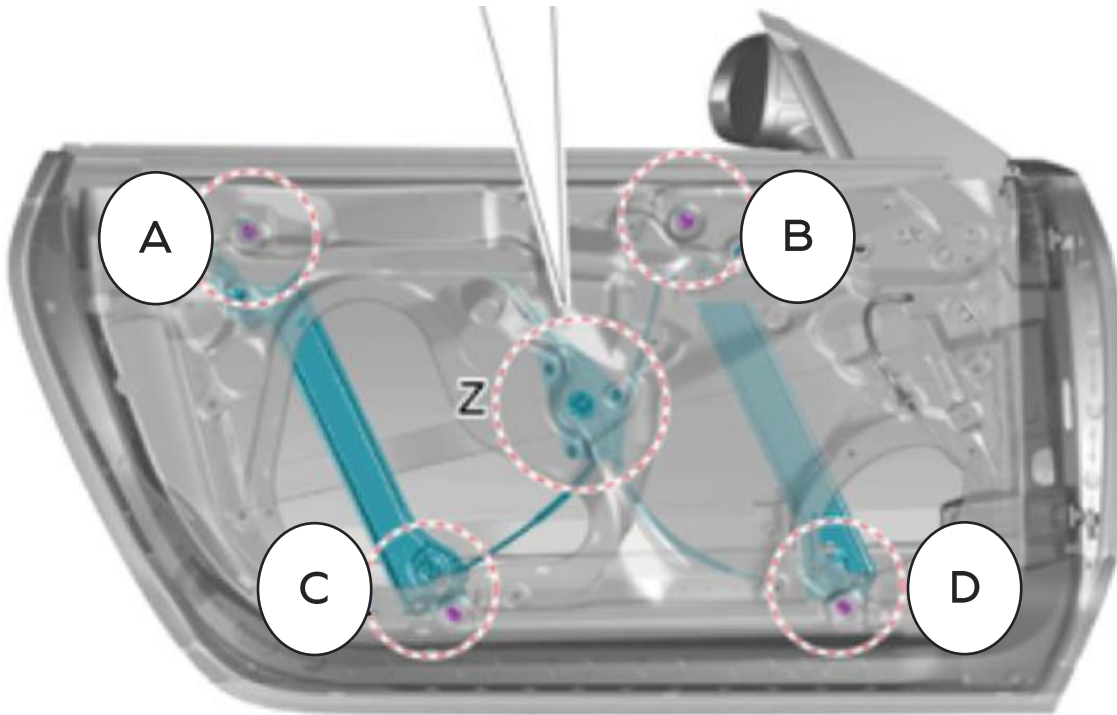
*Figure 2*

In instances of multiple window drop concerns it has been found that to achieve the glass set specification, some adjusters are being adjusted out of specification.

In some cases, since not all adjusters are visible, there is a possibility that the adjusters can be set to their maximum inboard/outboard and induce excess tension in the regulators and affect the angle the windows enter the seals. There is free play built into the front and rear regulators, therefore as the windows are being held in place by the cant rail/convertible roof seals when closed, this may not be apparent when measuring. However, these extreme adjustments can cause issues with how the windows enter the cant rail/convertible roof seals or how the front and rear glasses interlock with each other, in some cases this can cause the seals to pinch and cause an anti-trap condition leading to window reversal.

1. loosen the lock nut.
2. Screw the adjuster fully clockwise until it bottoms out on the frame.
3. Unscrew the adjuster counterclockwise by four complete turns.
4. Resecure the lock nut.

Finally, set the height and profile to the TPI specification before proceeding to the next step.

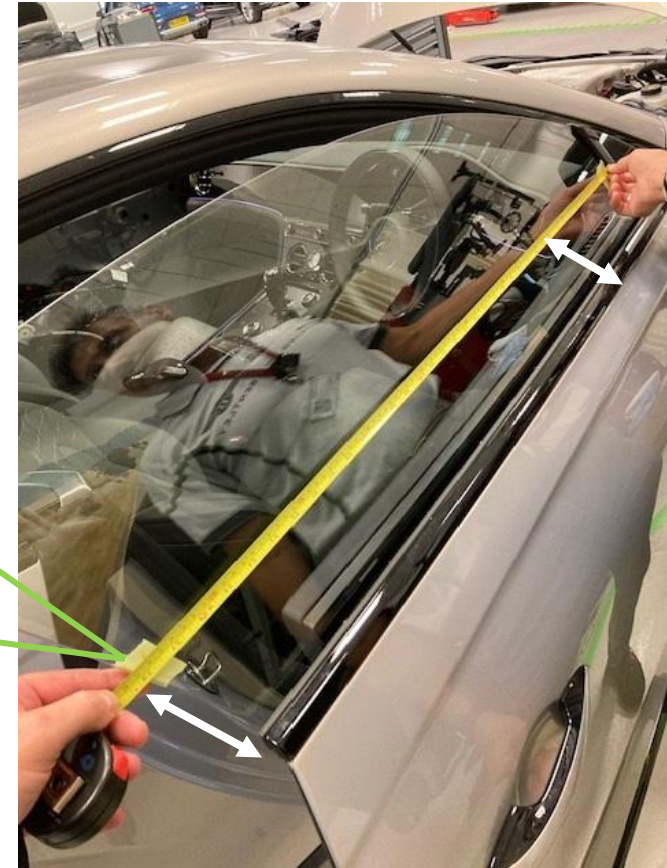
**Specification**  
971mm +2mm

Measure 100mm up from  
the waist rail

If out of specification, refer to the next slide to adjust the glass position

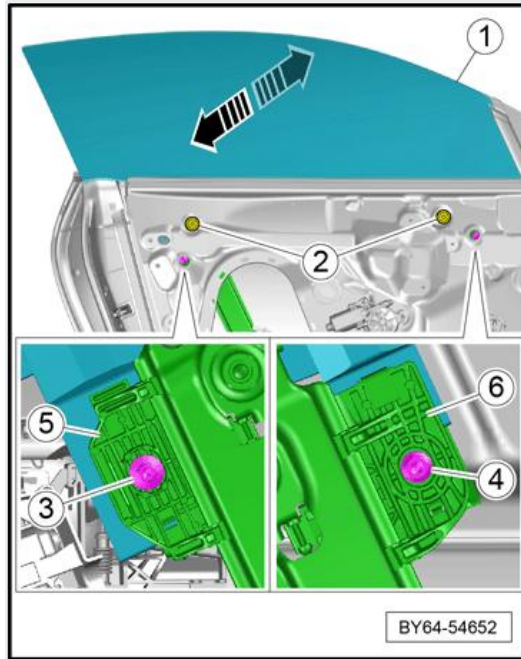
Figure 3

## Front door glass check and set

Then loosen the two purple bolts (-3- & -4-) in figure 3, raise the glass evenly as required, and re-secure the two purple bolts. Finally, return to the allen key (ratchet) adjustment to set interlock points 2, 3 and 4 to specification. Check the 971mm measurement has not altered, if so, re-adjust as required.

Loosen bolts -3- & -4- to ensure the glass sits in mounting position in its lowest position. Then resecure the bolts.

**NOTE:** If the 971 mm  $\pm$  1mm specification shown on the previous slide is incorrect, these bolts must be loosened to adjust the glass forward or backward as needed to meet the correct specification.

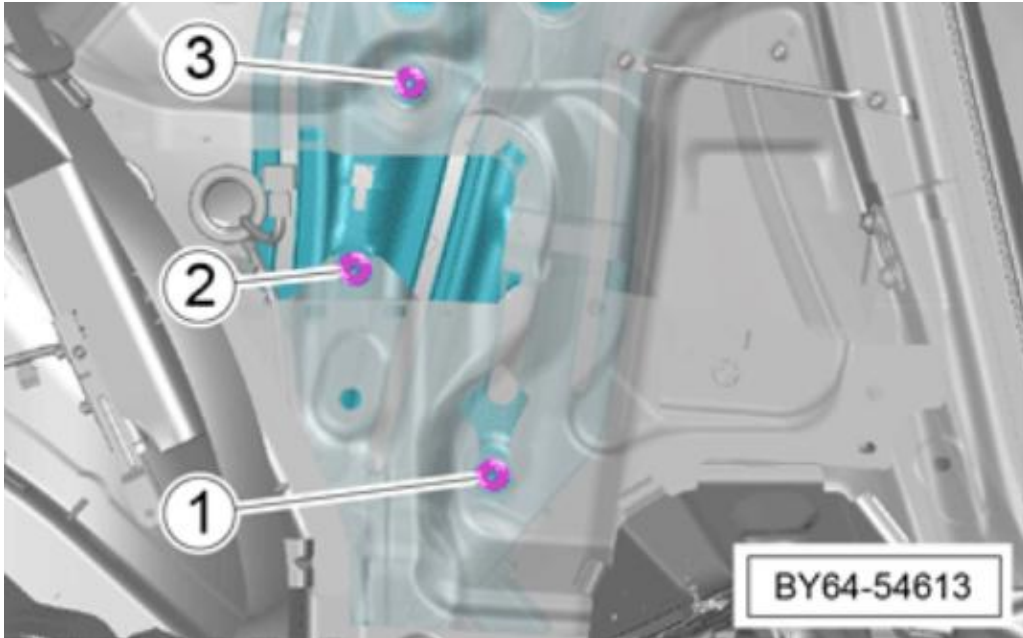
Figure 7

## Rear quarter regulator adjuster reset

Ensure blue closing panel (see image) is not stopping the regulator from moving when performing these adjustments by ensuring the nuts securing this are loose while resetting this regulator.

**NOTE:** After you have carried out the reset procedure, ensure measurements are rechecked as per the check & measurements attachment
