Subject: UPDATE: N242471460-01 – Customer Satisfaction Program  
Electrical Drive Unit Leak  
Updated Parts Information, Service Procedure

Models: 2024 Chevrolet Blazer EV  
2024 Chevrolet Equinox EV

## N242471460 Electrical Drive Unit Leak

| <b>Condition</b> | Certain vehicles listed above, may have been built with an Electric Drive Unit mounting bolt that is too long, causing damage to the Drive Unit case. |

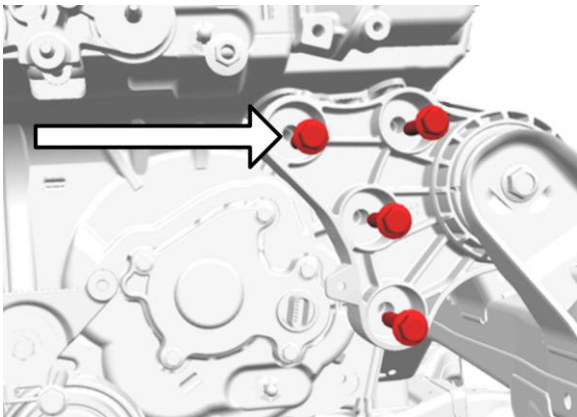
3. Inspect for the presence of fluid on and around the Right Side Drive Motor Mount.
- If fluid is present on or around the Right Side Drive Motor Mount, proceed to step 5.
  - If fluid is NOT present on or around the Right Side Drive Motor Mount AND THE VEHICLE IS IN DEALER INVENTORY, proceed to step 4.
  - If fluid is NOT present on or around the Right Side Drive Motor Mount AND THE VEHICLE IS CUSTOMER DRIVEN, Front Electric Drive Transmission Module is OK. Reinstall the Front Compartment Center Sight Shield and Compartment Support (if equipped) . Refer to *Front Compartment Center Sight Shield Replacement* and *Front Trim Finish Compartment Support Replacement* in SI. No further action is required.
