# HYUNDAI

## Technical Service Bulletin

**26-01-040H-1**

**SUBJECT:** INSIDE REAR COMBINATION LAMP ASSEMBLY INSPECTION – REPLACEMENT OR WASHER INSTALLATION (LIMITED COVERAGE CAMPAIGN LA19)

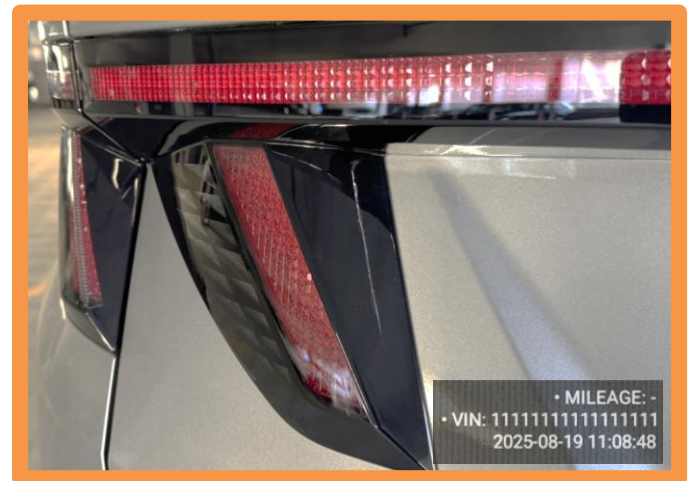
Using the STUI camera function, take a photo of the LH side of the existing inside rear combination lamp assembly.

Digital Documentation of the inside rear combination lamp assembly is required whether the assembly displays a crack **OR** is intact.

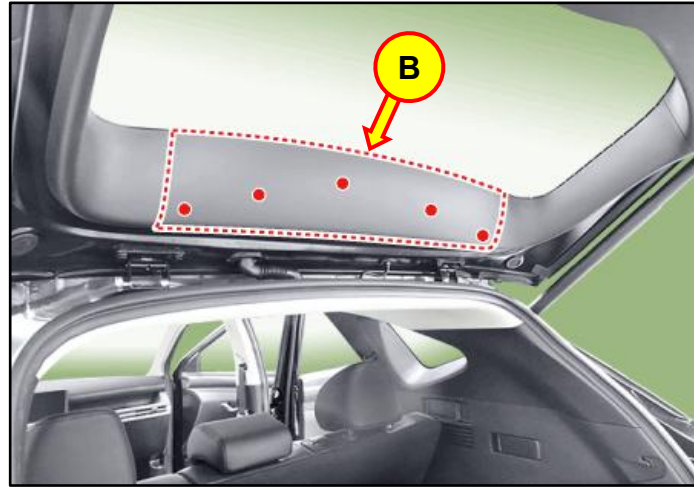
3. Open the tailgate and remove the tailgate upper trim (B).

Replace any damaged or broken clips (P/N: **82315-2P000**).

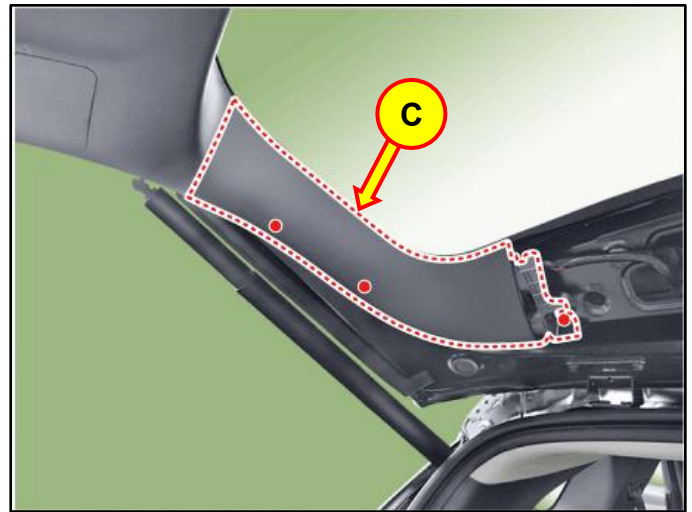
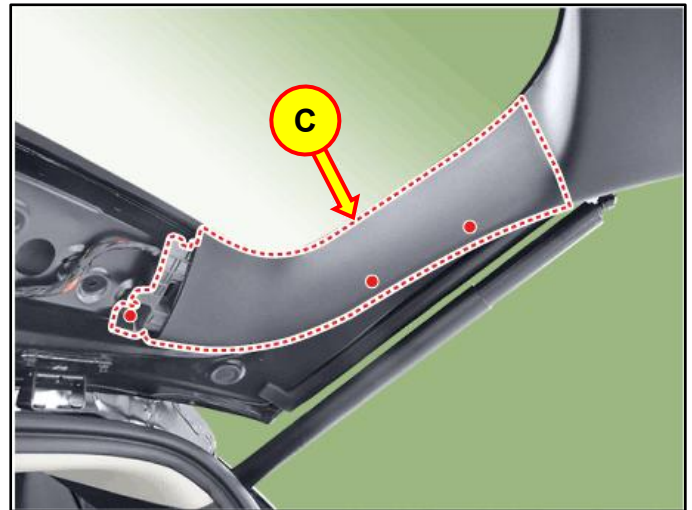
4. Remove the LH and RH tailgate side trim (C).

Replace any damaged or broken clips (P/N: **82315-2P000**).

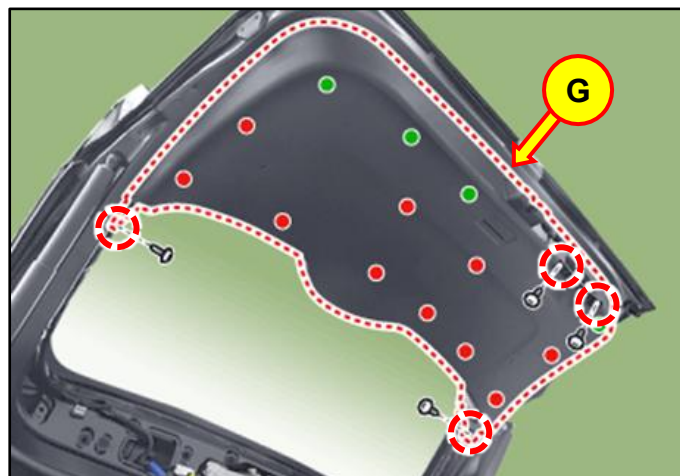
8. Remove the **4** screws then remove the tailgate lower trim (G).

Replace any damaged or broken clips (P/N: **82315-2P000** & **82315-33020**).

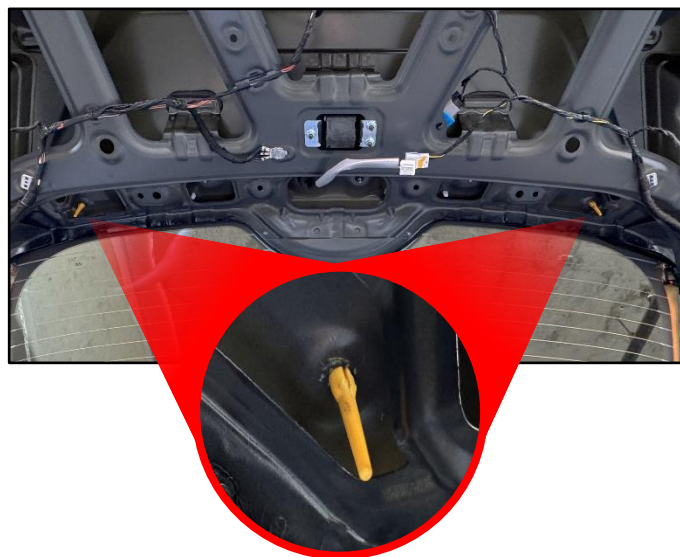
10. Disengage the **2** yellow clips from inside the tailgate then remove the tailgate upper garnish (I).

Replace any damaged or broken clips (P/N: **87378-A4000**).

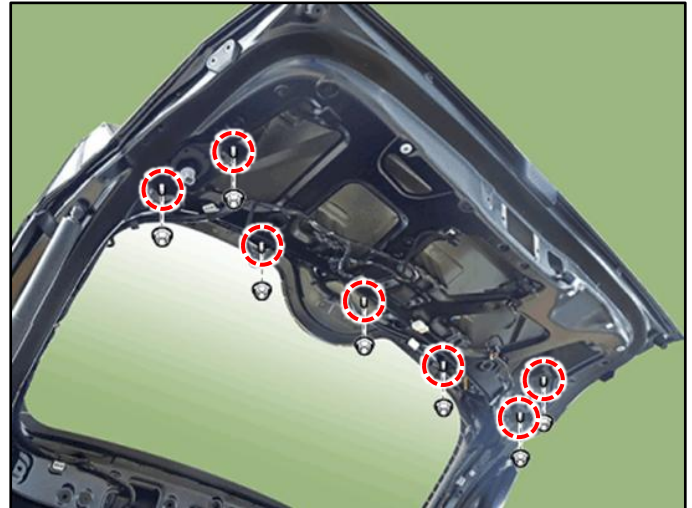
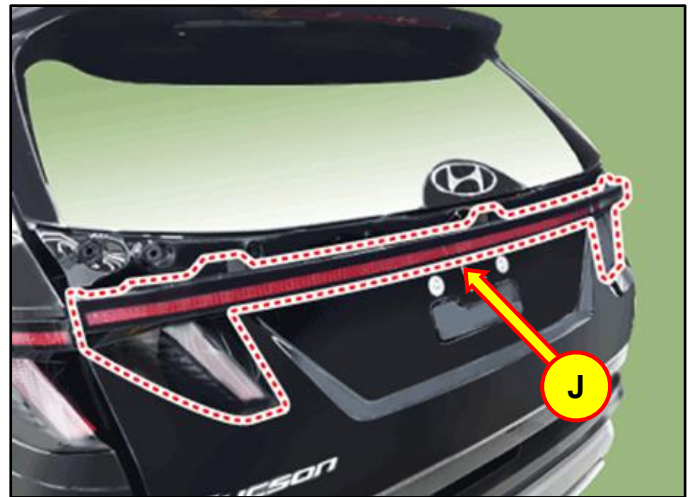
11. Remove the 7 nuts then remove the inside rear combination lamp assembly (J).

Use caution when removing the lamp assembly to prevent damage to the lamp and vehicle.

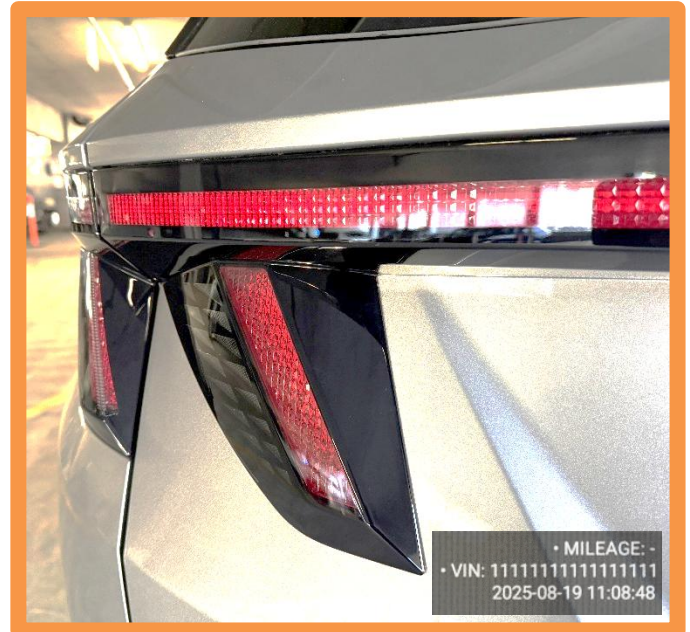
Using the STUI camera function, take a photo of the LH side of the new inside rear combination lamp assembly installed on the vehicle.

1. Install the new inside rear combination lamp assembly by first clipping it into place, then securing the **7** nuts.
2. Reinstall all parts in the reverse order of the removal process.

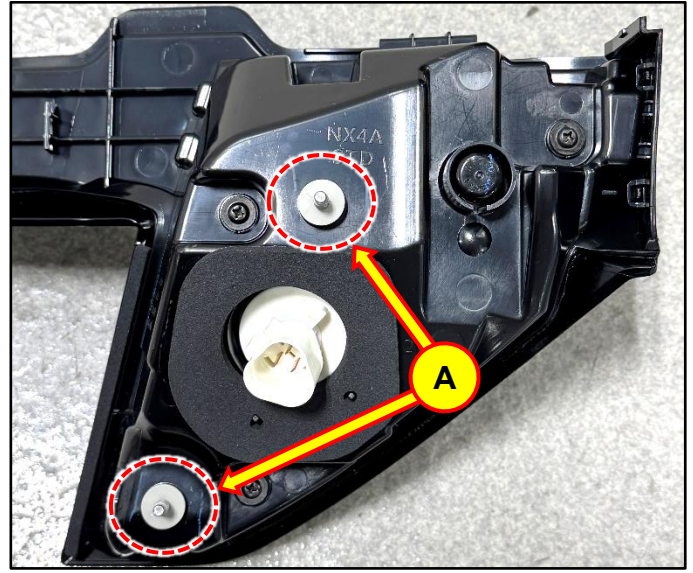
1. Remove the **2** rubber gaskets from the top and bottom studs (A) of the LH side of the inside rear combination lamp assembly.

2. On each stud, install the supplied metal washer (B) first, then replace the rubber gasket (C).

The metal washers **MUST** be installed before the rubber gaskets. Installing the metal washers after the rubber gaskets may damage the tailgate body and may **NOT** provide an adequate seal, potentially leading to water ingress into the tailgate panel.

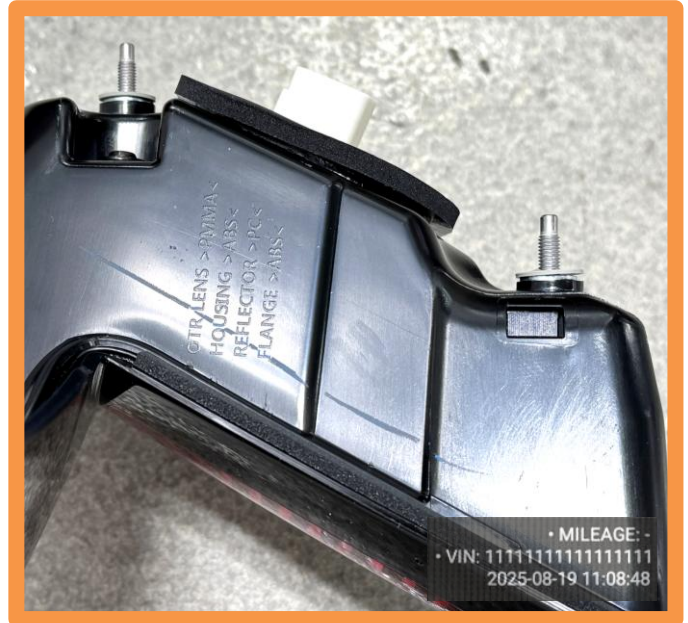
Using the STUI camera function, take a side-profile photo of the LH side inside rear combination lamp assembly with the washers installed, ensuring the image clearly shows the metal washer beneath the rubber gasket on the studs.
