2022-2024MY  
Carnival (KA4)

358

## TECHNICAL SERVICE BULLETIN

## HORN ASSEMBLY INSPECTION/REPLACEMENT (WTY048)

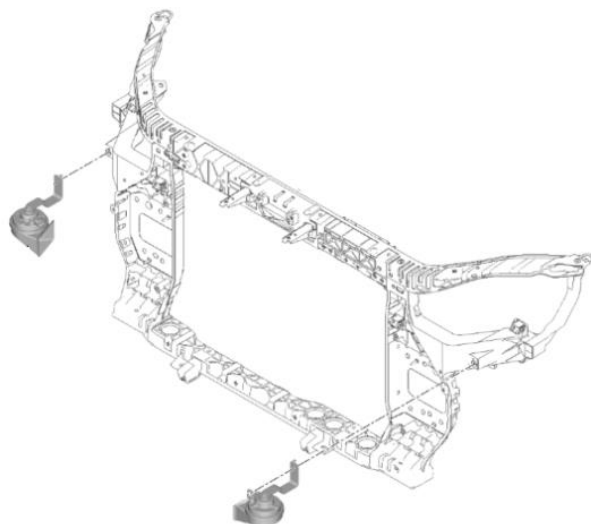
This bulletin provides information associated with the Warranty Extension Program (WTY048) to inspect and, if necessary, replace both the high-pitch and low-pitch horn assemblies on certain 2022-2024MY Carnival (KA4) vehicles produced from January 4, 2021 through July 4, 2024. The affected vehicles may experience a distorted or inoperative horn sound caused by excessive moisture and dust exposure over time. The warranty coverage for repairs related to the horn assembly has been extended from 5 years / 60,000 miles to 10 years / 120,000 miles, whichever comes first, starting from the date the vehicle was first put into service. Follow the procedure outlined in this publication to inspect and, if necessary, replace both the high-pitch and low-pitch horn assemblies with new ones on the applicable vehicle.
