## SERVICE BULLETIN

**APPLICABILITY:** 23-25MY Outback/Legacy Models (including Wilderness models)  
 23-26MY Ascent Models  
 24-26MY Impreza  
 24-26MY Crosstrek (including Wilderness models)  
 24-26MY WRX  
 25-26MY Forester  
 26MY Forester Wilderness

**NUMBER:** 15-305-22R  
**DATE:** 11/15/22  
**REVISED:** 08/20/26

**SUBJECT:** Reprogramming File Availability for Optimization of Gen 4.5 Denso CP1.5 Infotainment Systems

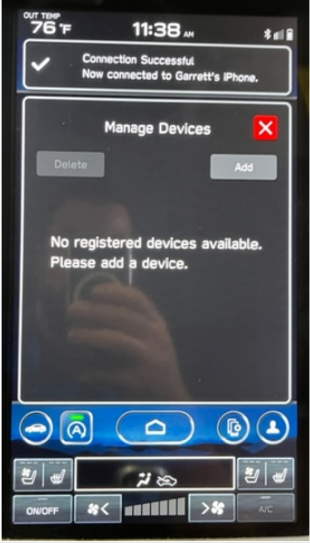
| Number | Category | Symptoms to be Improved: |
|---|---|---|
| 6 | Display | <p>The registered mobile device information is not displayed on the Manage Devices screen.</p> <p>(This occurs when the name or device ID of a mobile device contains a character code that cannot be displayed.)</p> <p>(only applicable to HIGH and MID trim)</p> |

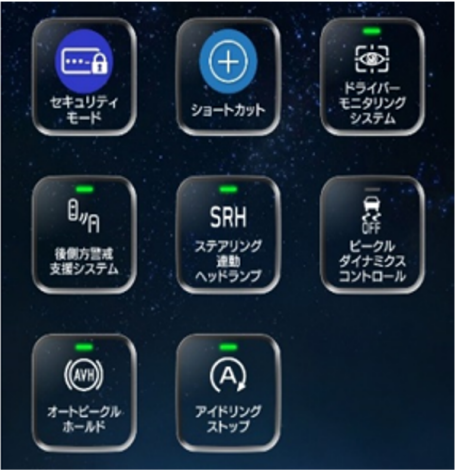
| Number | Category | Symptoms to be Improved: |
|---|---|---|
| | | <p>When turning off and on while two or more shortcuts of DMS/SRH/SRVD icons are set on the Home screen, the order of icons changes from DMS to SRVD, SRH, VDC, AVH, and ISS.</p> |

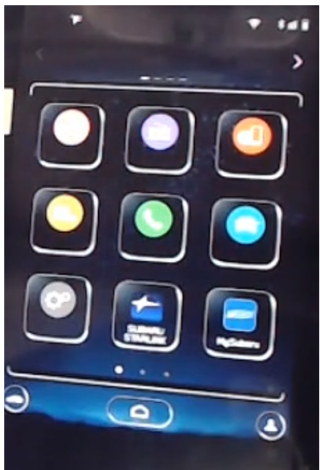
| Number | Category | Symptoms to be Improved: |
|---|---|---|
| 6 | Display | <p>The AVH icons on the HOME screen are initially lined up next to the Valet-Mode icon. However, in some cases they are placed at the top (upper left corner of the first page) or next to the MAP icon.<br/>(only applicable to HIGH and MID trim)</p> <div data-bbox="602 300 1403 680"> </div> <p>After switching the clock function to AUTO, the CID screen display may become distorted.<br/>(only applicable to HIGH and MID trim)</p> <div data-bbox="841 812 1159 1278"> </div> <p>It may take accessive time to start the CID screen after ignition on.</p> |

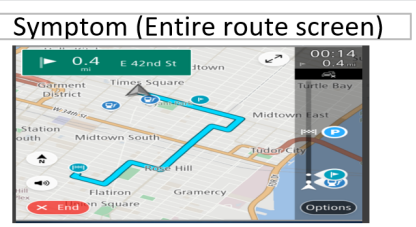
| Number | Category | Symptoms to be Improved: |
|---|---|---|
| | | <p>The route guidance operation starts with the screen displaying the entire route to the destination. Your Information &amp; Privacy screen is displayed when the navigation system is booting for the first time and you have not accepted the privacy policy. Set the destination of the navigation system by voice recognition commands, launch the navigation screen.<br/>(only applicable to HIGH trim)</p> <div style="display: flex; justify-content: space-around;"> <div style="text-align: center;"> <p>Normally</p> </div> <div style="text-align: center;"> <p>Symptom (Entire route screen)</p> </div> </div> |

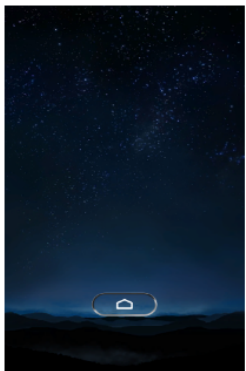
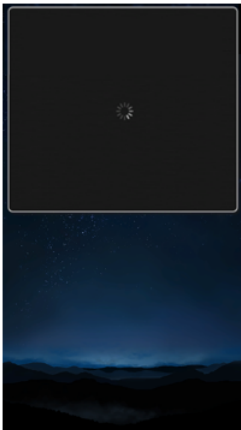
| Number | Category | Symptoms to be Improved: |
|---|---|---|
| | | -Right after starting up, the CID displays only background without icons and no further operation can be done (not applicable to WRX) |
| | | <p>After engine starts, only the black frame of the Caution screen display may remain on the CID screen.</p> <p>The rear view camera can be displayed by shifting to shift R.</p> |

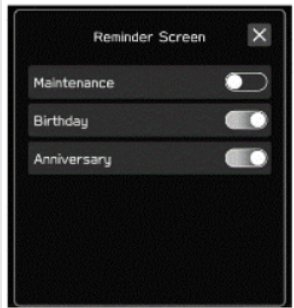
| Number | Category | Symptoms to be Improved: |
|---|---|---|
| | | <ul style="list-style-type: none"> <li>- When multiple reminders for maintenance dates, birthdays, and anniversaries are set and nearing, a series of pop-up notifications appear on the CID screen after starting the engine. If you try to delete a reminder right before it switches to the next one, the CID screen may reboot (not applicable to WRX)</li> </ul> |

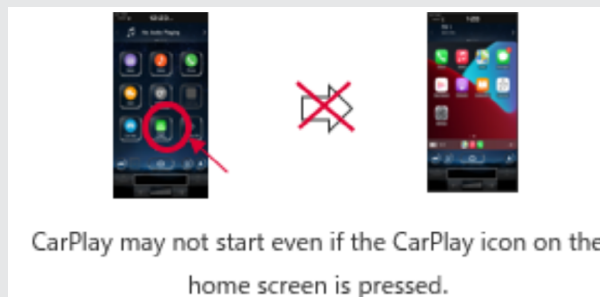
| Number | Category | Symptoms to be Improved: |
|---|---|---|
| | | - When starting the engine with the iPhone connected via USB, CarPlay may not start even if the CarPlay icon on the home screen is pressed. (This can be resolved by reinserting the USB cable.) |

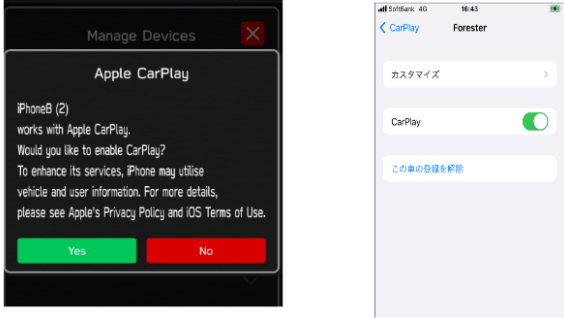
| Number | Category | Symptoms to be Improved: |
|---|---|---|
| 7 | Bluetooth | <p>- Bluetooth connection may not become active, and it may become impossible to switch Bluetooth-connected devices, when following steps below (turning on/off the connection)(not applicable to WRX):</p> <p>With the CarPlay usage confirmation screen displayed on the CCU, press the 'Yes' button. Almost simultaneously, on the iPhone's settings screen, turn off the CarPlay toggle switch.</p> |

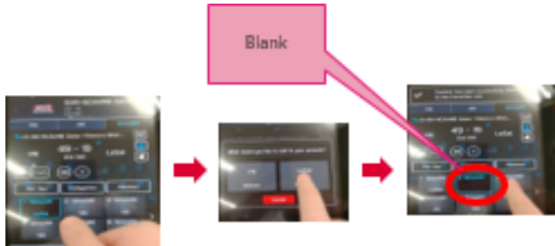
| Number | Category | Symptoms to be Improved: |
|---|---|---|
| | | <p>- When registering SXM sports team channels to the radio preset buttons if a team for which logo image cannot be captured is registered, the channel short name will not be displayed on the registered button and the button will be blank (not applicable to BASE trim)</p> |

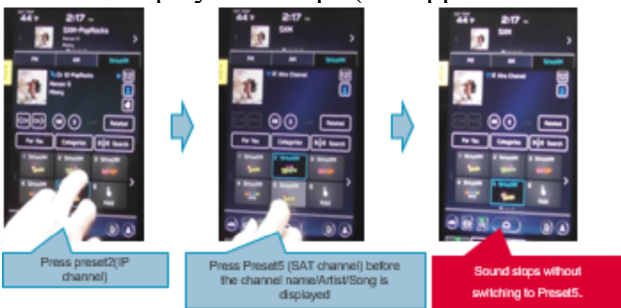
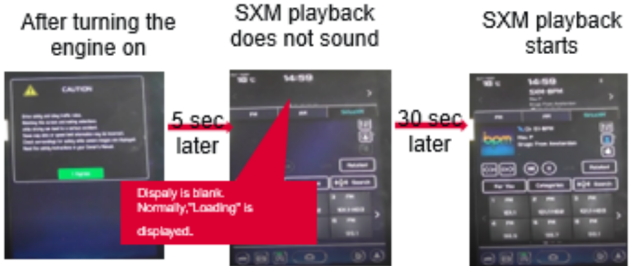
| Number | Category | Symptoms to be Improved: |
|---|---|---|
| 9 | SXM | <p>- When switching to the SAT channel (satellite channel) immediately after selecting the IP channel (Internet channel) on the SXM360, song information is not displayed and audio playback stops (not applicable to BASE trim)</p> <p>Press preset2(IP channel)      Press Preset5 (SAT channel) before the channel name/Artist/Song is displayed      Sound stops without switching to Preset5.</p> <p>- If the ignition-off/on operation is performed quickly immediately after ignition-on, the previously viewed channel in SXM may not start playing automatically (It will play by switching the audio source) (not applicable to BASE trim)</p> <p>- When the contract status is Demo, "Your Trial Expires in 0 Days" is displayed on the SXM Setiing screen. The display will be removed when the contract status is Demo (not applicable to BASE trim)</p> <p>- Gametime (1st Period, etc.) is not displayed on the pop-up screen of SXM Sports channel when a game starts</p> <p>- Registering a channel with blank information in presets results in a preset button with a blank label, and the channel logo is not displayed. Additionally, pressing the preset button with the blank label does not initiate playback of the channel.</p> <p>- After turning the engine on, "Loading" should appear on the channel information screen until SXM playback starts, but it does not appear and remains blank</p> <p>After turning the engine on      SXM playback does not sound      SXM playback starts</p> <p>5 sec later      30 sec later</p> <p>Display is blank. Normally, "Loading" is displayed.</p> |

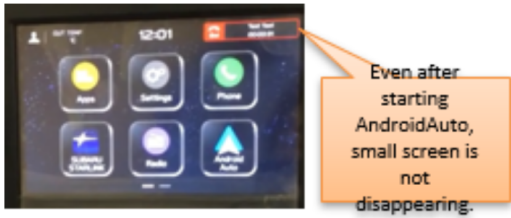
| Number | Category | Symptoms to be Improved: |
|---|---|---|
| 11 | Display Appearance | <p>- The call screen reduction appears in the Status Bar while connected to Android Auto. Originally, when Android Auto is activated during a hands-free call, the call screen reduction should disappear (only applicable to BASE trim).</p> |

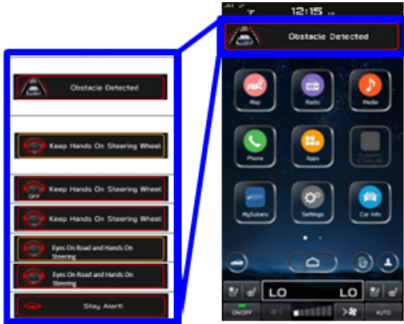
| Number | Category | Symptoms to be Improved: |
|---|---|---|
| | | <p>- If the language setting of the CID is changed while an alarm message by the Driver Monitoring System(DMS) is displayed on the CID, the alarm will be hidden (not applicable to BASE trim)</p> |

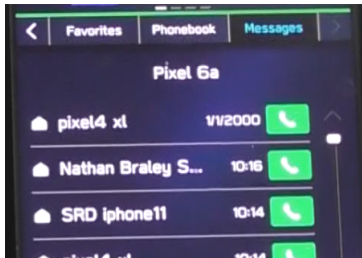
| Number | Category | Symptoms to be Improved: |
|---|---|---|
| | | <p>- The date for the message is displayed as 1/1/2000 instead of the correct date. This occurs on some models of phones with Android OS 13 or later.</p> |

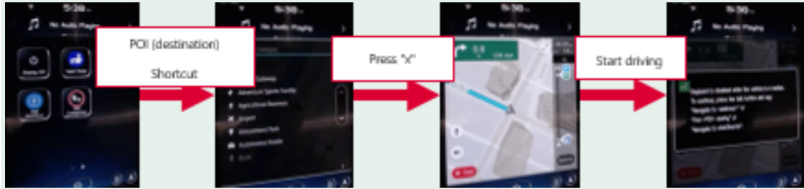
| Number | Category | Symptoms to be Improved: |
|---|---|---|
| 13 | Navi<br>Operation | <p>- "Keyboard is disable while the vehile is in motion"" is displayed on the screen when performing the steps below (only applicable to HIGH trim) :</p> <ol style="list-style-type: none"> <li>1. Press the POI (destination) Shortcut on the home screen to display the list of destinations.</li> <li>2. Press "x" to clear the list.</li> <li>3. Start driving with the Map screen displayed.</li> </ol> |

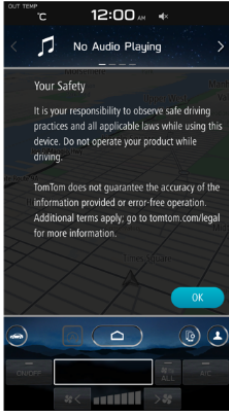
| Number | Category | Symptoms to be Improved: |
|---|---|---|
| 13 | Navi<br>Operation | <p>- The requirement to press ""OK"" on the Your Safety screen during the initial navigation launch sometimes wasn't displayed (only applicable to HIGH trim).</p> <p>Before the change:<br/>If the navigation app was launched for the first time from any icon other than the Map icon on the Home screen (e.g., through a rest suggestion feature) the Your Safety screen would not appear and navigation functionality could not be initiated.</p> <p>After the change:<br/>Even if the navigation app is launched for the first time from an icon other than the Map icon on the Home screen, the Your Safety screen will be displayed.</p> |

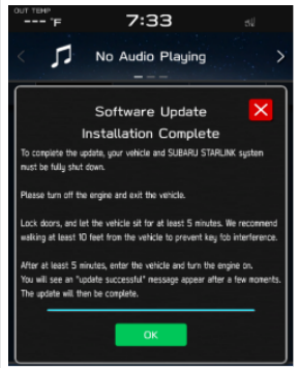
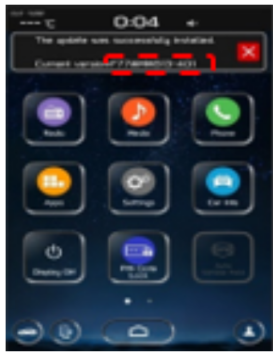
| Number | Category | Symptoms to be Improved: |
|---|---|---|
| 26 | Software Update | <p>- When the engine is turned off at a specific moment just before the completion of the CCU software update via FOTA, the expected completion notification screen does not appear when the engine is turned on next time (not applicable to BASE trim)</p> <p>- After the installation of software updates via OTA (Over-the-Air), the "Current Version" field in the popup screen that appears during the next IGN-ON may be blank or empty (not applicable to BASE trim)</p> |

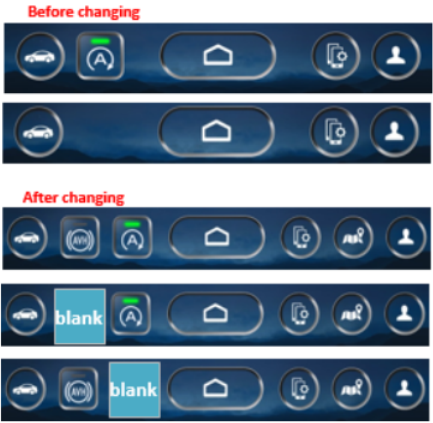
| Number | New Function or Enhancement |
|---|---|
| 9 | <p>- New shortcut button(s) are added in button bar of “Home” screen. AVH (Auto Vehicle Hold) ON/OFF Button for vehicle equipped with AVH (not applicable to BASE trim)</p> |

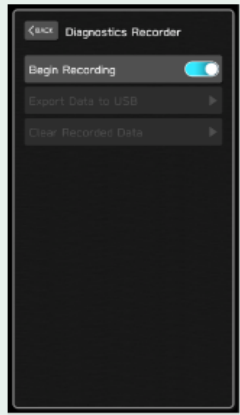
| Number | New Function or Enhancement |
|---|---|
| 11 | <p>When getting CCU USB logs at the Diagnostics Recorder screen in the Dealership Mode, it was necessary to turn off ""Begin Recording"" to ""Export Data to USB."" And after the log acquisition, it was necessary to turn ""Begin Recording"" ON again. The system interface is improved so that ""Begin Recording"" is automatically switched ON after log acquisition has been accomplished.</p> |

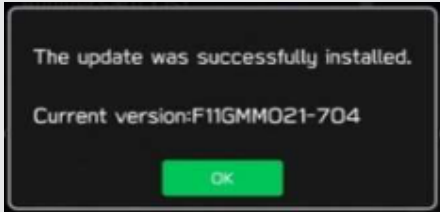
| Number | Symptoms to be Improved: |
|---|---|
| 15 | <p>Popup of “The update was successfully installed” is not displayed after reboot (IG-OFF and ON) operation of FOTA (Firmware Over The Air) update.</p> |

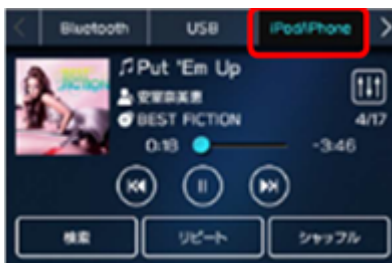
| Number | Symptoms to be Improved: |
|---|---|
| 1 | <p>iPod/iPhone tab in Media screen cannot be selected, when connected by USB.</p> <p>The symptom occurs when the iPhone is connected to CP1.5 via Bluetooth in parallel to USB connection by error. (It is supposed to be connected either via Bluetooth or by USB.)</p> |

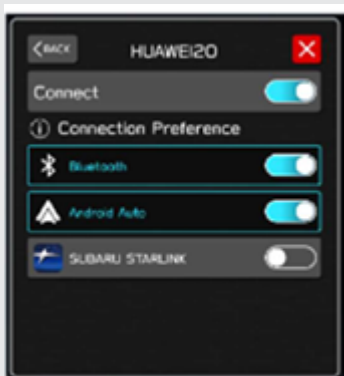
| Number | Symptoms to be Improved: |
|---|---|
| 2 | <p>On the "Manage Devices" screen Bluetooth cannot be selected as connection preference.</p> |

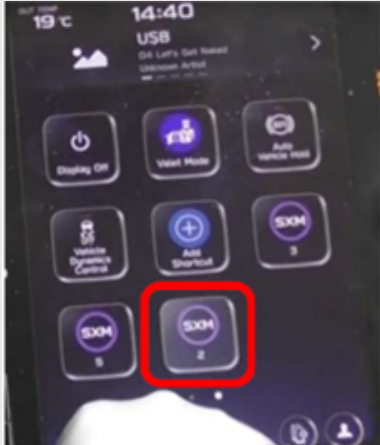
| Number | Symptoms to be Improved: |
|---|---|
| 6 | <p>SXM station shortcut created by the customer does not work when the SXM has not been used as audio source after the Ignition Switch was turned on in the ignition cycle.</p> |

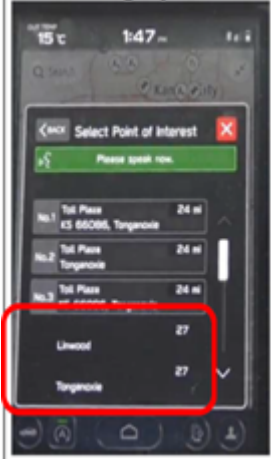
| Number | Symptoms to be Improved: |
|---|---|
| 9 | <p>POI Search Result shows only city names and distances (without unit) when voice recognition POI search with Category name like “Find toll gate” is used.</p> |

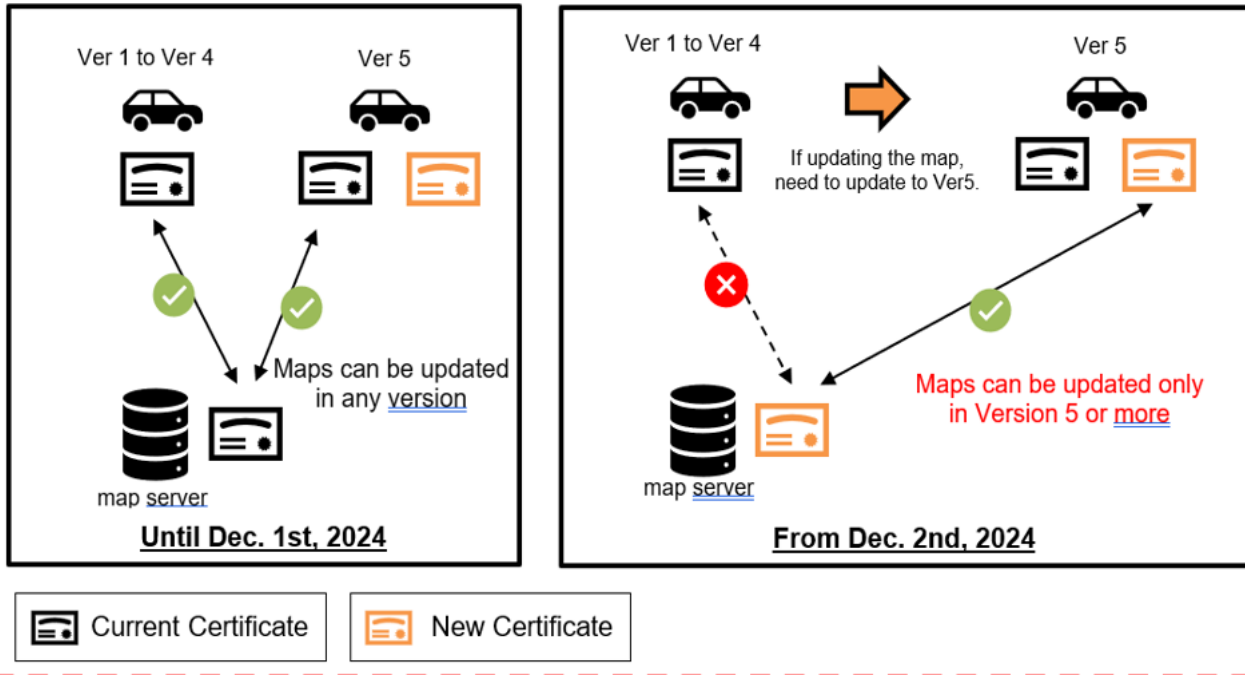
**IMPORTANT NOTE:** The certificate of the data distribution server for the map update service by Map OTA (MOTA) will be changed **from Dec 1<sup>st</sup>, 2024**, and the previous server certificate will no longer be eligible after **2<sup>nd</sup> December, 2024**. To get the MOTA service on and **after Dec 2<sup>nd</sup>, 2024, Ver. 5 software that includes new server certificate should be installed in advance.**
