## SERVICE BULLETIN

**APPLICABILITY:** 2024MY Crosstrek

**NUMBER:** 12-264-26

**SUBJECT:** Front Fender Garnish Design Change

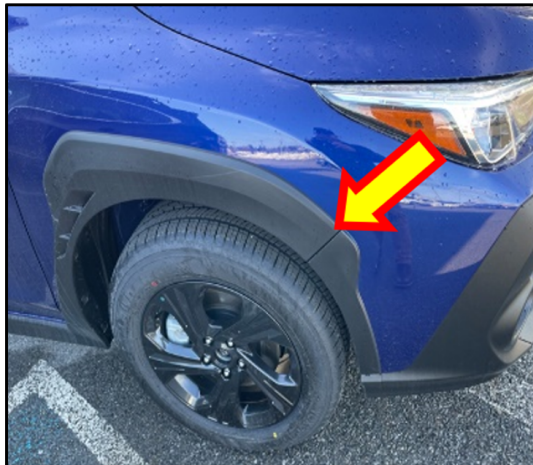
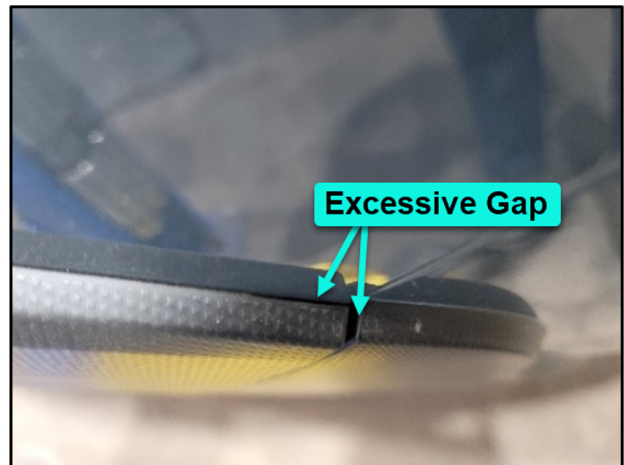
The new left and right front fender garnishes were incorporated into vehicle production starting with VIN **RH248904**.

This bulletin announces the availability of new front fender garnishes fitted with new clips to provide a more secure and streamlined fit. If excessive gap between the fender and the fender garnish is reported by a customer, replace the affected garnish with the new part(s).
