## SERVICE BULLETIN

**APPLICABILITY:** 2020-22MY Legacy  
 2020-22MY Outback(Including Wilderness)

**NUMBER:** 15-261-20R

**SUBJECT:** Reprogramming File Availability for Optimization  
 of Gen 4 Denso CP1 Infotainment Systems

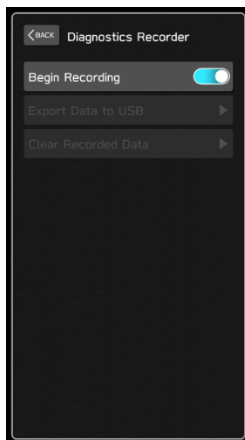
| Number | New Functions and Enhancements |
|---|---|
| 4 | When getting CCU USB logs at the Diagnostics Recorder screen in the Dealership Mode, it was necessary to turn off ""Begin Recording"" to ""Export Data to USB."" And after the log acquisition, it was necessary to turn ""Begin Recording"" ON again. The system interface is improved so that ""Begin Recording"" is automatically switched ON after log acquisition has been accomplished.<br> |

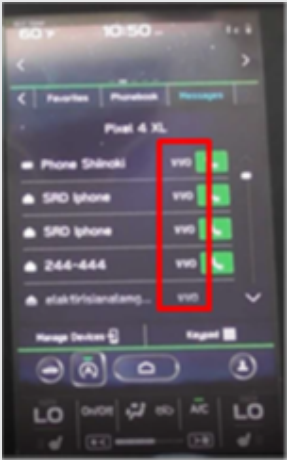
| Number | Symptoms to be Improved: |
|---|---|
| 16 | <p>When selecting “Phone-&gt;”Message,” message received time is displayed incorrectly as “1/1/0.”</p> <p>It can occur with an Android phone with a specific Android OS (Pixel 6, Pixel4a, Pixel4XL, Xperia etc. ) in which time zone data is attached to the message receiving time.</p> |

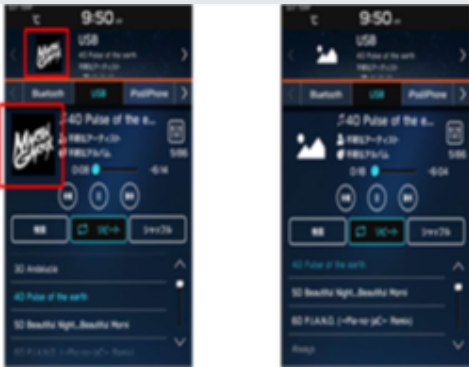
| Number | Symptoms to be Improved: |
|---|---|
| 18 | <p>Cover art of previous music is displayed when playing music without cover art in USB audio. It can occur when music with and without cover art is mixed and stored together a single USB.</p> |

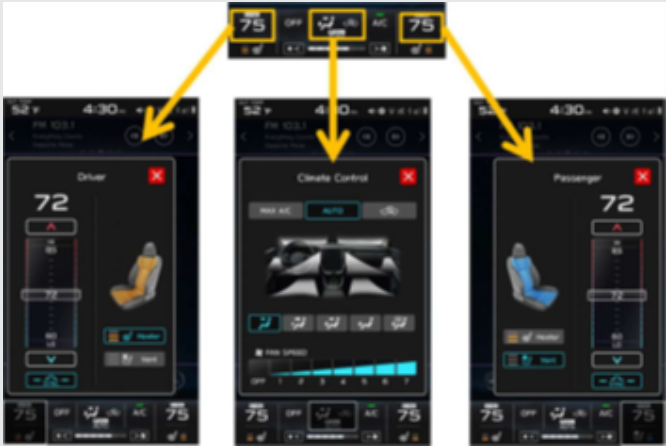
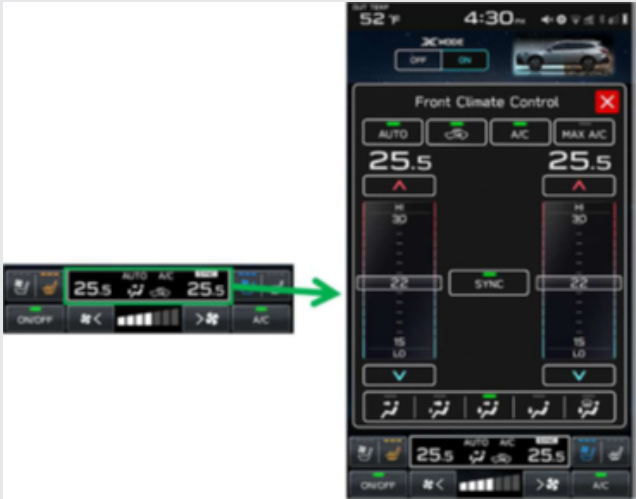
| Number | New Functions and Enhancements |
|---|---|
| 2 | <p>Air conditioner control interface is changed to that of 23MY.</p> <p>Current ( -22MY) screen transition:</p> <p>23MY screen transition:</p> |

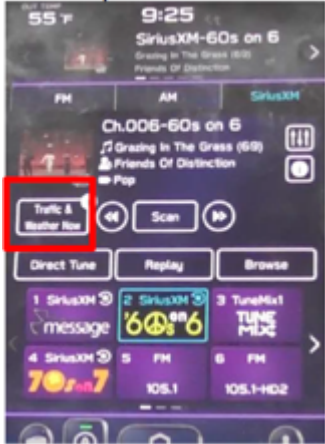
| Number | Symptoms to be Improved: |
|---|---|
| 25 | <p>No response when touching “Traffic &amp; Weather Now (TWN)” on SMX screen.</p> |

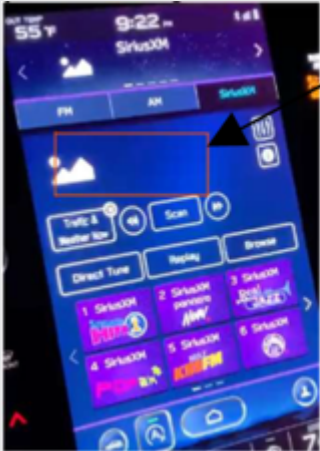
| Number | Symptoms to be Improved: |
|---|---|
| 26 | <p>SXM has blank screen and no sound when the SXM screen had been selected as audio source at the previous ignition off timing.</p> <div data-bbox="854 842 1411 940" style="border: 1px solid black; padding: 5px; display: inline-block;">No SXM Channel displayed</div> |

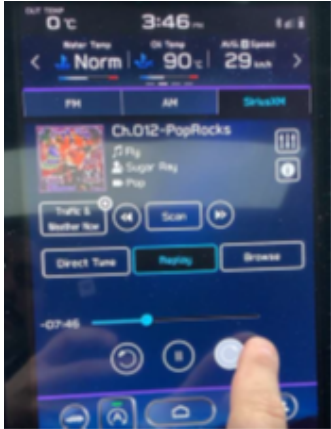
| Number | Symptoms to be Improved: |
|---|---|
| 29 | <p>“Fast forward” does not work in SXM replay function. (Fast Rewind works.)</p> |

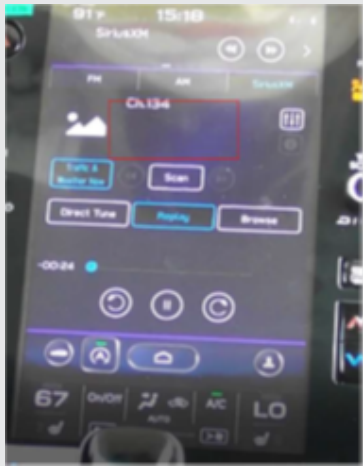
| Number | Symptoms to be Improved: |
|---|---|
| 30 | <p>The team logo is not displayed on Sports Flash screen when the SXM screen had been selected as audio source at the previous ignition off timing.</p> |

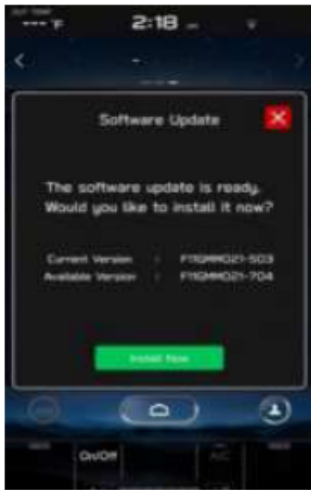
| Number | Symptoms to be Improved: |
|---|---|
| 1 | <p><b>System restarts itself during FOTA (Firmware Over The Air) update. FOTA operation is conducted in two processes: downloading (from the server to the Cockpit Control Unit via Wi-Fi) and installation (inside the Cockpit Control Unit). During the FOTA operation, after the new software has been downloaded to the Cockpit Control Unit (CCU) customer is to push “Install Now” on the Center Information Display (CID) to start installation of the software.</b></p> <p><b>FOTA Normal process</b></p> <p><b>However, in rare case, the CCU restarts itself* during installation.</b></p> <p><b>Linux reset occurs</b></p> <p><b>Note*</b> Even if this symptom occurs, after approximately 2 minutes, the system resumes, and the CID comes back to the below screen. Customer can then push the “Install Now” to proceed with the installation.</p> |

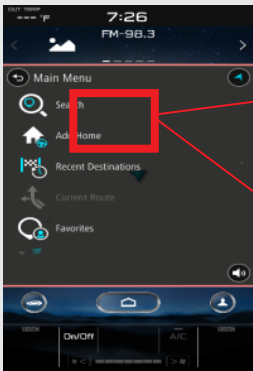
| Symptom # | Description of Symptom: |
|---|---|
| 2 | <p>After an extended period of usage, some white blinking dots appear on the display.</p> <div> <p>White Blinking Dots</p> </div> |

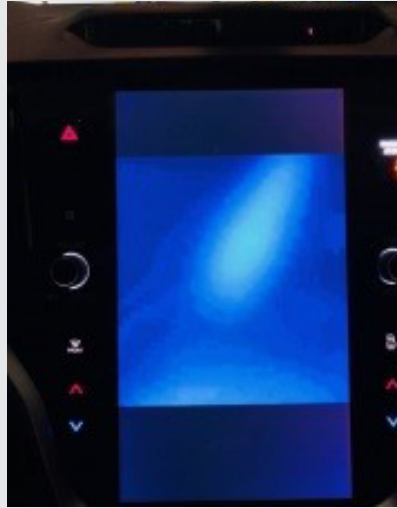
| Symptom # | Description of Symptom: |
|---|---|
| 14 | The HOME screen goes blank.<br>When the screen is switched from Camera mode to HOME, no icons are displayed as shown below. |

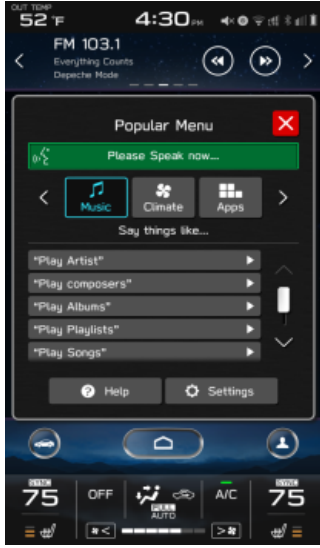
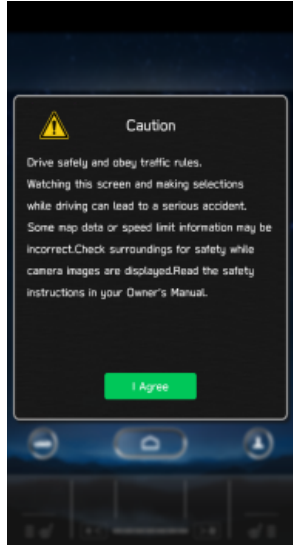
| Symptom # | Description of Symptom: |
|---|---|
| 5 | <p>When using Voice Recognition to search for a 'Nearby POI' (Point of Interest) in Canada with FRENCH language selected, the CP1 display turns black and displays a Caution / disclaimer message.</p> <div data-bbox="371 254 688 798"> </div> <div data-bbox="444 819 615 842">Voice Recognition</div> <div data-bbox="699 506 769 562">→</div> <div data-bbox="774 254 1075 798"> </div> <div data-bbox="862 819 987 842">Black Screen</div> <div data-bbox="1084 506 1154 562">→</div> <div data-bbox="1161 254 1451 798"> </div> <div data-bbox="1167 819 1446 842">Caution / Disclaimer Message</div> |
