# McLaren Artura Engine Oil Leak Diagnosis Guide - Oil Cooler

**Location:** Powertrain

**Topic:** McLaren Artura Engine Oil Leak Diagnosis Guide - Oil Cooler

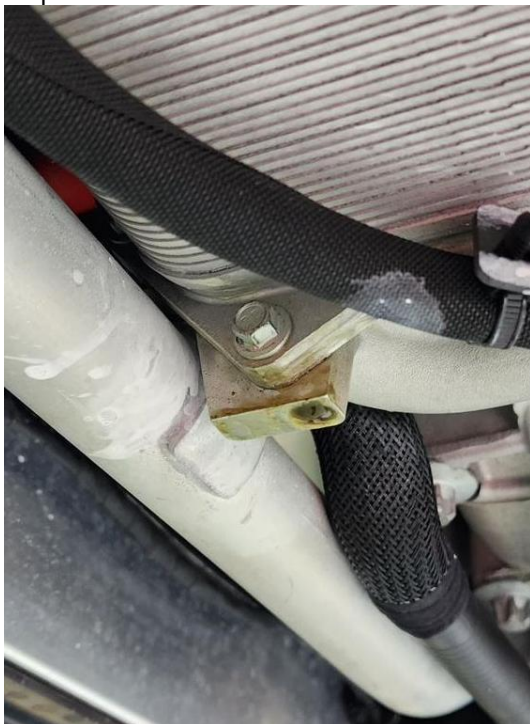
If an Artura is found to have a leak from the oil cooler area (oil or coolant), please follow the steps below

1. Raise vehicle on ramp as per McLaren Service Portal (MSP) instructions
2. Remove engine underfloor
3. Capture images prior to any cleaning, clearly showing the leaking area. Label images: "Pre-Cleaning"
4. Take picture of engine number and label image "Engine Number"

5. Clean area thoroughly using degreaser/solvent
6. Add engine oil dye to the engine - Please refer to latest update of KA-01458 for correct dye and torch to use
