**Technical Service Bulletin (TSB)**  
**Umbrella Valve Seal Missing From Cylinder Head Cover**

| REFERENCE: | TSB: 09-023-26<br>GROUP: 09 - Engine | Date: | September 25, 2026 | REVISION: | 09-020-26<br>09-017-26 REV A |
| VEHICLES AFFECTED: | 2026 - 2027 (WL) Jeep Grand Cherokee / Grand Cherokee L<br>This bulletin applies to vehicles built on or before **August 21, 2026 (MDH 0811XX)** equipped with a 2.0L Hurricane 4 Turbo W/ESS (Sales Code EC7). | | | MARKET APPLICABILITY:<br><div><input checked="" type="checkbox"/> NA<input checked="" type="checkbox"/> MEA</div> <div><input checked="" type="checkbox"/> EE<input checked="" type="checkbox"/> IAP</div> <div><input checked="" type="checkbox"/> SA<input type="checkbox"/> CH</div><br><b>NOTE:</b> This bulletin applies to North and South America, Enlarged Europe, Middle East & Africa, and India & Asia Pacific markets. | |

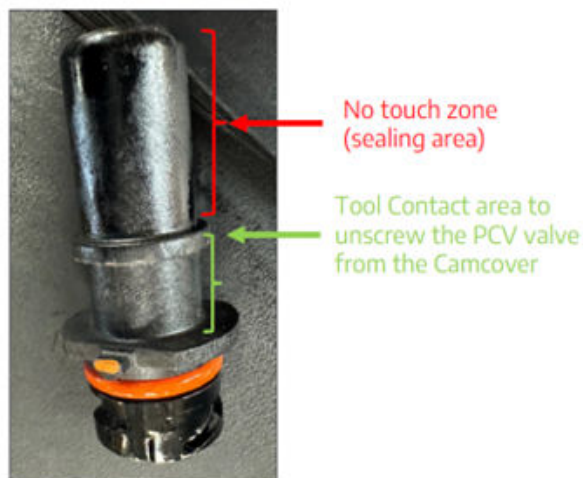
**Fig. 1**  
PCV Valve During Removal

**NOTE:** Be sure to follow warnings regarding location on the PCV valve where tool contact should be avoided [Fig. 1](#).

1. Remove the Positive Crankcase Ventilation (PCV) valve. Refer to the detailed service procedures available in DealerCONNECT/Service Library under: Service Info> 25 - Emissions Control / Crankcase Ventilation / Valve, Positive Crankcase Ventilation (PCV) / Removal and Installation.
