KA-02042

# McLaren Artura Drive Motor 'A' Position Diagnosis Guide

**Topic:** Hybrid Warning displayed due to Drive Motor A faults

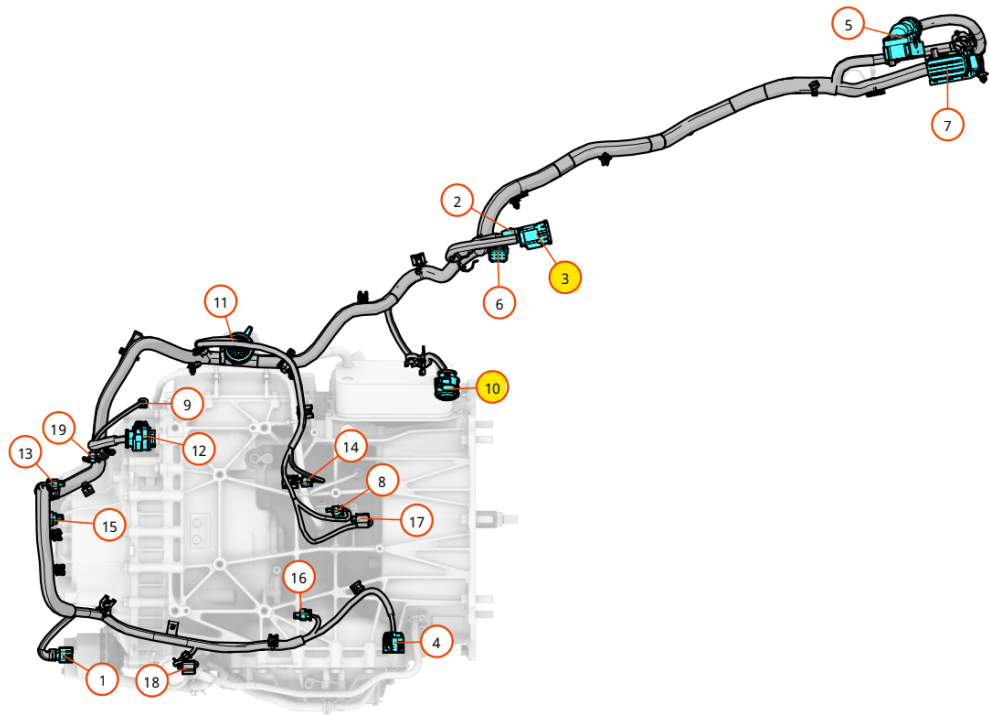
HTM Harness I\_TRE\_TRI2-F I\_TRE\_TRI2-M

2. Remove the HV Battery and Fuel Tank following MSP instructions and carry out resistance checks for the Rotor Position wiring from the MCU connector to the HTM harness at the front of the transmission. Checking for excess pin drag, contamination and corrosion.
3. Carry out resistance checks for the MCU ground from connector MBC027 to CGRND2.
4. Carry out resistance checks for the MCU power to Fuse 14, located in the Electric City fusebox.
5. Inspect the MCU casing ground. Ensure the ground is clean and was correctly torqued.

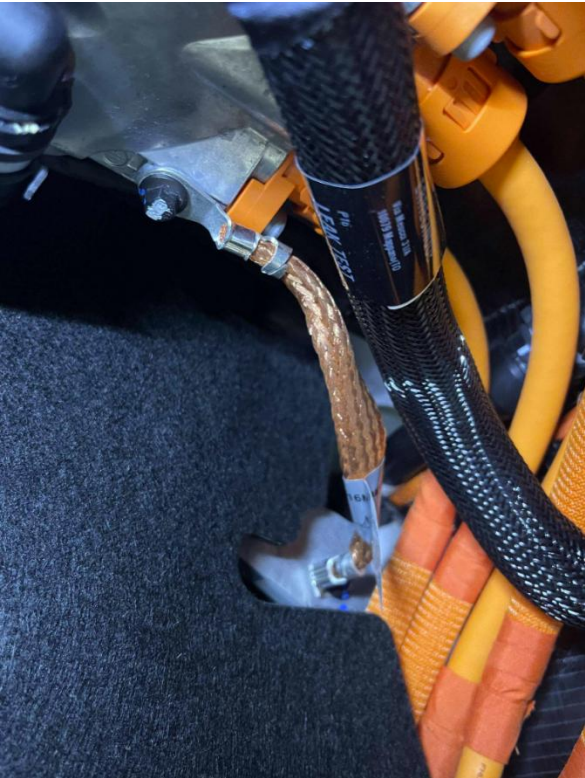
## MCU Case Ground

6. If high resistance is found in the wiring between the MCU and HTM connectors, inspect the Engine Bay inline connector I\_MBC\_TRE1-F I\_MBC\_TRE1-M. Checking for excess pin drag, contamination and corrosion. If concerns are found with this connector, capture images before cleaning.
