Z50 - LEFT FRONT SEAT ADJUSTER ASSEMBLY - CRACKED WELD

SEAT ADJUSTER ASSEMBLY
WELD CRACK LOCATRION

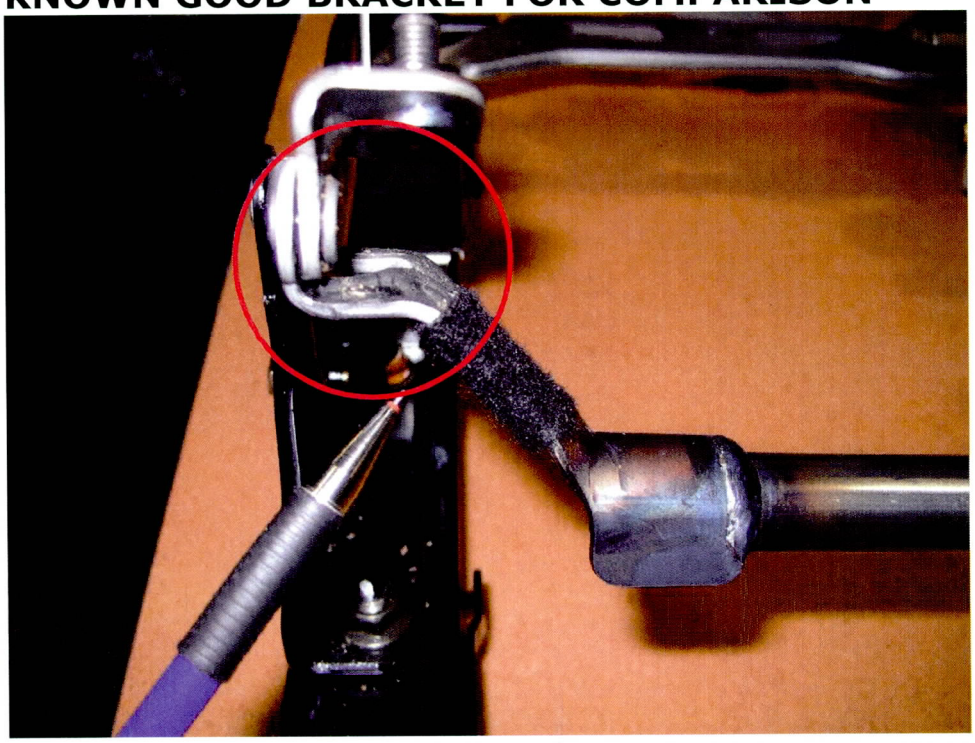
KNOWN GOOD BRACKET FOR COMPARISON

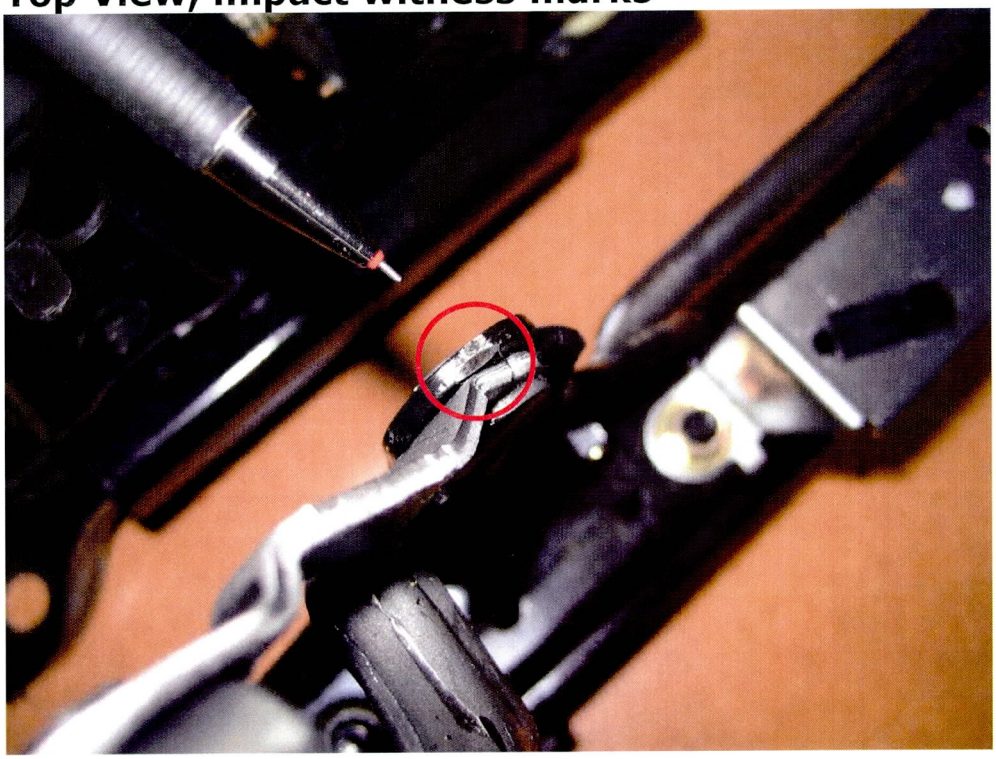
VIN: JN8AZ08W75W[redacted]

Top View, impact witness marks
