GENERAL MOTORS  
DCS7161  
URGENT - DISTRIBUTE IMMEDIATELY

Subject: N242452130 - Service Update  
Fuel Injector Flow Rate

Models: 2023-2024 Chevrolet Colorado  
2023-2024 Chevrolet Silverado 1500  
2023-2024 GMC Canyon  
2023-2024 GMC Sierra 1500

## N242452130 Fuel Injector Flow Rate

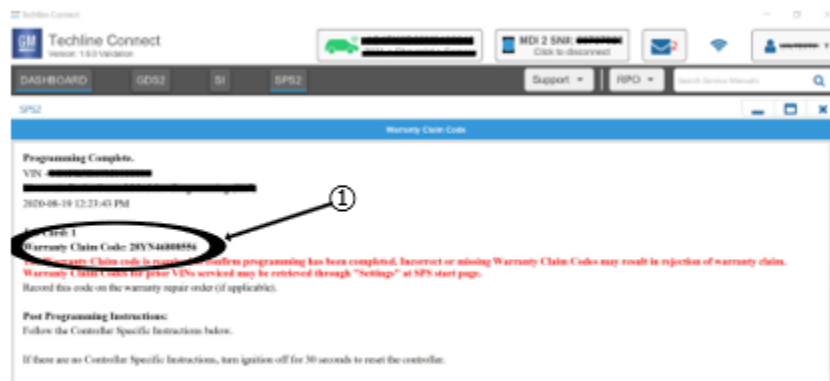
5644478

1. Reprogram the Engine Control Module. Refer to *K20 Engine Control Module: Programming and Setup* in SI.

**Note:** The screenshot above is an example of module programming and may not be indicative of the specific module that is being programmed. Module selection and VIN information have been blacked out.
