**DOT Auto Safety Hotline**  
**Vehicle Owner's Questionnaire**  
To Report Vehicle Safety Defects  
**1-888-DASH-2-DOT**  
(1-888-327-4236)  
**INTERNET:www.nhtsa.dot.gov/hotline**

Some vehicles may exhibit an OD OFF light flashing with DTC P1783 stored in memory after driving at highway speeds for extended periods. There may also be ATF leaking from the transmission vent tube onto the air cleaner box as well as intermittent hard shifting. These symptoms may be caused by operating conditions that cause the ATF temperature to exceed 135 degrees C (275 F). This concern is most likely to occur after extended periods of highway driving when air temperature exceeds 100 degrees F.

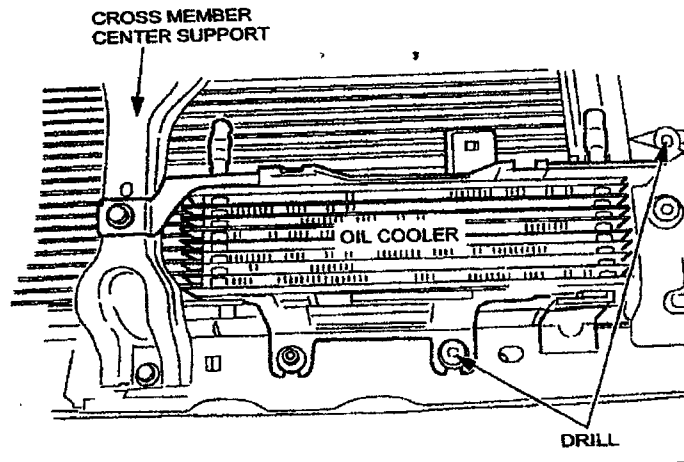
6. Temporarily install oil cooler into position at left front of vehicle.  
7. Align mounting tabs on left side of cooler with existing mounting holes located on cross member center support for hood latch.

8. Install two(2) 6x25mm bolts and temporarily tighten.  
9. Using a center punch, make a mark at the center of the two remaining mounting tab holes.  
10. Remove two(2) 6x25mm bolts (installed in STEP 8) and oil cooler.  
11. Using a 7mm (9/32") drill bit, drill 2 holes in the mounting locations marked in STEP 9.  
12. To prevent rust, apply a small amount of silicone or anti corrosion to the holes.  
13. Reinstall oil cooler.

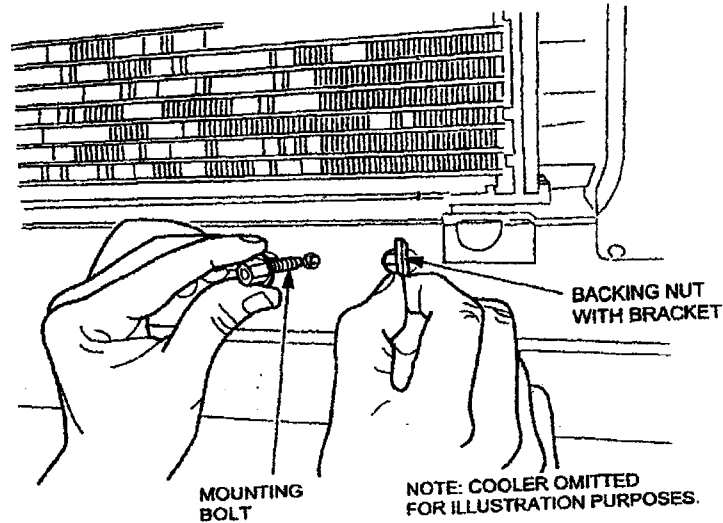
14. Install lower right mounting bolt using backing nut with L shaped bracket by inserting the nut through the slot to the right of the mounting hole.

15. Install upper right mounting bolt using one of the 6mm flange nuts.

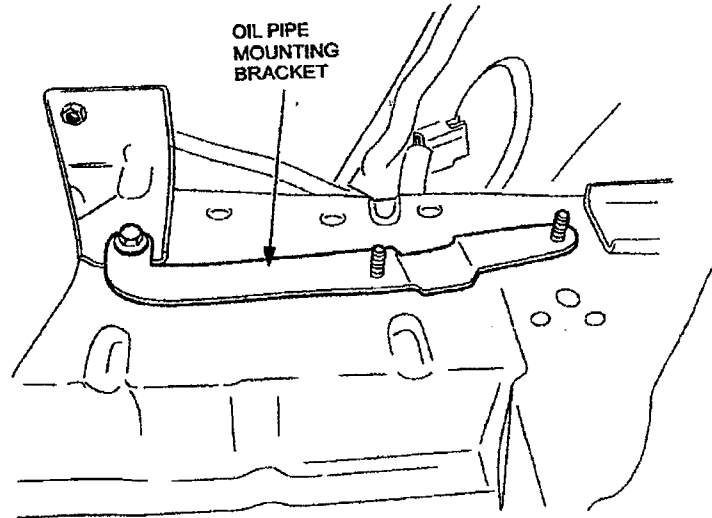
1. Remove lower left battery tray mounting bolt.
2. Position oil pipe mounting bracket so that mounting hole lines up over battery tray mounting hole and single large stud fits through hole in body on right side.

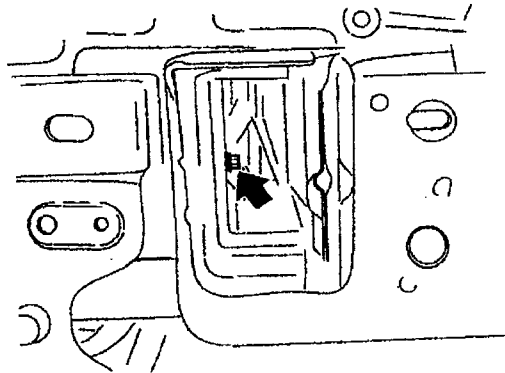
3. Reach through opening at front of body to install one 8mm washer and nut.

**WARNING:** To avoid injury, be careful when inserting hand through opening in front of body. This area contains sharp edges.
