PE19-010

NISSAN

ATTACHMENT B

FIELD REPORTS

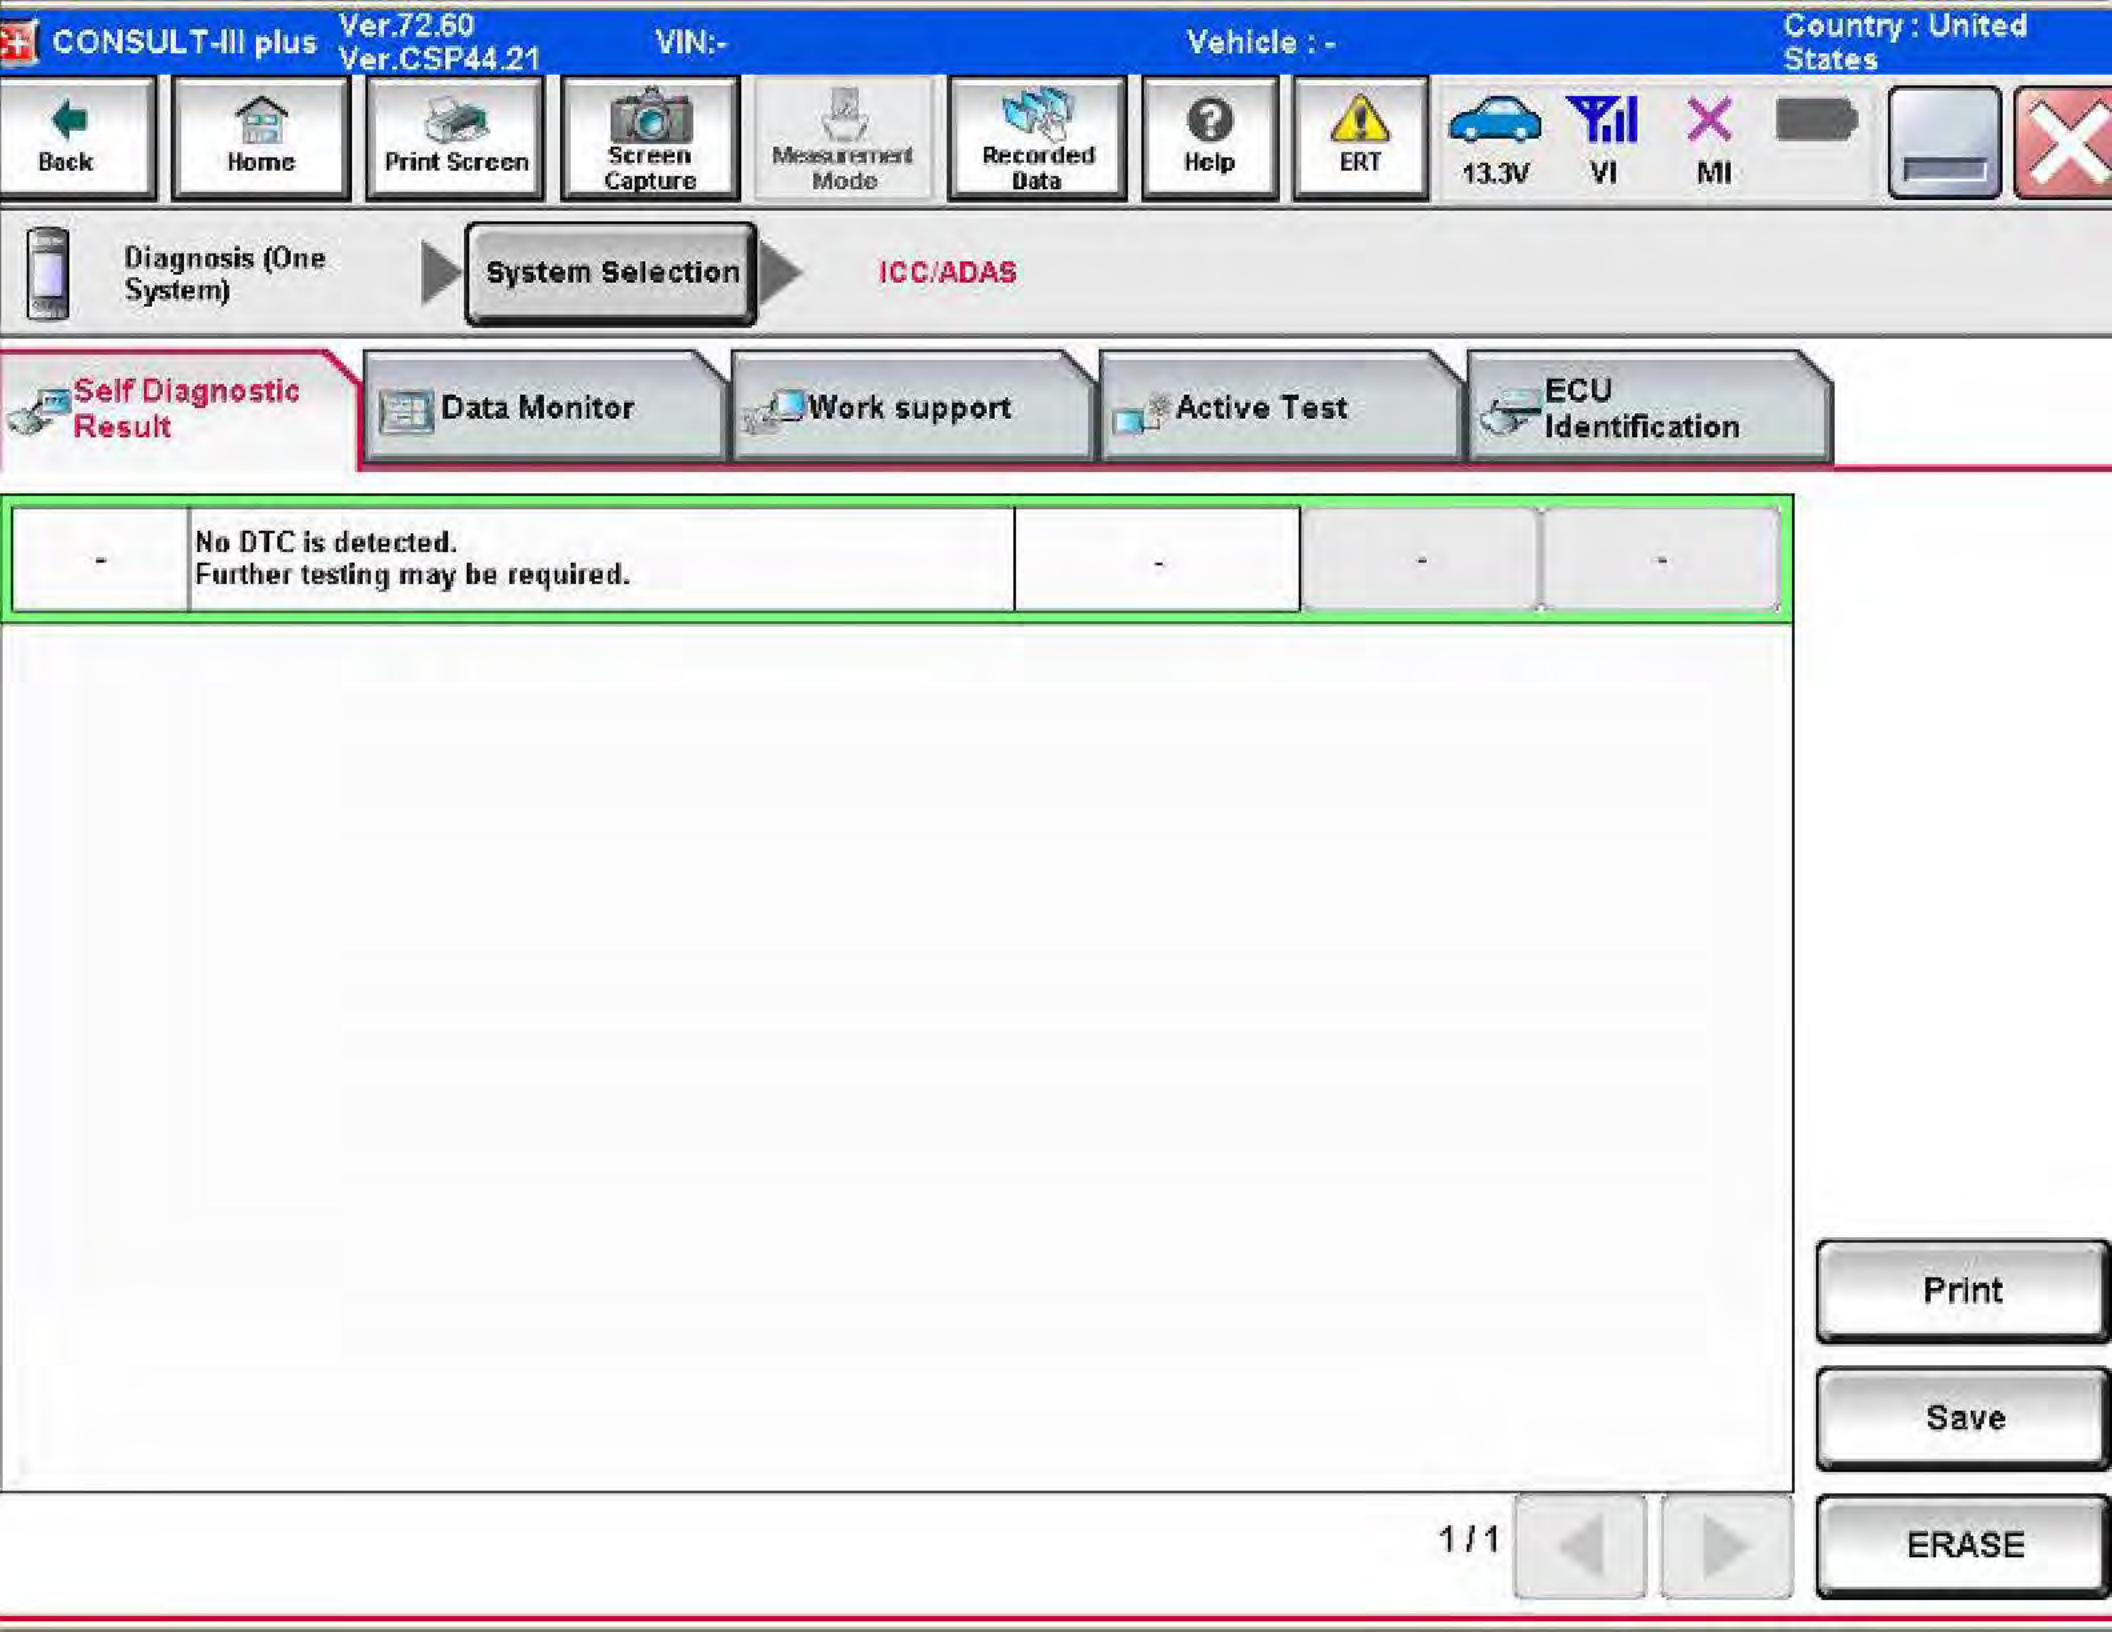
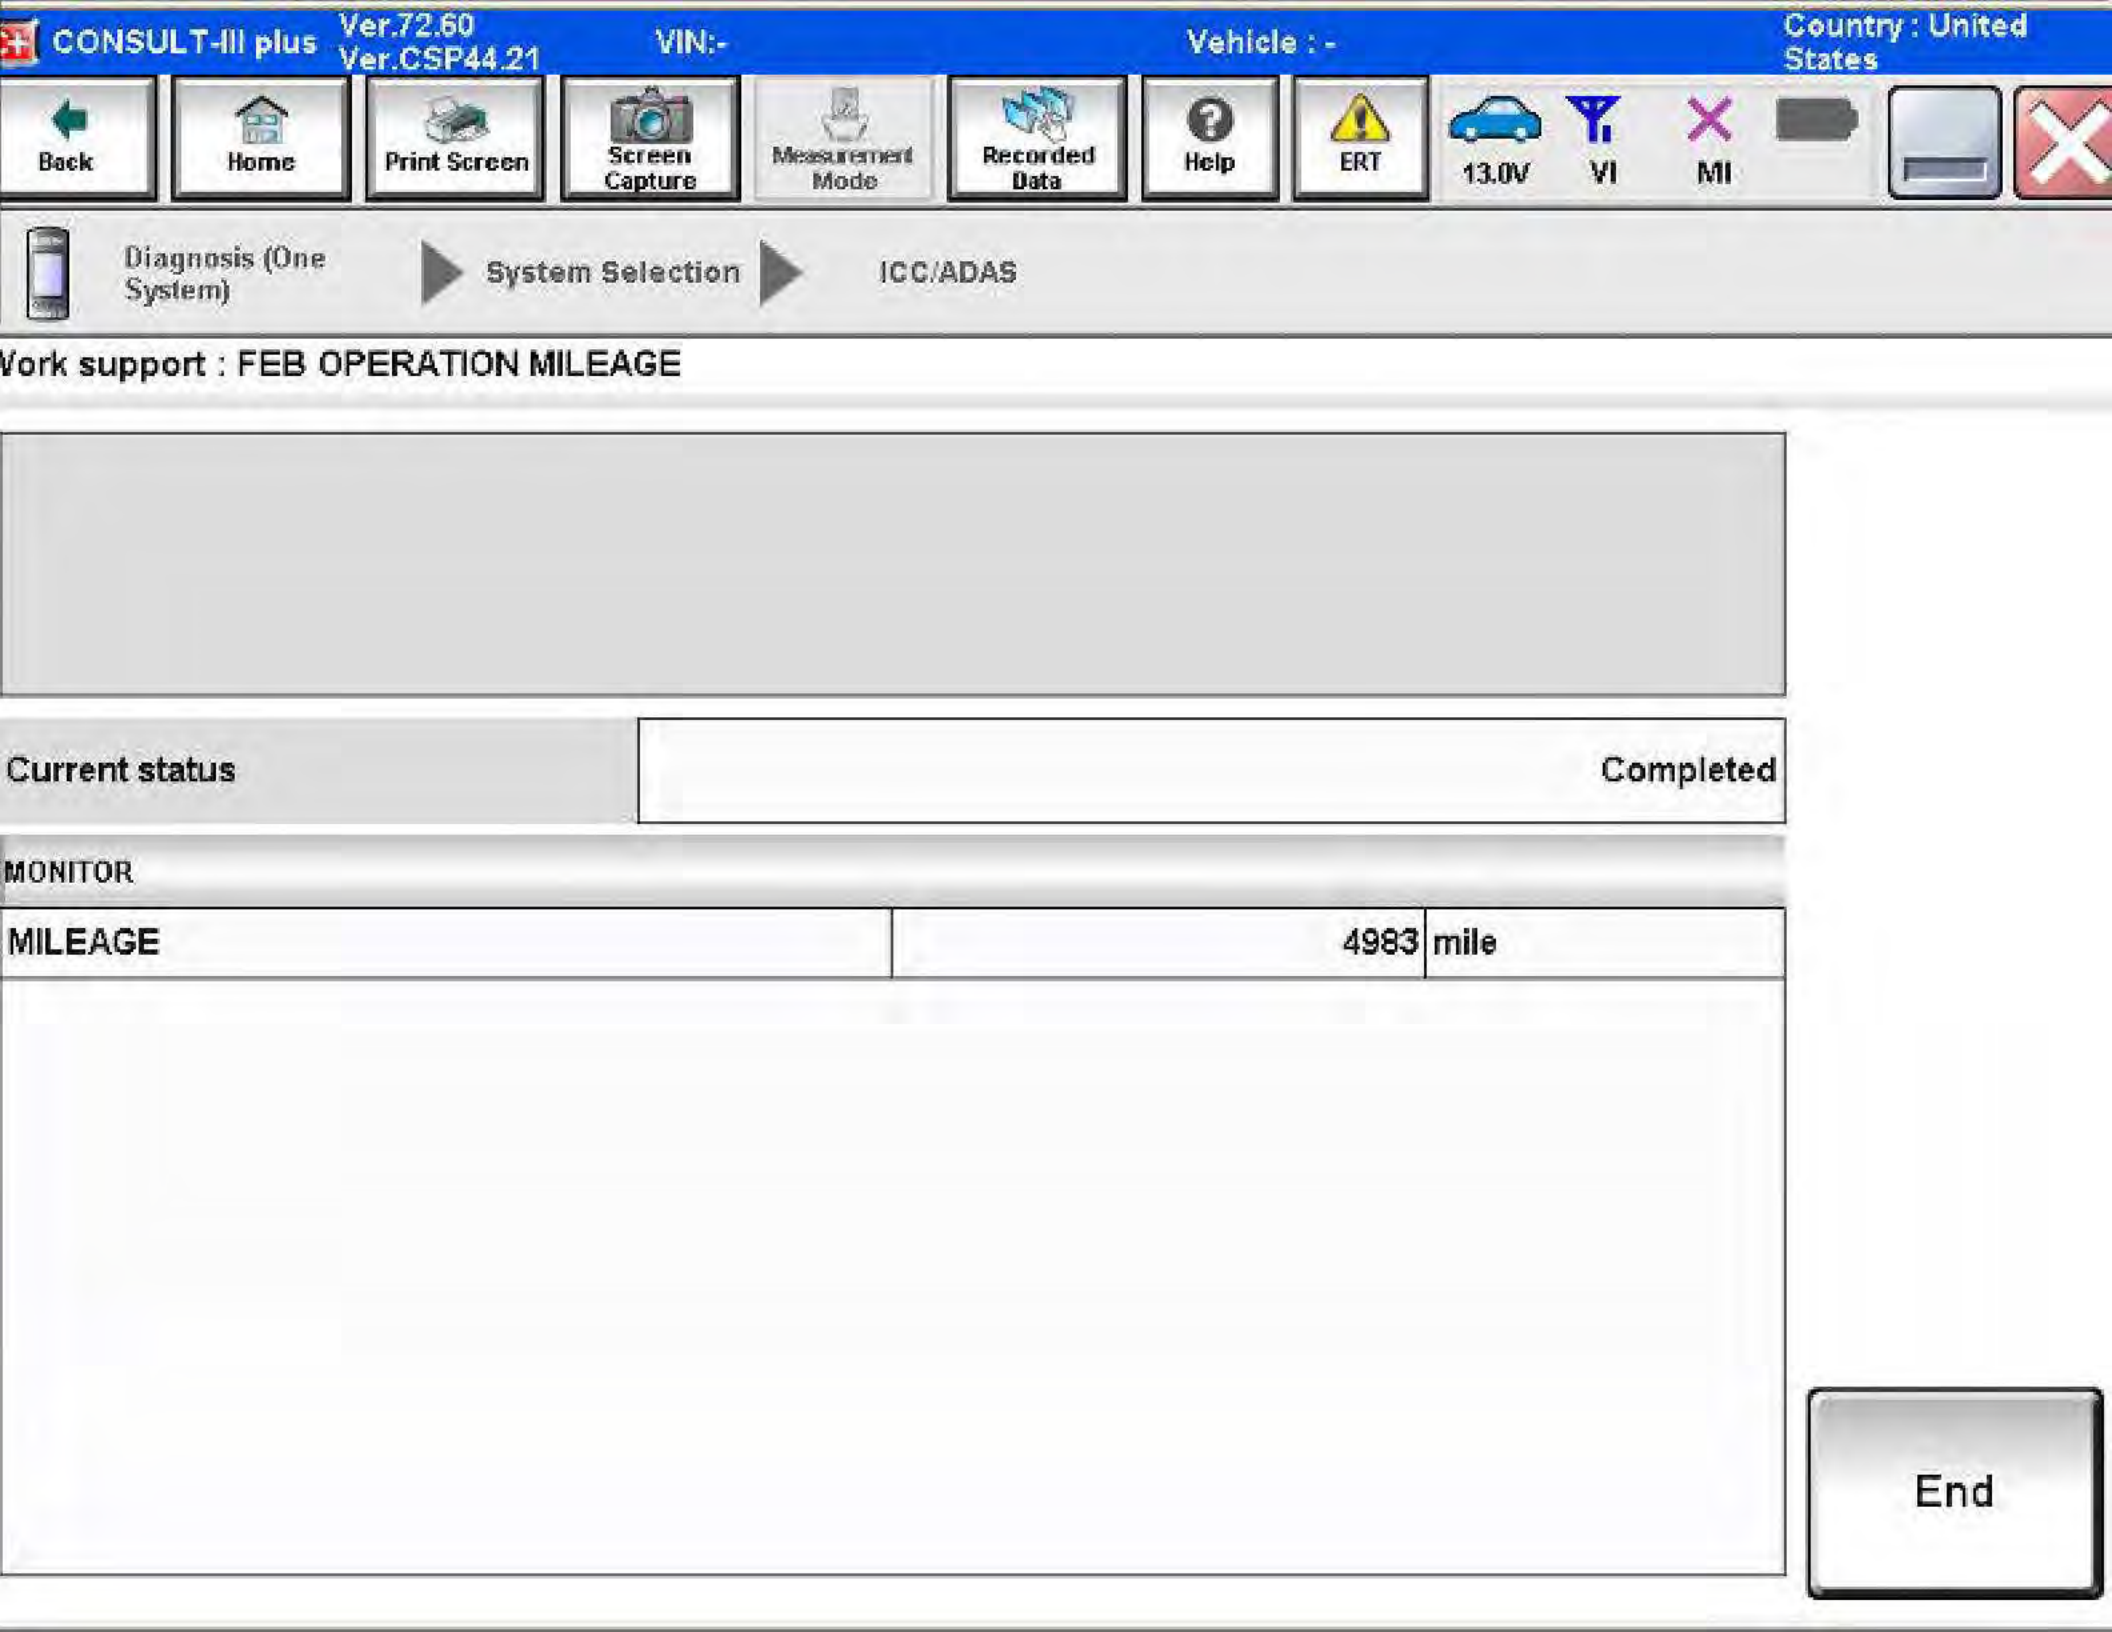
Diagnosis (One System) > System Selection > ICC/ADAS

-	No DTC is detected. Further testing may be required.	-	-	-
