U.S. Department of Transportation National Highway Traffic Safety Administration	<b>DOT Auto Safety Hotline</b> <b>Vehicle Owner's Questionnaire</b> To Report Vehicle Safety Defects 1-888-DASH-2-DOT (1-888-327-4236) INTERNET: www.nhtsa.dot.gov/hotline			FOR AGENCY USE ONLY 100148	
	Date Received 02-FEB-2007		Repository <input type="checkbox"/>		
	Reference No. 10181455				
<b>OWNER INFORMATION (Type or Print)</b>					
Name			Daytime Telephone Number		E-mail Address
Address			Evening Telephone Number		
City	State	Zip Code			
ELKRIDGE	MD				
Do you authorize NHTSA to provide a copy of this report to the manufacturer of your vehicle? <input checked="" type="checkbox"/> YES <input checked="" type="checkbox"/> NO					
In the absence of an authorization, NHTSA WILL NOT provide your name or address to the vehicle manufacturer.					
Signature of Owner _____ Date 2/9/07					
<b>VEHICLE INFORMATION</b>

17 digit Vehicle Identification Number Located at bottom of windshield on driver's side KMHDN56DX5L			Make HYUNDAI	Model ELANTRA	Model Year 2005
Date Purchased 28-MAR-05	Dealer's Name and Telephone Number ANTWERPEN 4105315702		Engine: No: Cylinders 4	Fuel Type: Gas	
Original Owner <input chec

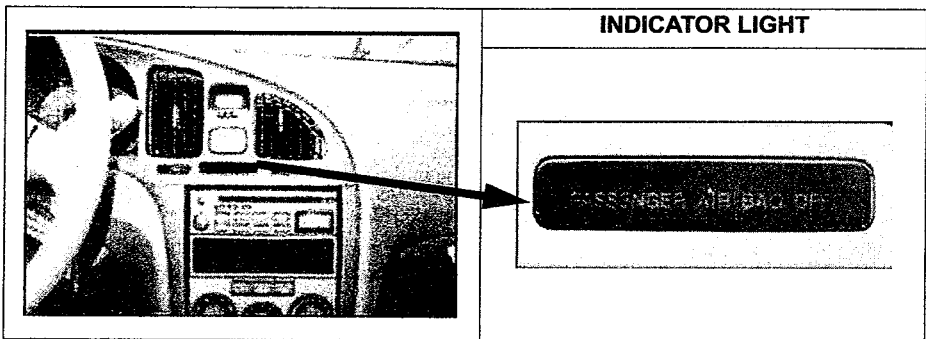
This OCS reprogramming procedure may be performed on **an individual customer complaint basis only**, and only if the "PASSENGER AIR BAG OFF" indicator light remains on or switches on and off when small stature adults are seated in the right front passenger position.

- Model: 2004-2005 ELANTRA vehicles produced beginning June 12, 2003.

1. The customer must contact the dealership regarding the "PASSENGER AIR BAG OFF" indicator light operation.
2. Make an appointment when customer can bring both the car and the passenger who has experienced the "PASSENGER AIR BAG OFF" indicator light condition.

- c. If sitting in the proper position does not cause the "PASSENGER AIR BAG OFF" light to turn off, and not switch on and off, the OCS may be reprogrammed to help detect the presence of a properly seated small stature adult.

- d. If sitting in the proper position does cause the "PASSENGER AIR BAG OFF" light to turn off, then the vehicle should **NOT** be reprogrammed.
