TECHNICAL SERVICE BULLETIN

Victory Motorcycle

Bulletin Number: **V-06-01**
Model Years: **2006**

SUBJECT: INCORRECT TIRE LOADING INFORMATION ON VIN DECAL

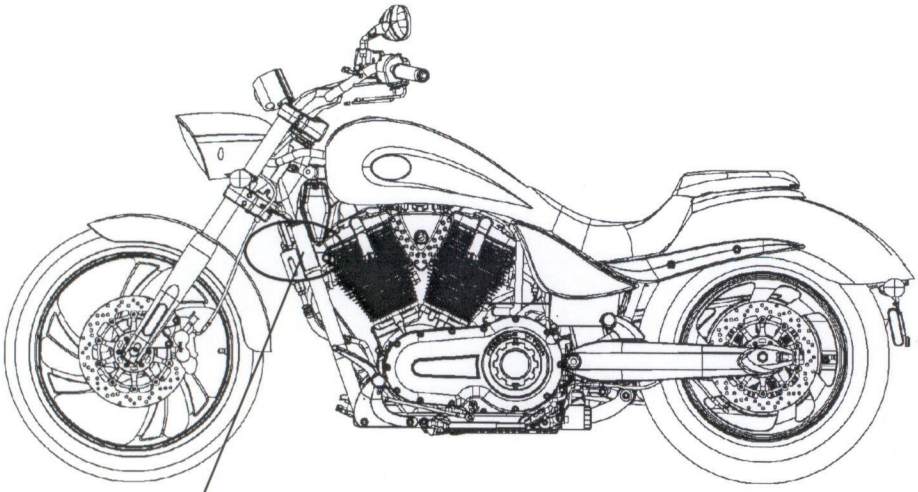
On the affected motorcycles, the Vehicle Identification Number (VIN) decal located on the left front downtube of the motorcycle frame incorrectly lists the GAWR (Gross Axle Weight Rating) for the front axle as 405 pounds. The correct GAWR for the front axle is 390 pounds. Reliance on the incorrect data may lead to overloading of the front tire which can result in a sudden loss of vehicle control and possibly a crash.

1. Clean the decal on the motorcycle with warm soapy water to remove all oil, grease or dirt.
2. Rinse with clear water.
3. Dry decal and surrounding area thoroughly.
4. Carefully remove a new GAWR decal at right and apply it over the GAWR area of the decal on the motorcycle as shown. Be sure all previous GAWR information is covered, and press decal firmly in place.

Apply decal over the GAWR portion of the VIN decal on the motorcycle.

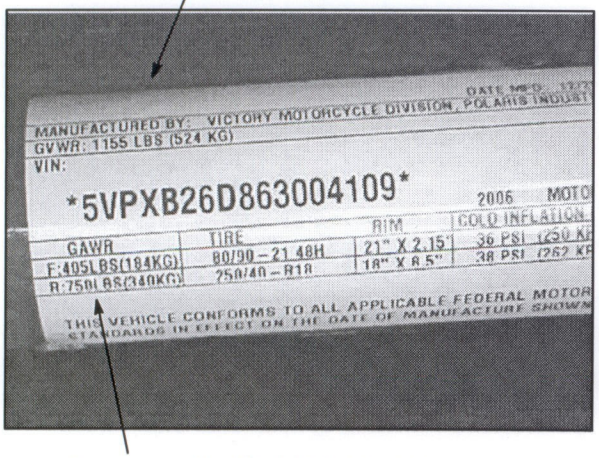
Incorrect: F: 405 LBS (184KG)
R: 750 LBS (340KG)

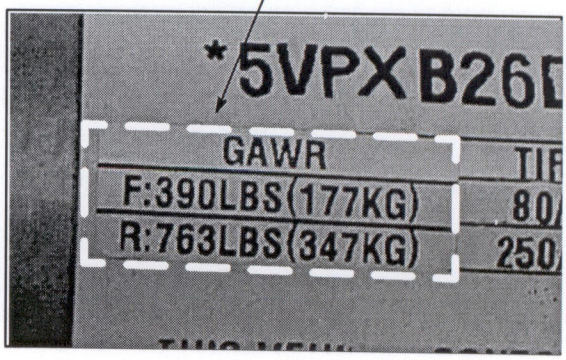
Correct: F: 390 LBS (177KG)
R: 763 LBS (347KG)
