Product Recall

Subject: RECALL 10V-396/10V-397 MVP-EF Mega fuse Junction Block

Date: December 8, 2010

SUBJECT: REWORK MEGA FUSE JUNCTION BLOCK ENCLOSURE

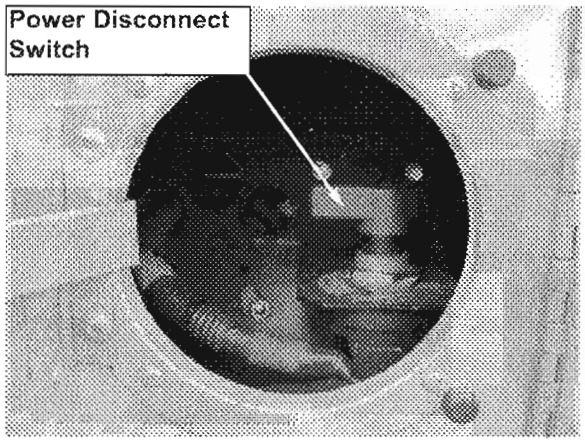
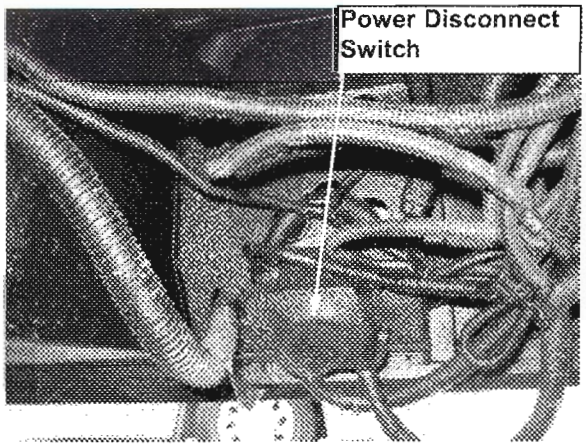
Figure 1

1. Chock the tires and be sure the ignition key is in the "Off" position.
2. Turn the power disconnect switch to the "Off" position and disconnect the Negative battery Cable from the batteries.
3. Locate the Mega Fuse Junction Block (MFJB) mounted to the back of the Disconnect Switch enclosure. **Figures 1 & 2**
