| <b>DOT Auto Safety Hotline</b><br><b>Vehicle Owner's Questionnaire</b><br><b>To Report Vehicle Safety Defects</b><br><b>1-888-DASH-2-DOT</b><br><b>(1-888-327-4236)</b><br><b>INTERNET: www.nhtsa.dot.gov/hotline</b> | | FOR AGENCY USE ONLY 100148 | |

### Campaign - Side Air Bag/Tensioner Harness Repair

Restraint systems Recall  
Campaign - Side Air Bag / Tensioner Harness  
Repair

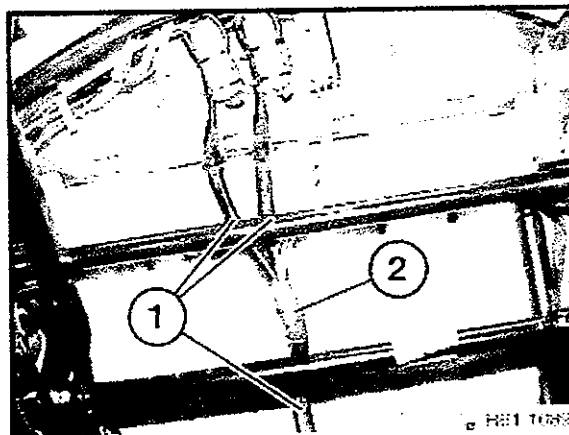
42. Slide the wire sheathing (1) over the wiring harness and secure with fabric tape (2).

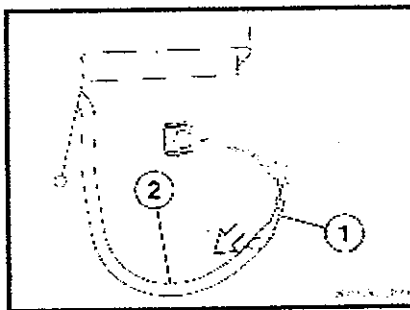
34. Remove fabric adhesive tape (1) from the vehicle wiring harness and slide back sheathing (2) by approximately 300 mm.

35. Fix sheathing in place with cable tie or fabric adhesive tape.

**Preparing the body wiring harness for repair.**

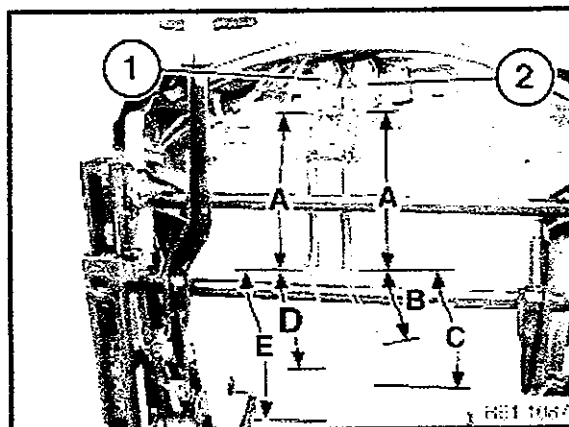
31. Cut the repair wiring harnesses for the side airbag (1) and belt tensioner (2) to offset lengths with the following dimensions:

29. Shorten the repair wiring harness for side airbag (1) and seat belt tensioner (2) as follows:
30. Shorten the outer sheaths of the repair wiring harnesses to A = 150 mm

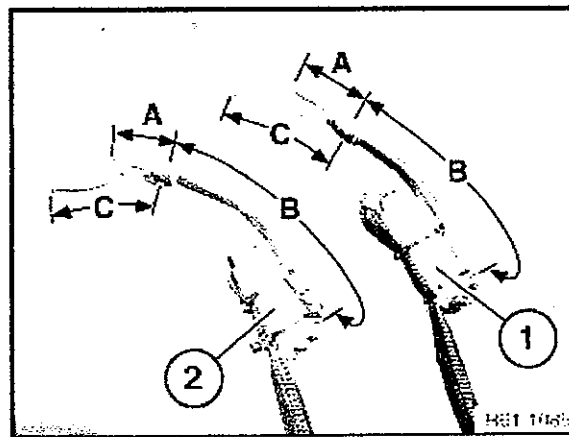
Repair wiring harness for side airbag (1):  
**Black/White** triggering circuit wire A = 40 mm

**Violet/White** triggering circuit wire C = 70 mm

23. Crimp the repair wiring harnesses to the seat wiring harnesses in accordance with the attachment Chart A. Make sure that the proper wire colors are used based on the manufacturing date of the repair harness.

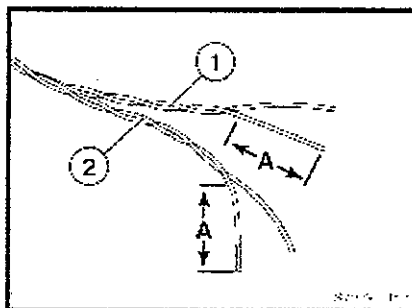
16. Strip the ends of the triggering circuit wires on the seat wiring harnesses to a length of 4 mm. Install shrink tube (1) (PN 61 13 0 149 206) over the wires.

14. Shorten the outer sheath of the seat wiring harnesses by approximately 50 mm from the wire ends. Take care not to cut the wiring. Seal the outer sheaths to the wires using fabric adhesive tape.

Seat wiring harness for belt tensioner (2):

Green triggering circuit wire A = 30 mm

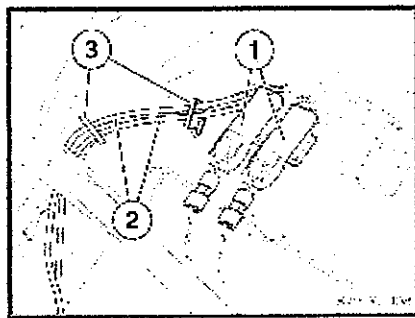
9. Release the connector housing (1) by turning it slightly.

10. Release the seat wiring harnesses (2) for the side airbag and seat belt tensioner from the retainers (3).

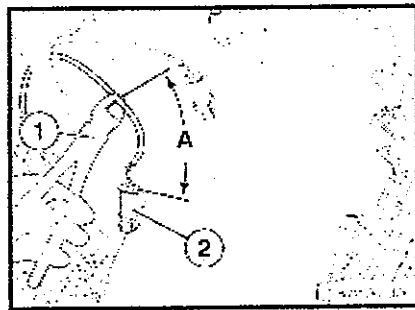
11. Locate the yellow side airbag connector (2). Cut the wire as shown, 100 mm from the connector (A).

Tag the removed part with the VIN. Do not scrap the removed part - it may be necessary to ship the part to BMW for analysis (DO NOT DISCONNECT THE CONNECTOR).

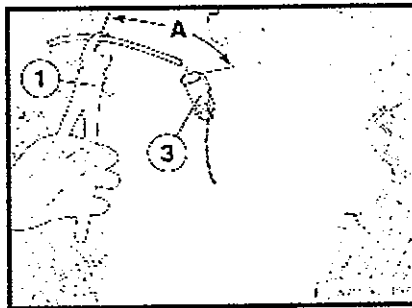
12. Locate the blue seat tensioner connector (3). Cut the wire as shown, 100 mm from the connector (A)

Tag the removed part with the VIN. Do not scrap the removed part - it may be necessary to ship the part to BMW for analysis (DO NOT DISCONNECT THE CONNECTOR).

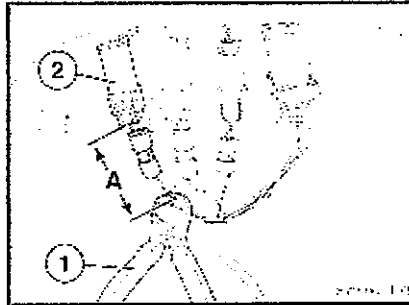
6. Locate the blue seat tensioner (DO NOT DISCONNECT). Cut the wire as shown, 100 mm from the connector (A)

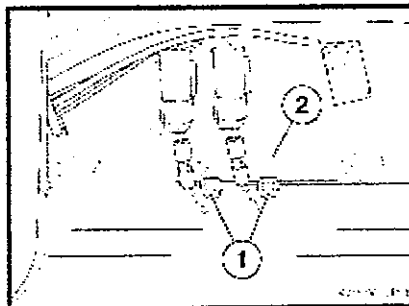
8. Install the new cable tie with holder (1) (PN 61 13 0 302 824) and fit to the carrier (2). Remove the cable tie for later use.
