RE: FORD E-150 VAN WAGONS (2009-2011)
2011 E-150 CLUB VAN XL PASSENGER WAGON WITH
TOWING PACKAGE
VIN #1FMNE1BWD [REDACTED]

SUBJECT: SUSPECTED CAUSE OF BODY ROLL, SWAY, AND WANDERING OF
E-150 ECONOLINE VANS (SEE ENCLOSED PHOTOGRAPHS FOR
CONCLUSIVE PROOF

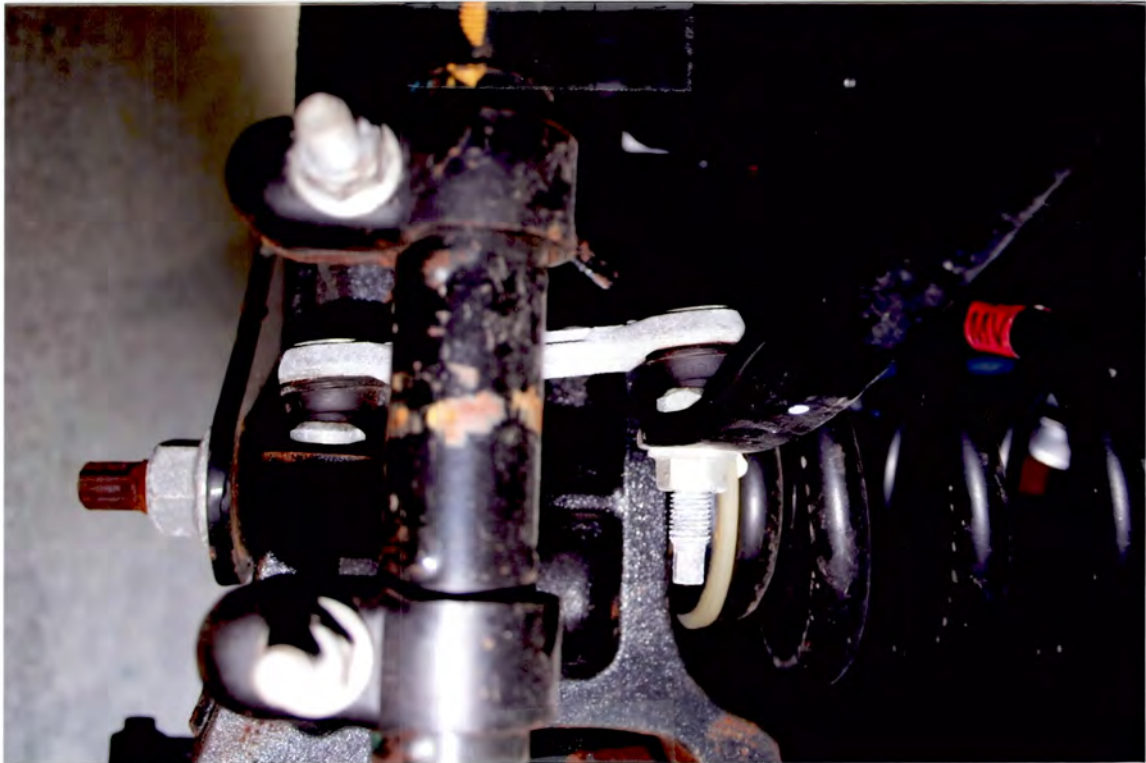
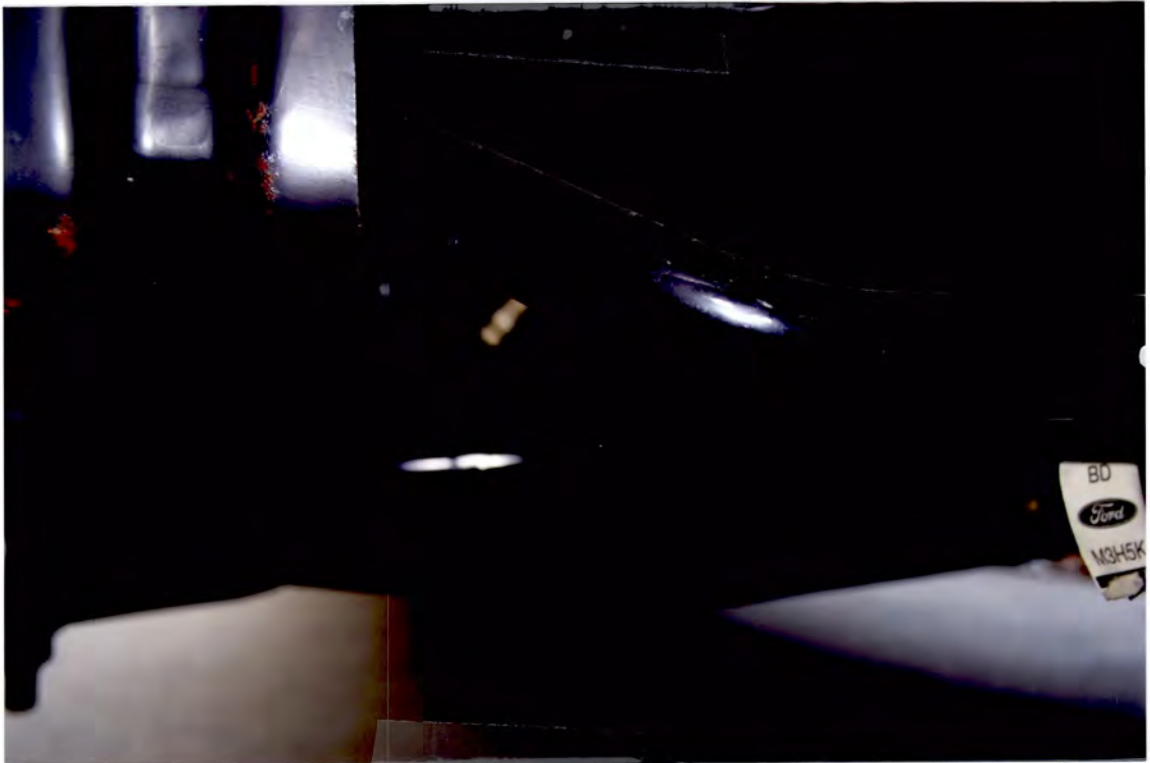
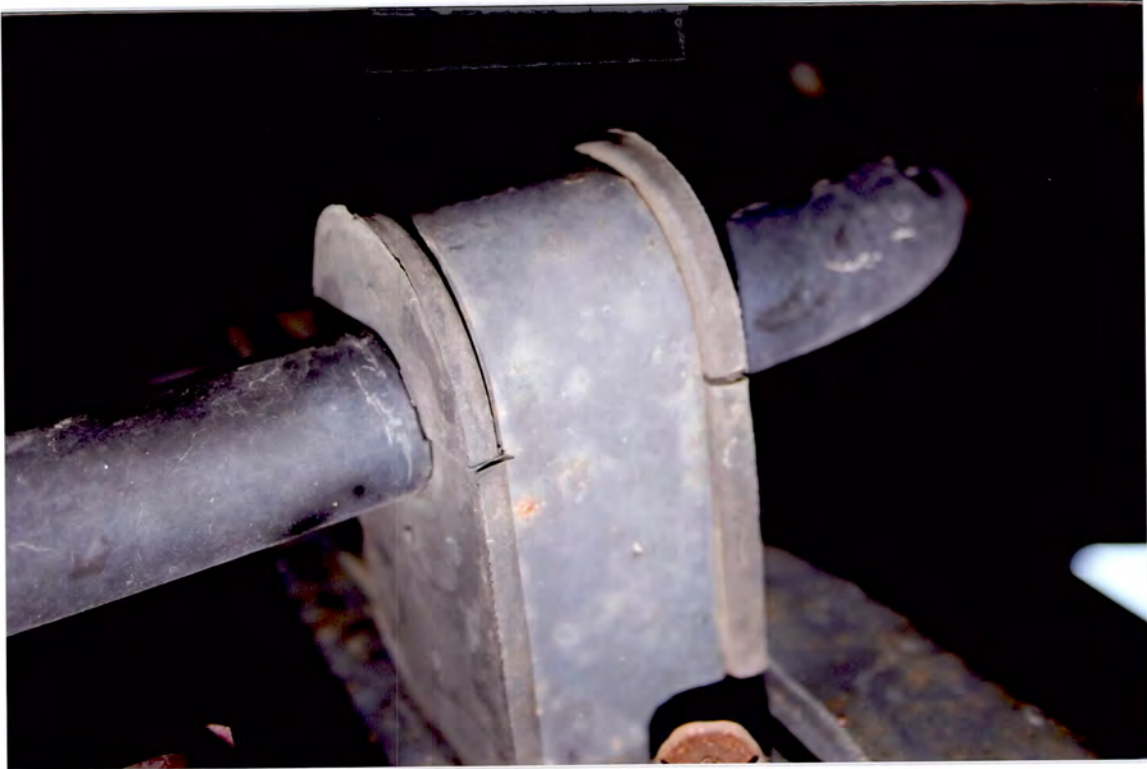
Please see the enclosed explanation for the photographs enclosed. Unfortunately, I was ignorant and was looking for a rear anti sway bar when there is only a front anti sway bar. The zinc coated links are pivoting and cannot hold the sway bar in its proper field position. The links are like pivots and levers that move allowing the sway bar to move from left to right and right to left. This is the apparent cause of all of the sway body roll and wandering problems being reported by consumers on 2009, 2010 and 2011 models. The dealership and Ford Motor denies that a problem exists. Please do not wait until someone gets killed.

I crawled under the van on November 9, 2011 with Andy Kuhn, a re-certified ASE Master Mechanic. Mr. Kuhn pointed out the metal to metal contact between the sway bar and the frame bracket resulting from the right to left shifting of the sway bar. I believe the front sway bars last shift movement was so strong that the bar remains skewed, jammed and "locked up" when the last shift movement was from the driver's side to the passenger side. The links should be vertical. The top of each link should not be severely angled toward the passenger side.

- #3993 – This is a photograph of the E-150 Club Passenger Van, Year Model 2005 that I own. Notice that the sway bar is directly inserted into the suspension frame. The sway bar is connected by the frame clamp toward the front of the vehicle. This is a picture of the left wheel and coil. The sway bar goes over the steering rod and inserts directly into the frame. There is no link. Examine the bracket and based on the dirt and corrosion it is easy to observe that there has been no movement of the sway bar in years.

You were provided photographs of the 2005 E-150 van that I currently own. Over time you can observe the dirt build-up around the edge of the frame clamp bushing. There has been no left to right movement of the sway bar on the 2005 model for six years. This is why to this day we do not experience any sway whatsoever, regardless of the wind conditions. The sway bar cannot move left to right because it is directly anchored into the frame suspension. As mentioned in my previous communication, there are now empty holes in the frame on the 2011 model so it is not a difficult fix to have a sway bar design and inserted and bolted in with bushings. If it is a solid tempered bar as opposed to a hollow tube bolted directly to the frame, then all sway, wandering and all other problems reported by hundreds of consumers will be eliminated.
