SAFETY RECALL DSF and E04

FRONT PASSENGER AIRBAG INFLATOR MODULE

CERTAIN 2003 – 2006 MODEL YEAR TUNDRA

Updated 7-17-18

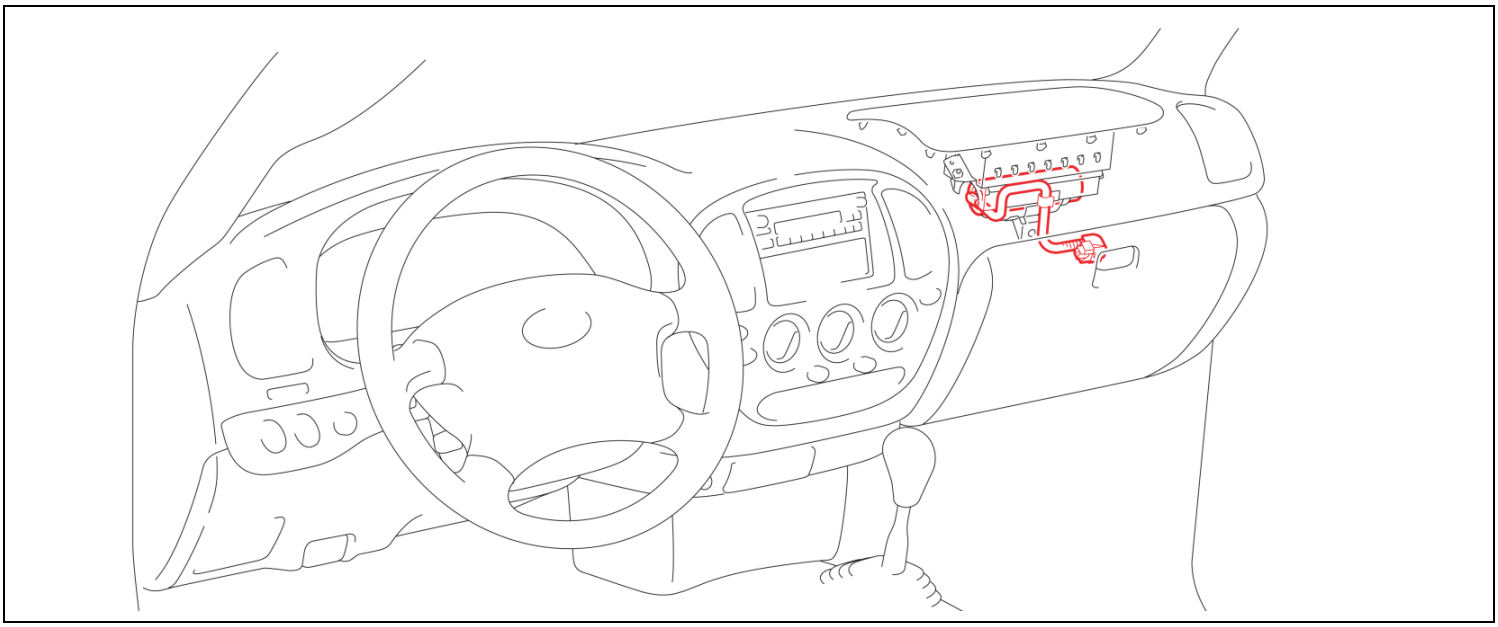
The subject vehicles are equipped with front passenger airbag assemblies. When located in areas with consistently high absolute humidity, the front passenger airbag inflator could be susceptible to rupture in a crash. An inflator rupture may result in metal fragments striking and potentially seriously injuring the vehicle occupants. The cause of the potential ruptured inflators and influence of high absolute humidity are under investigation.

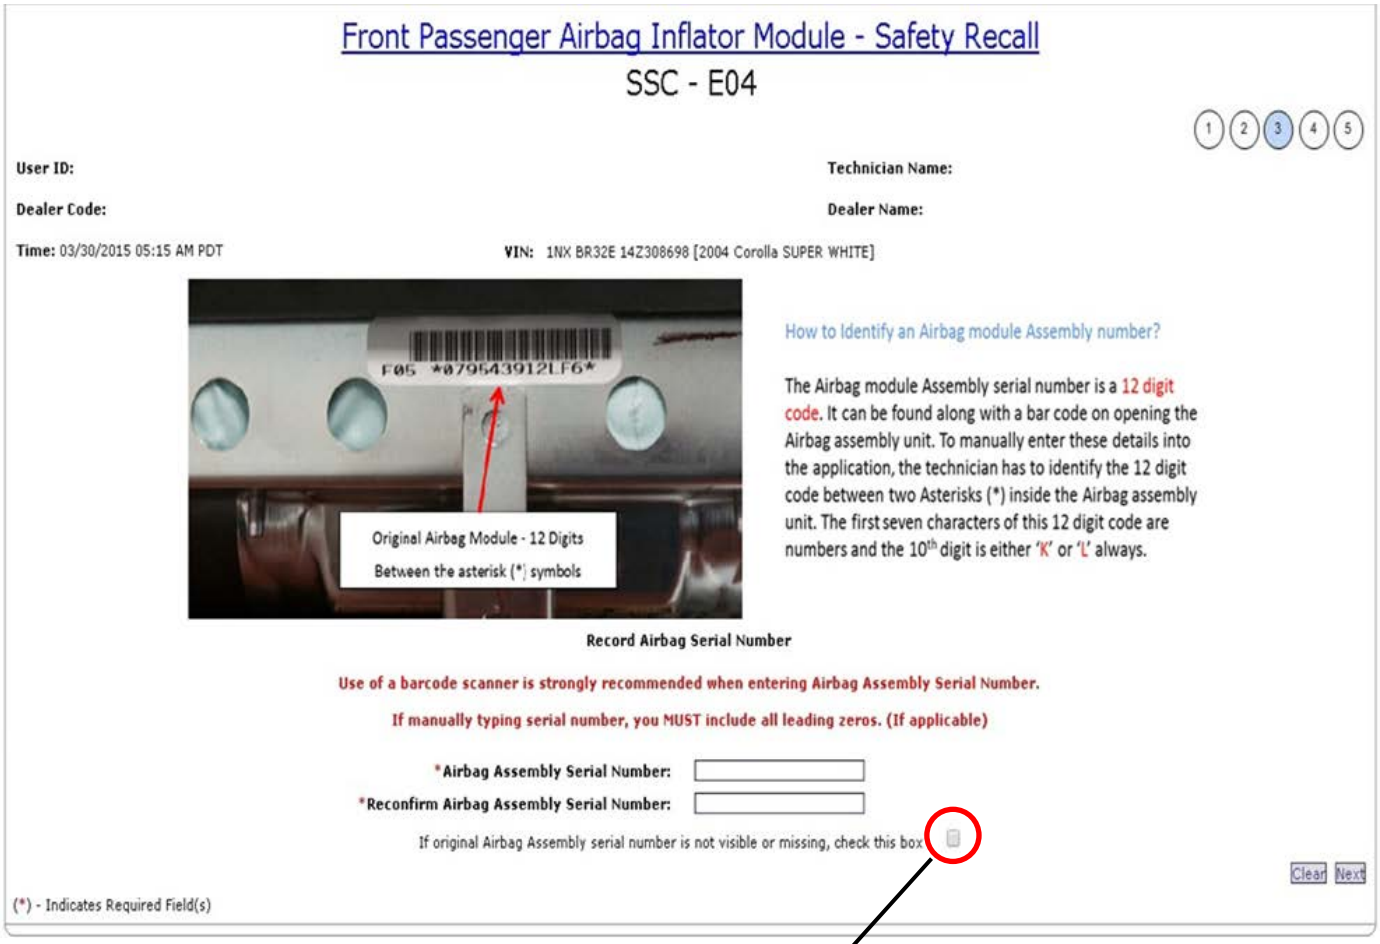
AIRBAG SERIAL NUMBER IS MISSING OR CANNOT BE SCANNED

If the airbag barcode cannot be scanned or is not present, check the box in the application indicating the barcode is not legible and contact your regional representative to replace the airbag assembly.

a) If the airbag serial number cannot be scanned or is not present check the box as shown below.

Checking this box requires Airbag Assembly replacement.
****Note** Contact your region in the event that you are unable to read the serial number.**
DO NOT ATTEMPT TO INSTALL INFLATOR

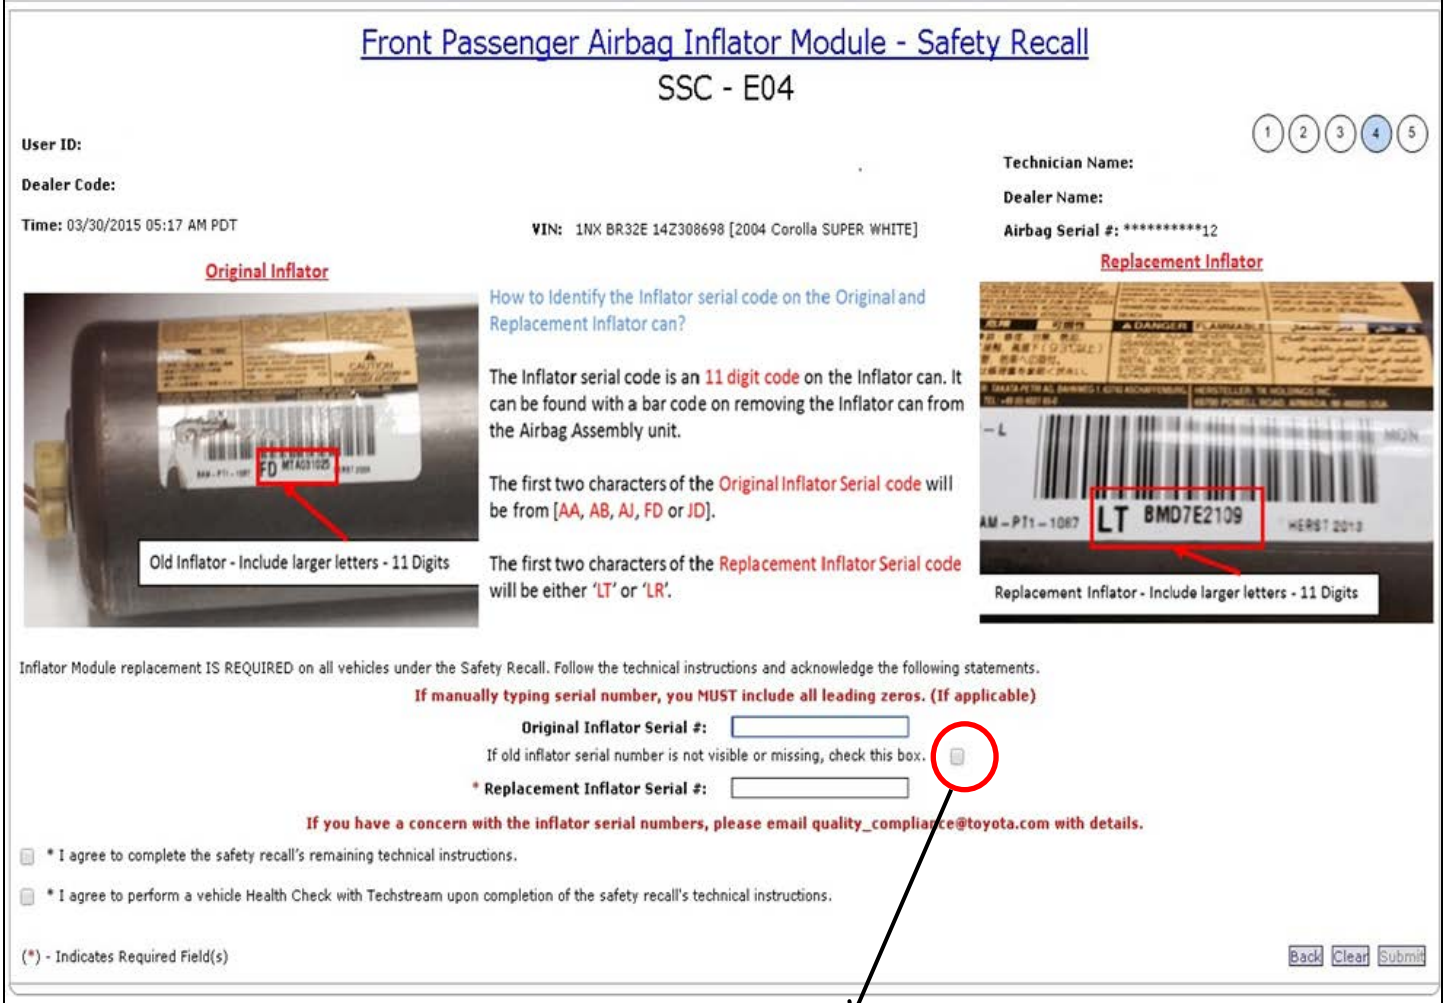
c) If the inflator serial number cannot be scanned or is not present check the box as shown below.

Checking this box requires Airbag Assembly replacement.
****Note** Contact your region in the event that you are unable to read the serial number.**
DO NOT ATTEMPT TO INSTALL INFLATOR

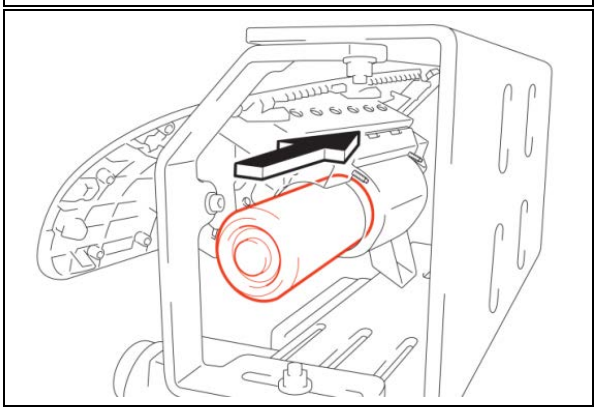
a) Fold the seal in order to prevent it from being caught under the airbag assembly bracket in the next step.

NOTE: *DO NOT* fully remove the seal until just before connecting the harness.
