October 14, 2026 Version 3

Safety Recall: 2015 CR-Z Takata Driver's Airbag Inflator

Supersedes version 2 to revise the information at:

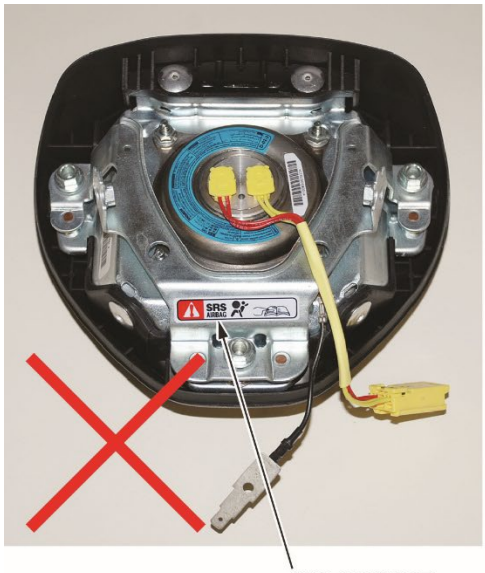
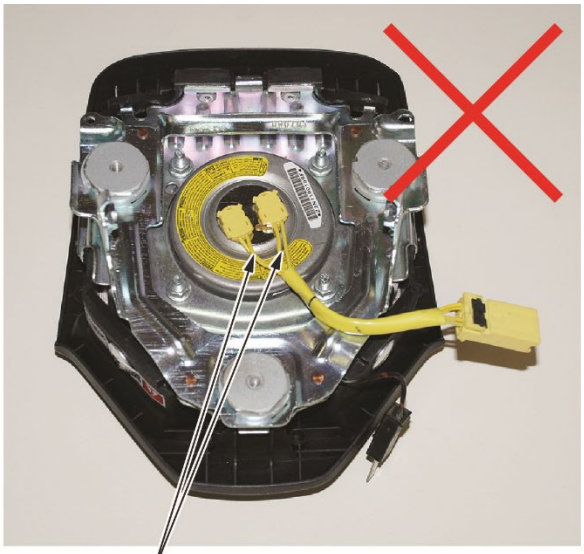
- If there is nothing unusual about the airbag or the inflator, go to step 5.
- If there are any unusual markings, like an incorrect label or a model year written in marker, the airbag and inflator may not be the correct airbag and/or inflator for the vehicle or it may be a counterfeit part. For more information about counterfeit airbags, you can refer to *safercar.gov*, enter keywords **MANAGING COUNTERFEIT**, and select **Recommended Dealer Guidance for Managing Counterfeit Air Bags** from the list. **If you suspect that the airbag or inflator is counterfeit, do not continue this procedure**. Contact your DPSM for assistance.

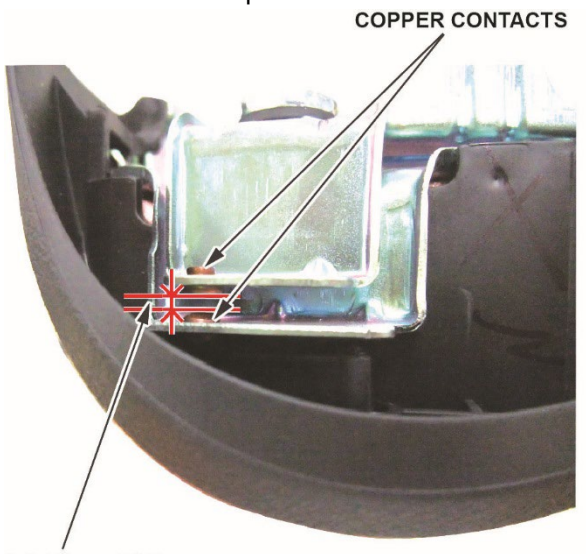
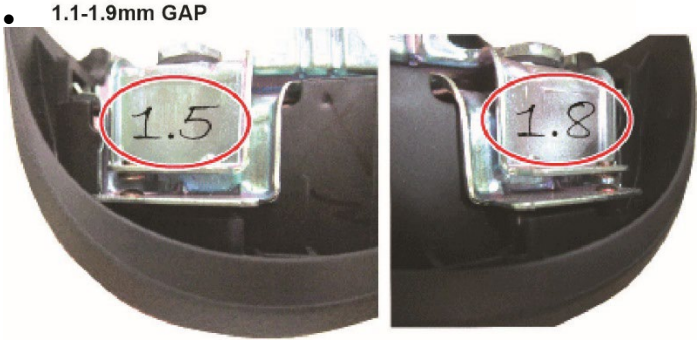
- Measure the space between the two copper contacts on the horn plate as shown. The space should be between 1.1 and 1.9 mm.
  NOTE: There is a copper contact on each side of the airbag module.
  - If the spaces are within specification, write the measurements on the side of the horn plate.
  - If either of the spaces is out of specification, try to correct it. If the space is too large, use a pair of pliers to close the space, or if the gap is too small, use a flat headed screwdriver to open it up so that the copper contacts are within specification. Write down the measurement on the side of the horn plate.
