RE: File 545009 (Refer to this number when contacting our agency)

I received a complaint from [REDACTED] concerning an unsatisfactory transaction with your business. A copy of the complaint is enclosed for your review.

Campaign SB10-11-S002A Corrosion Affecting the Forward Rear Suspension Lower Link Brackets Regional Safety Recall 10V-436

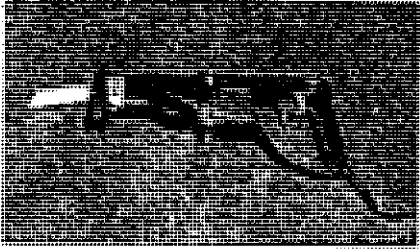
Reciprocating Saw 14 TPI blade	* Pop Nut Installer w/ regulator

- *1/4" drill bit guide or equivalent (optional method SnapOn E1521 with 3/16" drill bit)
- *33/64 Silver/Deming Drill HSS.118 Degree (Grainger P/N 2BT43)
- *Pop Nut Installer w/regulator
- 4" X 4" X 7" wood blocks (2) and 4" X 4" X 10.25" wood blocks (2)

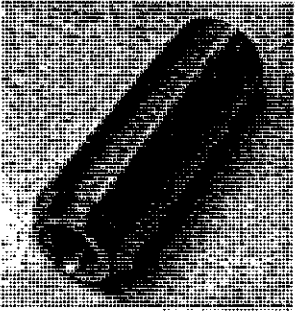
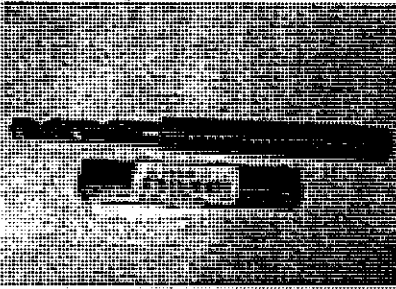
* 1/4" drill bit guide	* 33/64" Drill Bit Grainger P/N 2BT43

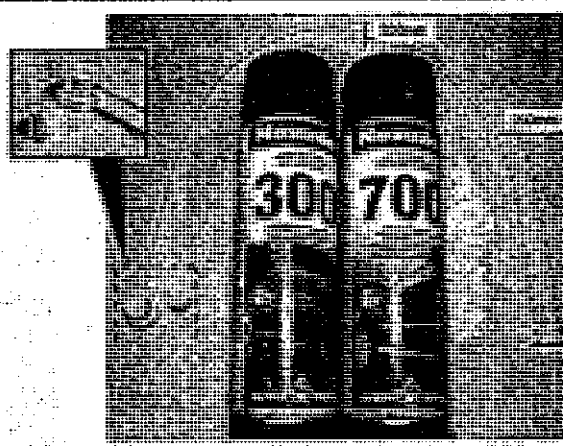
Figure 7 - Noxudol with long and short spray nozzles

6. Locate the long spray nozzle for Noxudol 700 and place a mark (tape or pen) 300mm (12 inches) and 200mm (7 inches) from the spray end of the nozzle. This mark indicates how far you will insert the long nozzle for some of the following steps. See Figure 7. Install the long spray nozzle onto a can of Noxudol 700.

11. Switch from the long spray nozzle to the short spray valve shown in Figure 7 and spray one coat of Noxudol 700 onto the outside of both driver and passenger side in the area indicated in Figure 4. Be careful not to overspray onto the exhaust system or body painted areas.

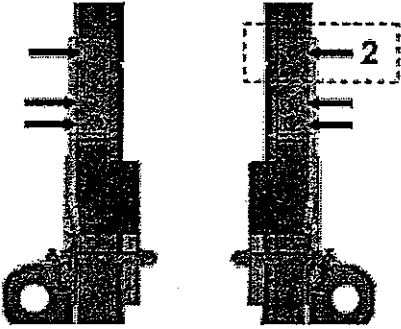
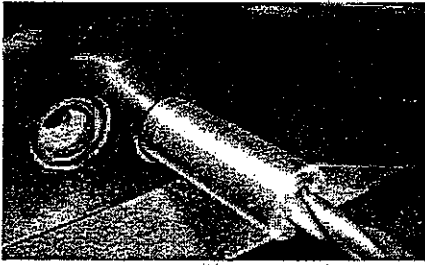
<p>Figure 17 Drilling Locations [2. This location has welded nut on some models –</p>	<p>Figure 18 Drill guide and bracket</p>	<p>Figure 19 1/2" holes</p>

7. Using the 1/4" drill bit guide or equivalent, drill 1/4" pilot holes for 6 new Pop-nut locations (See Note and Figures 17, 18 and 19 for reference).

NOTE: Some 2000MY vehicles' frames already have a nut welded into the driver side frame at location 2 in Figures 16 and Figure 17. For 2001 and 2002MY vehicles this location is for the fuel tank protector. DO NOT DRILL THIS LOCATION IF A WELDED NUT IS PRESENT

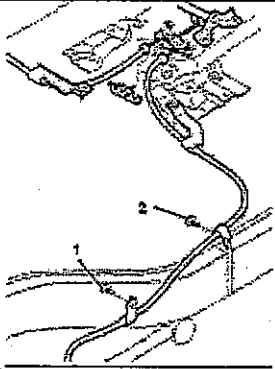
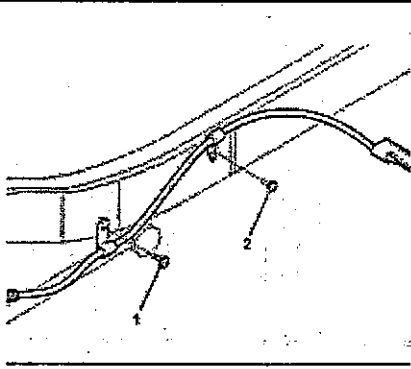
Figure 31 Parking brake cable Pass.	Figure 32 Parking brake cable Dr.	Figure 33 Wire Harness

a. Parking brake cable passenger side mounting bolts (2 points). See Figure 31.

b. Parking brake cable driver side mounting bolts (2 points). See Figure 32.

c. Wiring harness clips from frame driver side (6 points). See Figure 33.

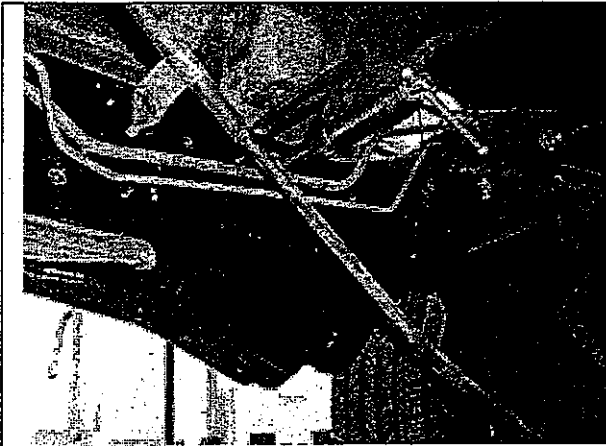
Figure 39
Wood block installed at #4 body mount

10. Using wooden blocks, support the body off of the frame at body mount #5 and #4. Body mount #5 should be 10.25 inches (260 mm) above the frame and body mount #4 should be at least 6.9 inches (175 mm) to allow access for the following steps. See Figures 38 and 39.
