<p>U.S. Department of Transportation National Highway Traffic Safety Administration</p>		<p><b>INFORMATION ACT (FOIA), 5 U.S.C. 552(B)(6)</b> DOT Auto Safety Hotline</p> <p><b>Vehicle Owner's Questionnaire</b> To Report Vehicle Safety Defects 1-888-DASH-2-DOT (1-888-327-4236) INTERNET: www.nhtsa.dot.gov/hotline</p>		<p>FOR AGENCY USE ONLY 100148</p>	
<p>Date Received <b>OCT 10 2012</b> 04-SEP-2012</p>		<p>Repository <input type="checkbox"/></p> <p>Reference No. 10473822</p>			
<p><b>OWNER INFORMATION (Type or Print)</b></p>					
<p>Name [REDACTED]</p>		<p>Daytime Telephone Number [REDACTED]</p>		<p>E-mail Address [REDACTED]</p>	
<p>Address [REDACTED]</p>		<p>Evening Telephone Number <i>same as above</i></p>			
<p>City EAGAN</p>	<p>State MN</p>	<p>Zip Code [REDACTED]</p>			
<p><i>The information you provide will be used to identify potential safety-related defects. We may share your information with the applicable vehicle manufacturer during an investigation or recall in accordance with the routine uses described in the agency's Privacy Act notice. See 49 FR 53971 (Sep. 3, 2004).</i></p>

2006 Hyundai Sonata L4-2.4L  
Seat Occupant Classification Module - Air Bag  
TSB Title: NHTASA

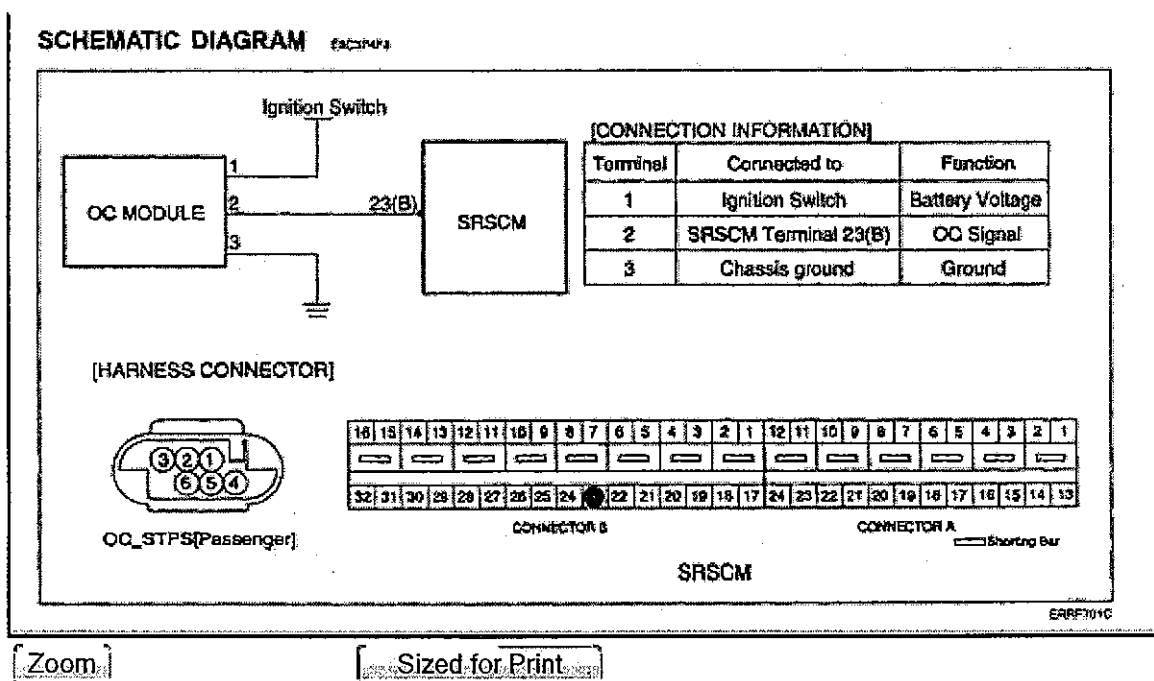
The passenger occupant classification system consists of the SRSCM and the OC module. The above DTC is recorded when a defect or communication error of the OC module is detected in the OC module circuit.

DTC Detecting Condition		
<b>DTC DETECTING CONDITION</b> <small>62074807</small>		
DTC	Condition	Probable cause
B1448 B1449 B1450	<ul style="list-style-type: none"> <li>• OC module Malfunction</li> <li>• SRSCM Malfunction</li> </ul>	<ul style="list-style-type: none"> <li>• Wiring Harness</li> <li>• OC module</li> <li>• SRSCM</li> </ul>

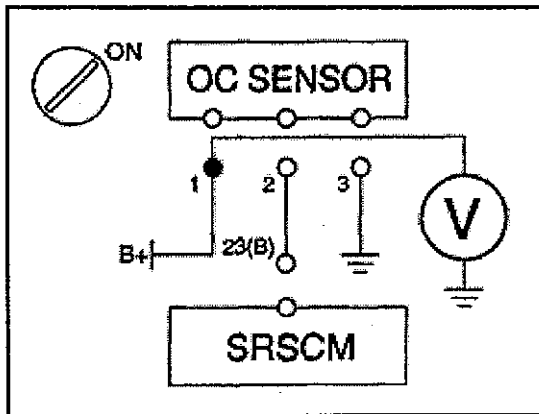
1. Connect the negative (-) terminal to the battery.

- Turn the ignition switch to ON.

**NO:** Repair or replace the wiring harness between the OC Sensor and ignition switch.

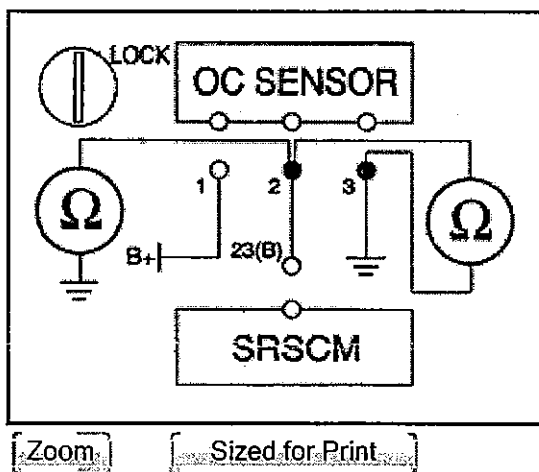
#### 4. CHECK SHORT TO GROUND

- Disconnect the negative (-) terminal from the battery.
- Turn the ignition switch to LOCK.
- Disconnect the negative (-) terminal from the battery.
- Measure resistance between the terminal 2 of OC Sensor harness connector and chassis ground.

- Measure resistance between the terminal the terminal 2 and 3 of OC Sensor harness connector

Specification:(resistance) : Infinite

**NO:** Repair or replace the wiring harness between the OC Sensor and the SRSCM.

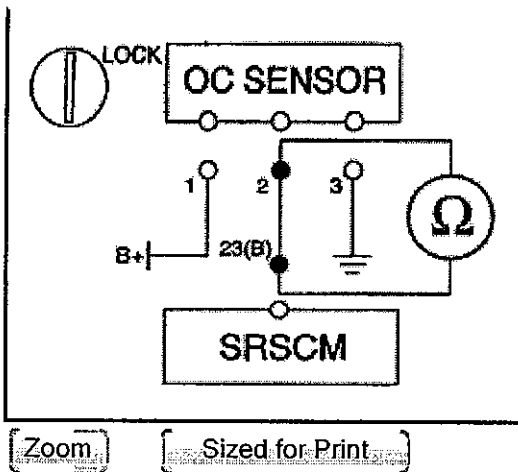
#### 5. CHECK OC SENSOR CIRCUIT

1. Measure resistance between the terminal 2 of OC Sensor harness connector and the terminal 23 of the SRSCM harness connector(B).

specification(resistance) : below 1 Ohm

**NO:** Repair or replace the wiring harness between the OC Sensor and the SRSCM.
