March 26, 2021 Version 4

Safety Recall: 2016-18 MDX and 2015-19 TLX V6 Fuel Pump

Supersedes 19-011, dated February 13, 2019. See REVISION SUMMARY.

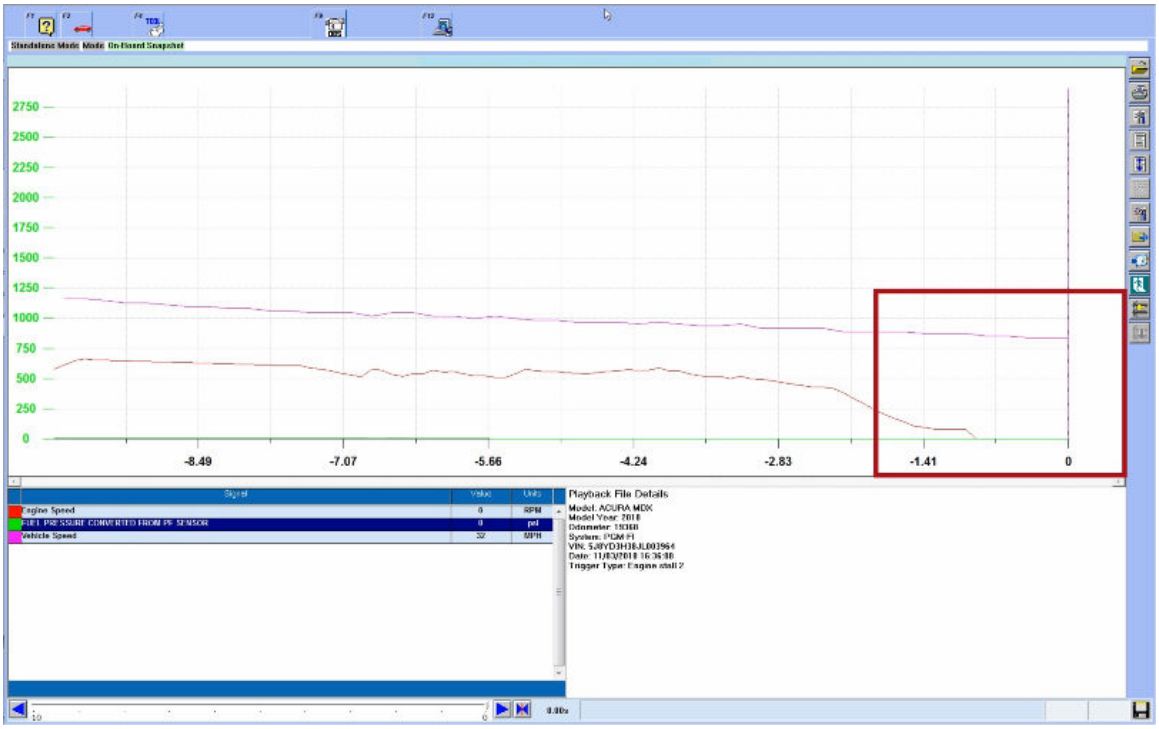
- For MDX and TLX AWD, if **Engine Speed** is **0 RPM** and **Fuel Pressure** is **0**, while **Vehicle Speed** is greater than **0 MPH**, the engine stalled. Proceed to the next step.

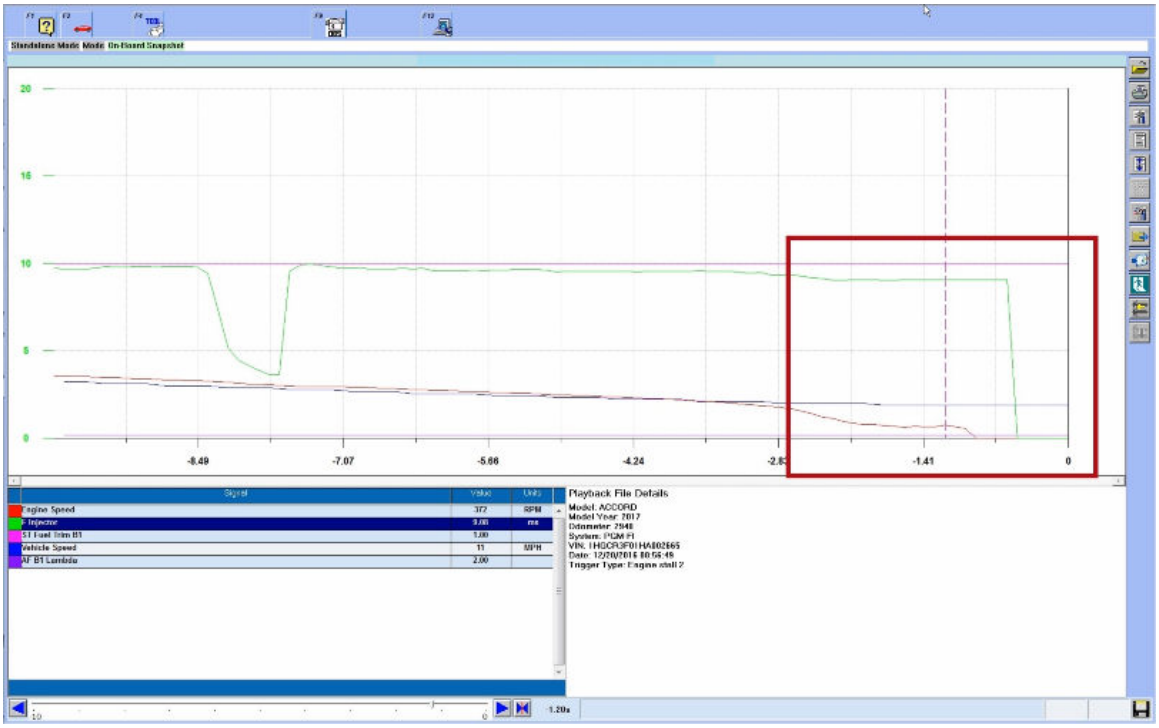
- For TLX 2WD, if **Engine Speed** is **0 RPM** and **AF Lambda** is **2**, while **Vehicle Speed** is greater than **0 MPH**, the engine stalled. Proceed to the next step.
