# Vehicle Owner's Questionnaire

## 3.8L V6 Naturally Aspirated and Supercharged Engine Preliminary Inspection

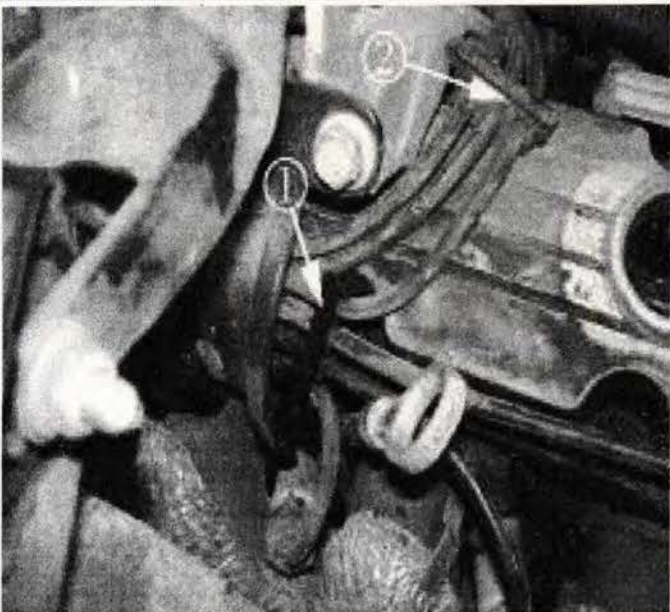
7. Ensure that spark plug retainer (1) is connected to spark plug wire 4 and spark plug wires 1, 3, and 5. Make sure that spark plug wires 2, 4 and 6 are secured to the original retainers and under the left engine mount strut bracket (2).

**Note :** Do NOT position the retainers above an exhaust runner.
