From: [REDACTED]
 To: [EVOQ \(NHTSA\)](#); [REDACTED]
 Cc: [NHTSA ODI CRD](#); [REDACTED]
 Subject: ODI-11461478
 Date: Friday, April 22, 2022 11:56:35 AM
 Attachments: [REDACTED]

HYUNDAI MOTOR AMERICA (HYUNDAI) IS RECALLING CERTAIN 2015-2016 VELOSTER, 2012 SANTA FE, 2011-2013 SONATA HYBRID, AND 2016 SONATA HYBRID VEHICLES. THE CONNECTING ROD BEARINGS INSIDE THE ENGINE MAY WEAR PREMATURELY, WHICH OVER TIME CAN RESULT IN ENGINE DAMAGE.

Service Procedure: Bearing Clearance Test

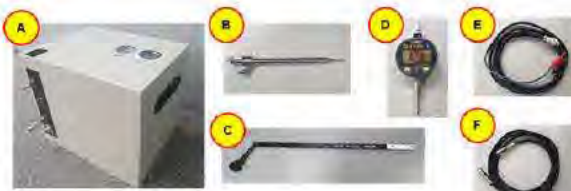
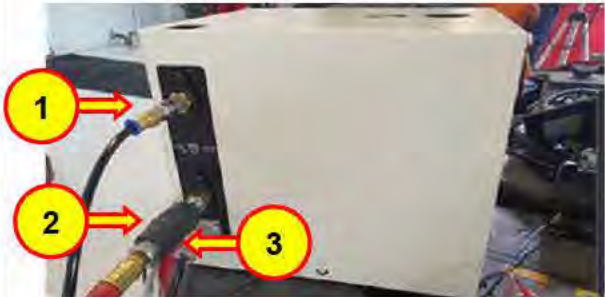
Part Name	Part Number / Figure	Note
BEARING CLEARANCE TESTER SET (BEARING TOOL)

<p>(1) TEST HOSE (2) MAIN HOSE (3) POWER SUPPLY CABLE</p> <p>One BEARING CLEARANCE TESTER SET provided to dealers. (Additional units can be ordered.)</p>	<p>Confirm the following pressures meet requirements. The correct ranges for AP/VC air pressures are also indicated with red/blue decals on the gauges:</p> <p>Shop air supply: 50 psi minimum</p> <p>AP: 0.1 ~ 0.11MPa VC: -73 ~ -83Kpa (Refer to TSB 20-GI-009H or later for calibration procedure)</p>

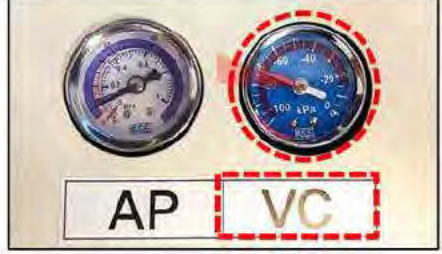
KQ231-2T110QQH	BEARING CLEARANCE TESTER SET (BEARING TOOL) (includes A - F)
	KQ231-2T100QQH	(A) BODY

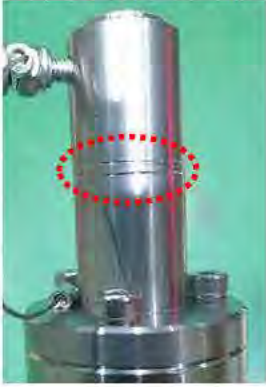
<p>(B) SPARK PLUG ROD (M12 for GD and Theta II MPI Hybrid engines)</p> <p>← Upper body portion is smooth with no grooves.</p>
	<p>KQ231-2T107QQH</p>

<p>(B) SPARK PLUG ROD (M14 for MPI engines)</p> <p>← 2 machined identification grooves on upper body.</p>
	<p>KQ231-2T102QQH</p>	<p>(C) CRANK ROTATOR TOOL</p>
	<p>KQ231-2T103QQH</p>	<p>(D) CLEARANCE GAUGE</p>
	<p>KQ231-2T104QQH</p>	<p>(E) POWER SUPPLY CABLE</p>
	<p>KQ231-2T105QQH</p>	<p>(F) TEST HOSE (AIR HOSE FOR CLEARANCE GAUGE)</p>

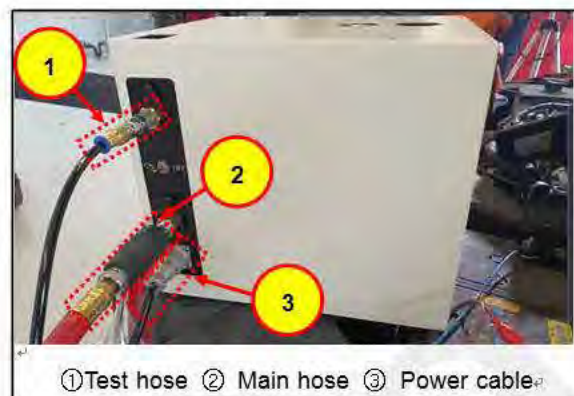
1. Connect the main hose (shop air supply) and test hose to the bearing tool (with other end of the test hose disconnected). (The power to the bearing tool main unit is not necessary at this time.)

Confirm the shop air pressure and AP/VC pressures on the bearing tool meet requirements. The correct ranges for AP/VC air pressures are also indicated with red/blue decals on the gauges. Using STUI in the GDS, take and submit a picture of the gauges with the pressure levels clearly visible and the VIN in the background of the photo (RO or last 6 digits written on paper) for records.

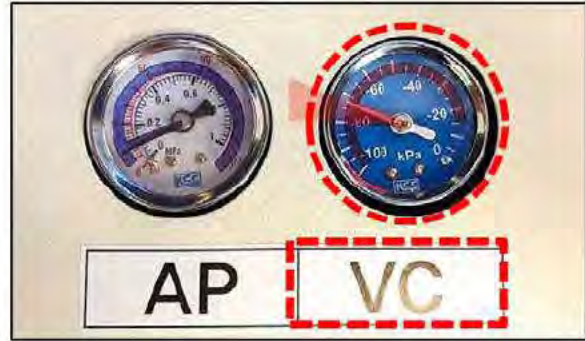
Shop air supply: 50 psi minimum

AP/VC air pressure calibration check:

- a) Connect the main air compressor hose.
- b) Connect the test hose. (The other end of the test hose should be left disconnected from the spark plug rod.)
- c) Confirm that the AP/VC toggle switch at top is in the middle position.
- d) Inspect the AP/VC gauge indicators and compare to the specification range:
 - **AP:** 0.1 ~ 0.11MPa
 - **VC:** -73 ~ -83Kpa

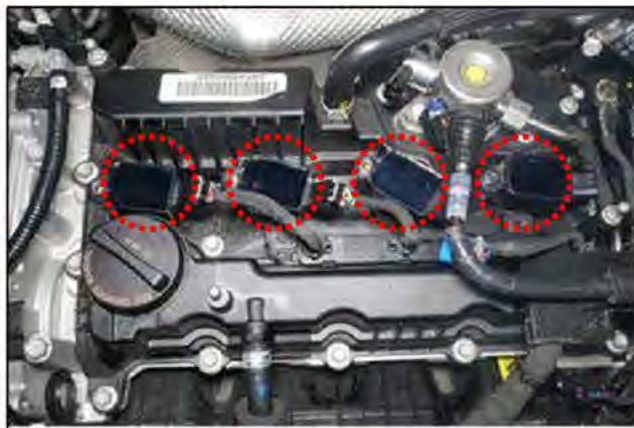
2. Remove the engine cover and the 4 ignition coils.

Tightening Torque (ignition coils):
9.8 - 11.8 N·m
(1.0 - 1.2 kgf·m, 7.2 - 8.7 lb·ft)

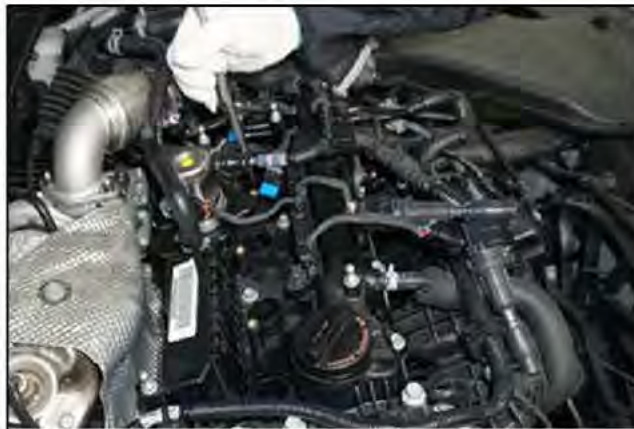
3. Remove the 4 spark plugs.

Tightening Torque:
14.7 - 24.5 N·m
(1.5 - 2.5 kgf·m, 10.9 - 18.0 lb·ft)

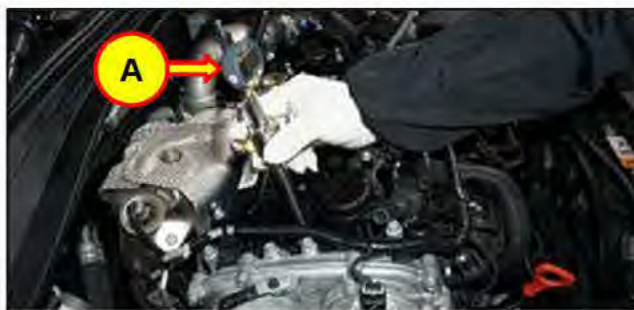
4. Insert the appropriate (use **M12 for GDI and Theta MPI Hybrid engines** or **M14 for all other MPI engines**) spark plug rod SST (A) into Cylinder #1 spark plug hole and turn until hand tight. Insert the clearance gauge SST into the spark plug rod and tighten using the thumb screw.

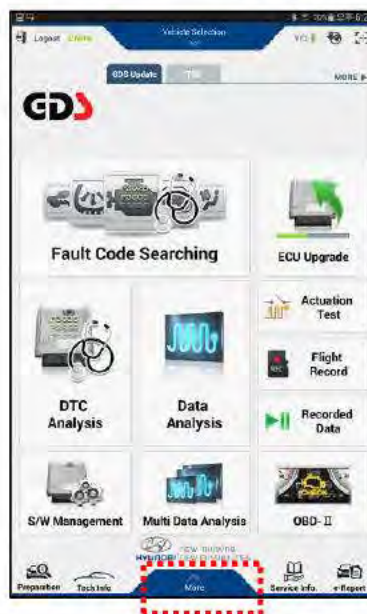
6. Swipe up on the 'More' tab at the bottom of the GDS home screen. Select the 'Special Inspection' function.

7. Enter the vehicle info into the GDS as prompted then select 'Next'.

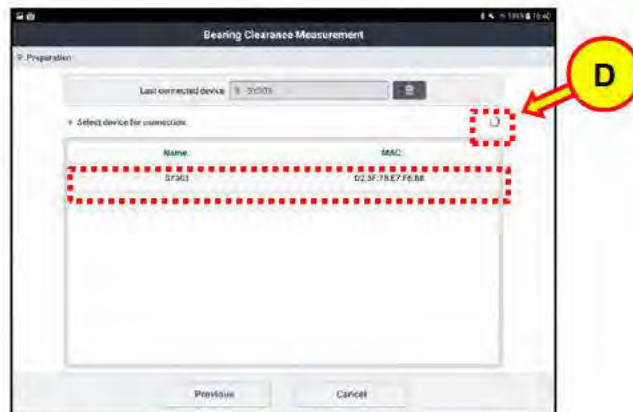
8. Connect the GDS to the clearance gauge SST (gauge) via Bluetooth:

- Press the “Set’ button (B) on the gauge to turn it on.
- Press the “Set” (B) and “Mode” (C) buttons at the same time for about 4 sec until the “reset” message is displayed.
- Select the gauge in the list of devices on the GDS. Select the ‘Refresh’ icon (D) if the gauge doesn’t appear automatically.

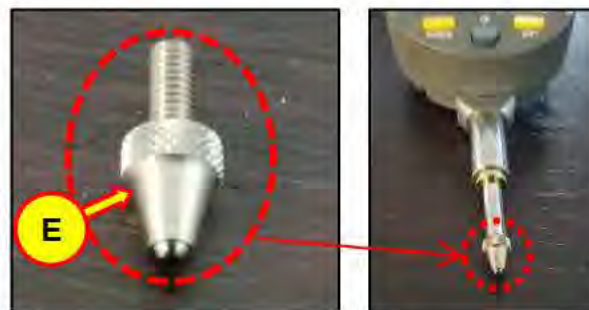
- Check that the ball point tip (E) of the clearance gauge SST is securely installed to the tool as shown. **Do not continue if ball point tip (E) is loose or missing.**

If loose, apply Blue Loctite (or equivalent) to the tip thread and retighten securely to the gauge plunger.

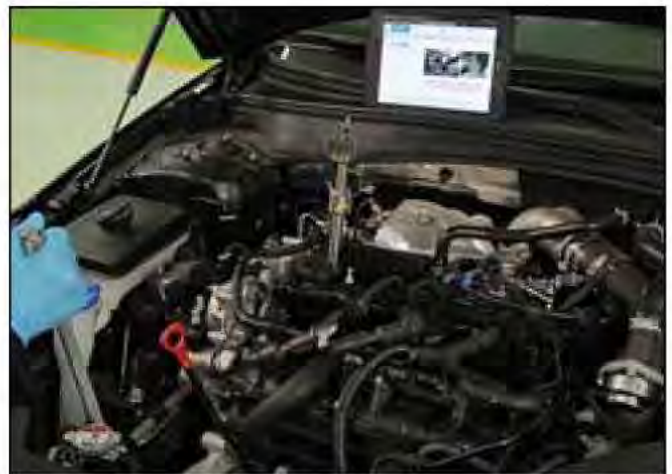
- For the step below, the engine must be rotated **SLOWLY** using the crank rotator SST.
 - Abrupt or erratic movements may cause improper TDC setup and test errors.
- Do **NOT** stop rotating the engine before reaching **MAX TDC**, especially during the initial rotation towards TDC where the value may be at 0mm and change all the sudden.
 - Be sure to find TDC correctly by slowly and slightly nudging the engine a little more to verify no change in value to confirm that the piston is at **MAX TDC**.

- ❖ Monitor the piston height value on GDS screen or the clearance gauge SST while rotating the engine clockwise using the Crank Rotator Tool.
 - Rotate the engine **SLOWLY** as the value increases towards a MAX value. (BTDC → TDC)
 - When the value changes direction (increasing/BTDC → TDC → decreasing/ATDC), stop rotating the crank when the piston height is at MAX value minus 0.03mm.

The testing point is slightly towards ATDC from TDC when the piston has moved down 0.03mm from its highest position.

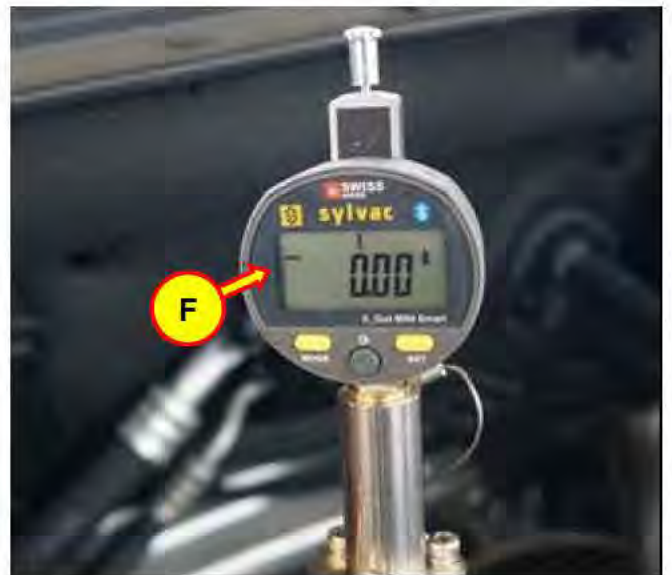
12. Select 'Next' when TDC is found.
- ❖ Ideal set point for testing from TDC is found when the maximum value minus 0.03mm is reached on the clearance gauge SST (F).
 - ❖ The value is also displayed on the GDS.

The value at TDC varies depending on the specific vehicle and engine type.

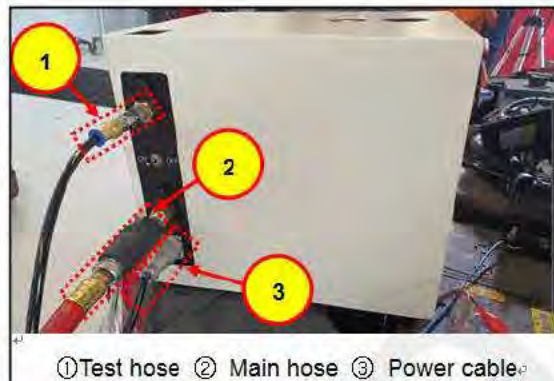
14. Connect the test hose (1) to the spark plug rod SST and to the bearing tool SST.

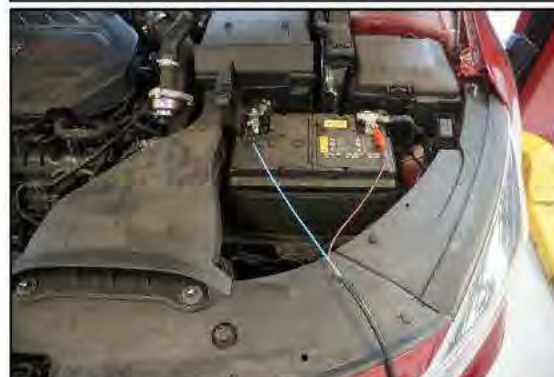
15. Connect the SST power cables to a fully charged 12V battery or to an external AC/DC power supply.

- Turn the bearing tool SST power switch 'ON'.

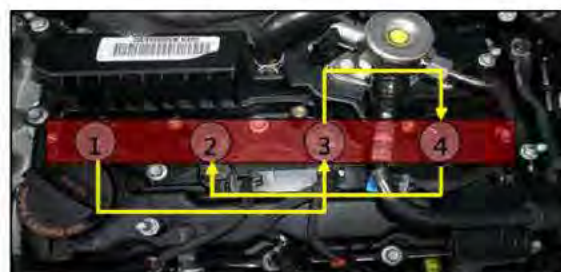
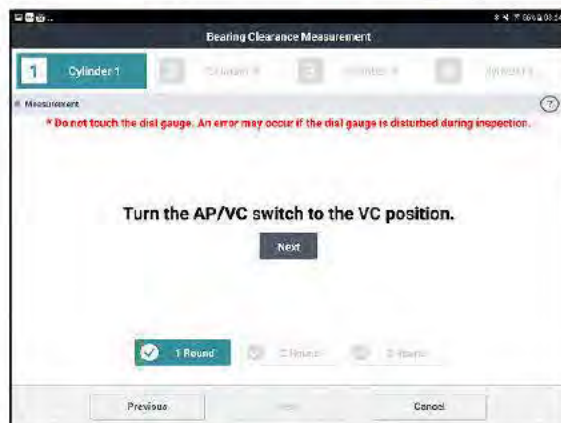
- The cylinders will be checked per the engine firing order: #1→#3→#4→#2.

18. On the bearing tool SST, change the AP/VC switch to the VC position when instructed by the GDS.

If the bearing measurement value does not change when the AP/VC is switched or the “Unable to measure” message appears on the GDS, rotate the crankshaft further as the exhaust valves could be open. Set the crankshaft to TDC again (Step 11).

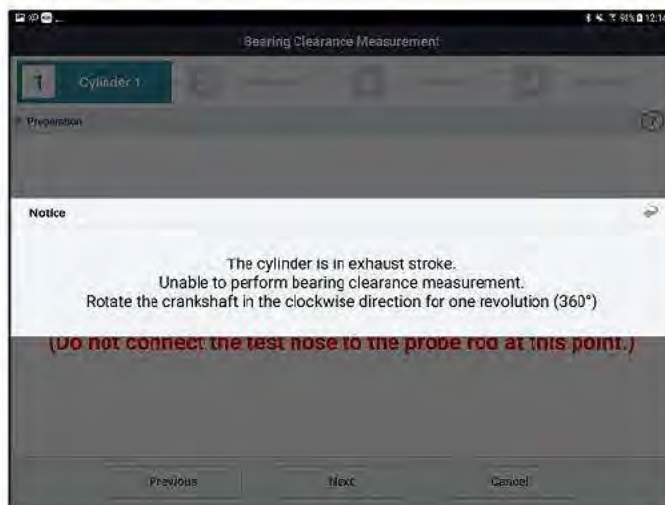
Ensure the test hose is disconnected from the clearance gauge SST when finding TDC.

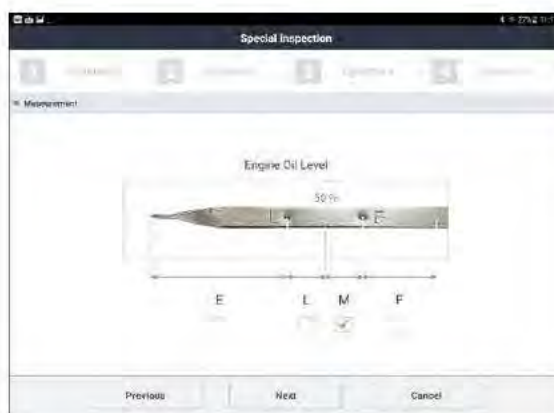
19. Continue following the instructions on the GDS to complete the bearing inspection. Check the engine oil level and select the level in the GDS.

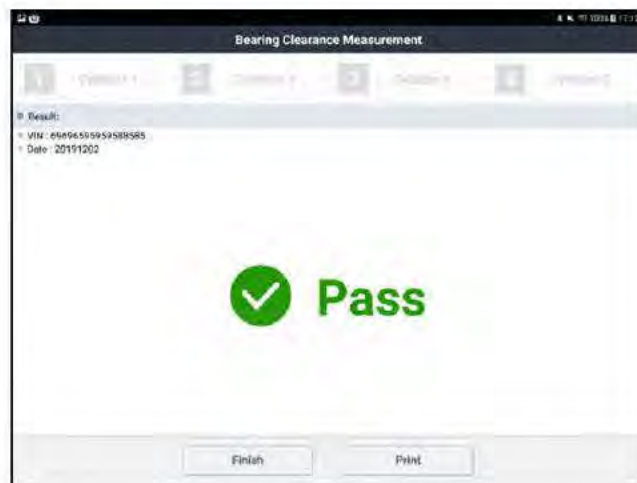
20. If the test result is “PASS”:

- Save a screenshot of the results screen.
- Reinstall all components in the reverse order of removal.
- Check for DTCs and perform the appropriate diagnostic service. Ensure no warning lights are present to complete the procedure.

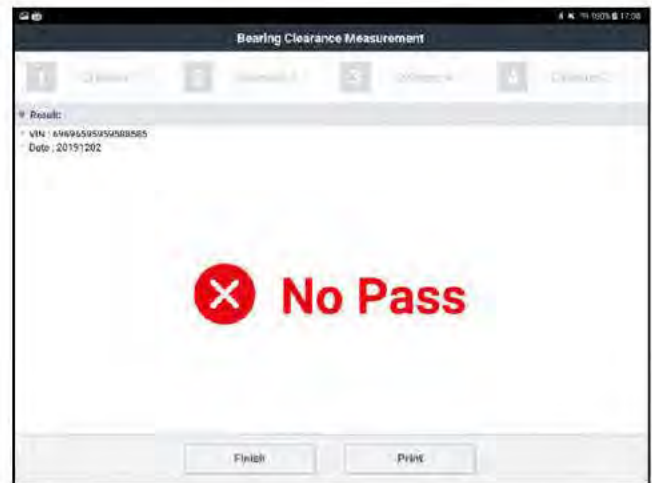
If the test result is “NO PASS”:

- a) Save a screenshot of the results screen.
- b) Submit PA for engine replacement approval.
- c) Follow remainder of the separate reference TSB to complete the service procedure.
- d) Check for DTCs and perform the appropriate diagnostic service. Ensure no warning lights are present to complete the procedure.

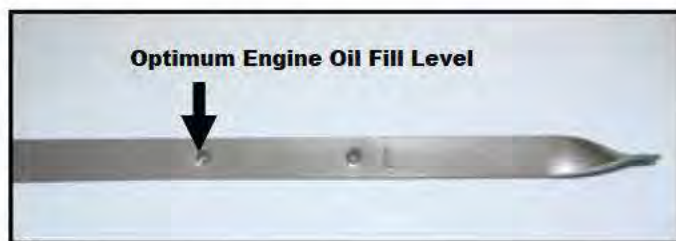
- Check for any leaks during this time.
 - After the engine has warmed up to normal operating temperature, turn the engine off, wait a few minutes, and then **adjust the engine oil level up the “F” mark as shown.**

- Perform the appropriate diagnostic service for any DTC's.
 - Ensure no warning lights are present.
 - **Reset the engine adaptive values** using the GDS.

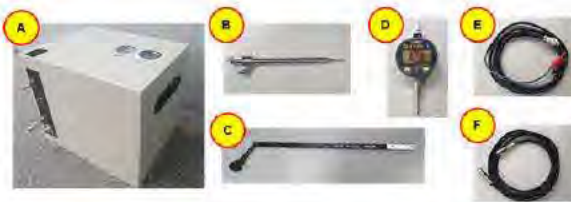
Part Name	Part Number / Figure	Note
BEARING CLEARANCE TESTER SET (BEARING TOOL)

<p>(1) TEST HOSE (2) MAIN HOSE (3) POWER SUPPLY CABLE</p> <p>One BEARING CLEARANCE TESTER SET provided to dealers. (Additional units can be ordered.)</p>	<p>Confirm the following pressures meet requirements. The correct ranges for AP/VC air pressures are also indicated with red/blue decals on the gauges:</p> <p>Shop air supply: 50 psi minimum</p> <p>AP: 0.1 ~ 0.11MPa VC: -73 ~ -83Kpa (Refer to TSB 20-GI-009H or later for calibration procedure)</p>

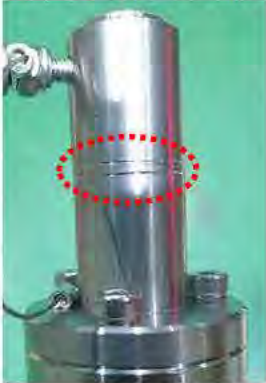
<p>(B) SPARK PLUG ROD (M12 for GD and Theta II MPI Hybrid engines)</p> <p>← Upper body portion is smooth with no grooves.</p>
	<p>KQ231-2T107QQH</p>

<p>(B) SPARK PLUG ROD (M14 for MPI engines)</p> <p>← 2 machined identification grooves on upper body.</p>
	<p>KQ231-2T102QQH</p>	<p>(C) CRANK ROTATOR TOOL</p>
	<p>KQ231-2T103QQH</p>	<p>(D) CLEARANCE GAUGE</p>
	<p>KQ231-2T104QQH</p>	<p>(E) POWER SUPPLY CABLE</p>
	<p>KQ231-2T105QQH</p>	<p>(F) TEST HOSE (AIR HOSE FOR CLEARANCE GAUGE)</p>

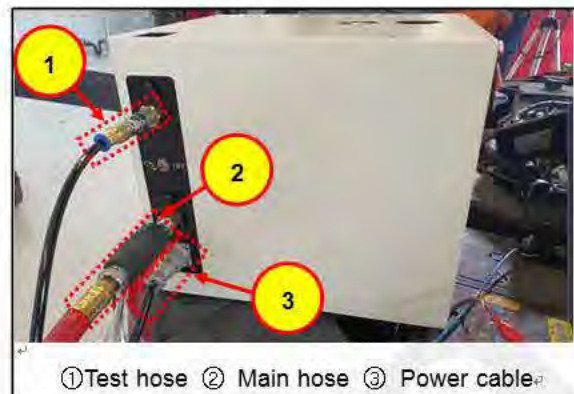
1. Connect the main hose (shop air supply) and test hose to the bearing tool (with other end of the test hose disconnected). (The power to the bearing tool main unit is not necessary at this time.)

Confirm the shop air pressure and AP/VC pressures on the bearing tool meet requirements. The correct ranges for AP/VC air pressures are also indicated with red/blue decals on the gauges. Using STUI in the GDS, take and submit a picture of the gauges with the pressure levels clearly visible and the VIN in the background of the photo (RO or last 6 digits written on paper) for records.

Shop air supply: 50 psi minimum

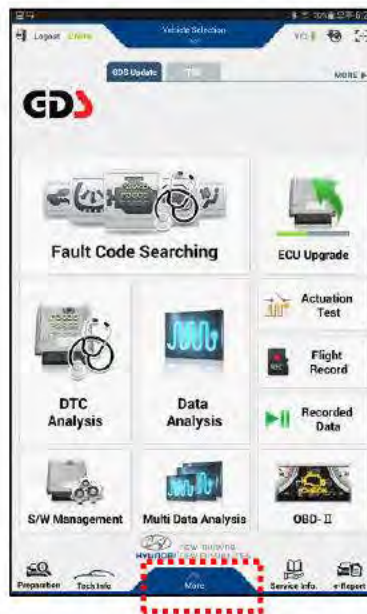
6. Swipe up on the 'More' tab at the bottom of the GDS home screen. Select the 'Special Inspection' function.

7. Enter the vehicle info into the GDS as prompted then select 'Next'.

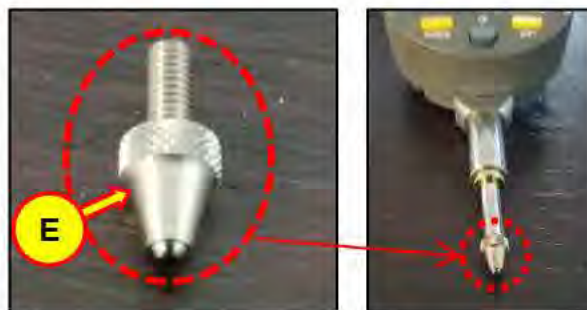
If loose, apply Blue Loctite (or equivalent) to the tip thread and retighten securely to the gauge plunger.

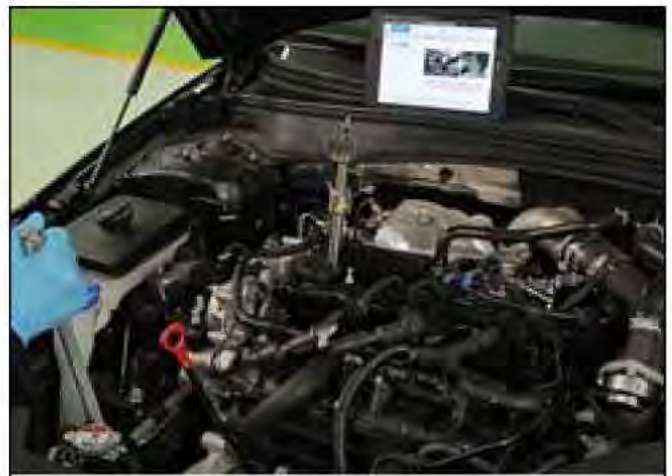
- For the step below, the engine must be rotated **SLOWLY** using the crank rotator SST.
 - Abrupt or erratic movements may cause improper TDC setup and test errors.
- Do **NOT** stop rotating the engine before reaching **MAX TDC**, especially during the initial rotation towards TDC where the value may be at 0mm and change all the sudden.
 - Be sure to find TDC correctly by slowly and slightly nudging the engine a little more to verify no change in value to confirm that the piston is at **MAX TDC**.

- ❖ Monitor the piston height value on GDS screen or the clearance gauge SST while rotating the engine clockwise using the Crank Rotator Tool.
 - Rotate the engine **SLOWLY** as the value increases towards a MAX value. (BTDC → TDC)
 - When the value changes direction (increasing/BTDC → TDC → decreasing/ATDC), stop rotating the crank when the piston height is at MAX value minus 0.03mm.

The testing point is slightly towards ATDC from TDC when the piston has moved down 0.03mm from its highest position.

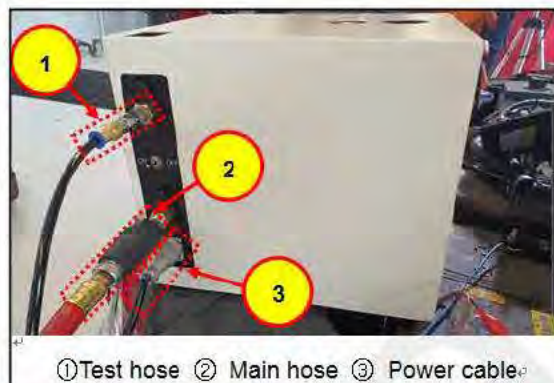
14. Connect the test hose (1) to the spark plug rod SST and to the bearing tool SST.

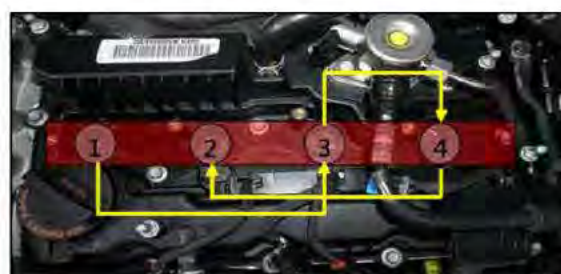
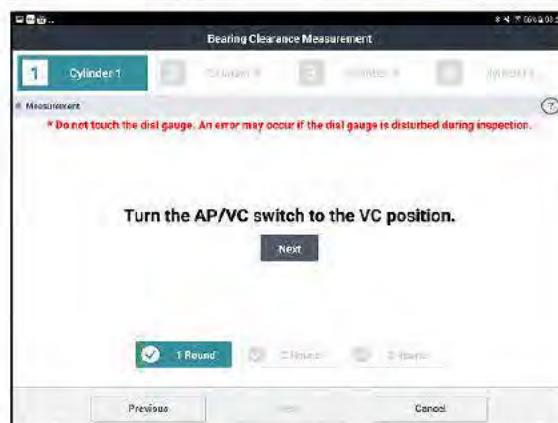
- The cylinders will be checked per the engine firing order: #1→#3→#4→#2.

18. On the bearing tool SST, change the AP/VC switch to the VC position when instructed by the GDS.

If the bearing measurement value does not change when the AP/VC is switched or the “Unable to measure” message appears on the GDS, rotate the crankshaft further as the exhaust valves could be open. Set the crankshaft to TDC again (Step 11).

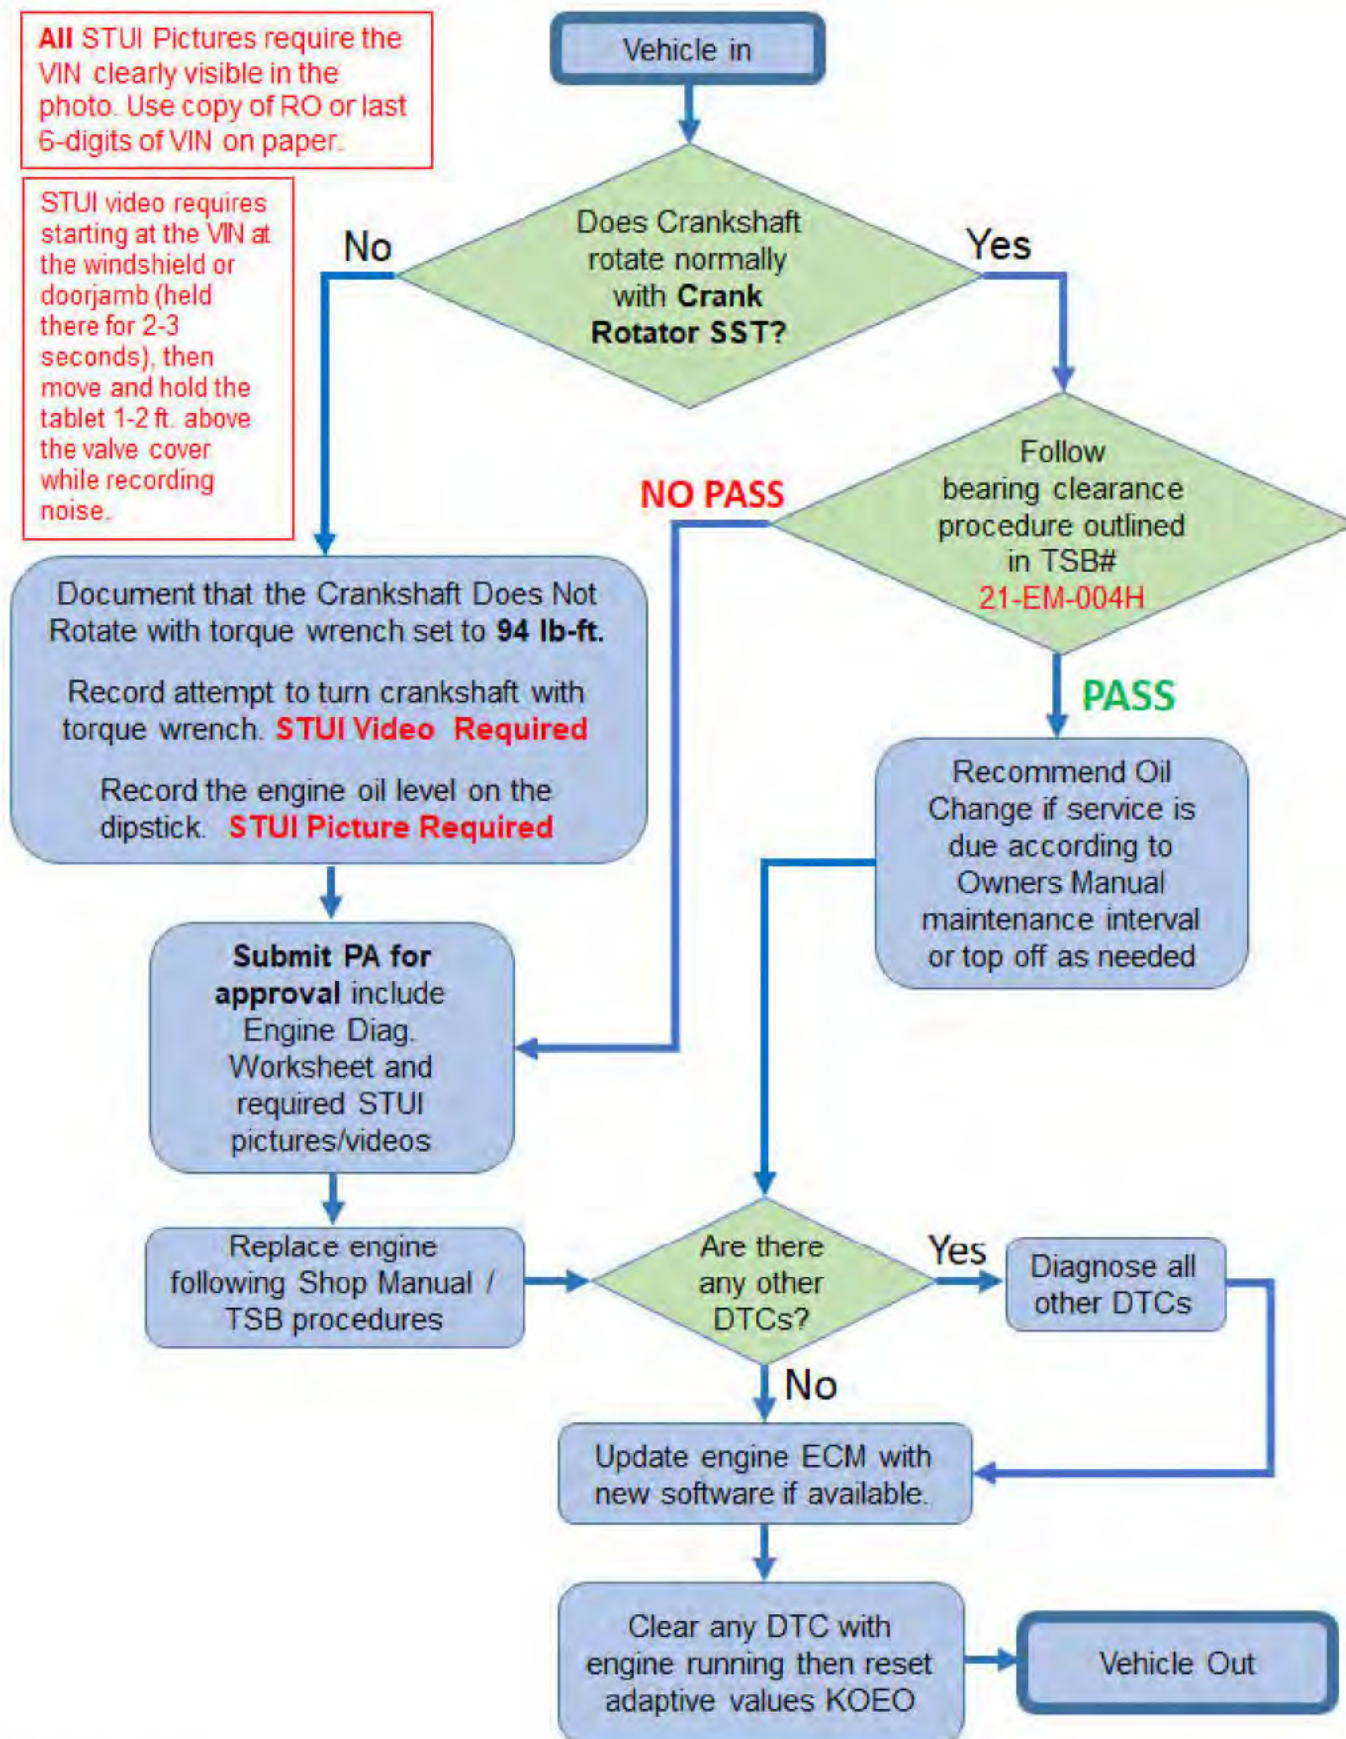
Service Procedure Flowchart:

Service Procedure:**Engine Inspection - (Engine Rotation Check)**

1. Rotate the crankshaft with the crank rotator SST.
 - If the crankshaft cannot be turned with a moderate force, then measure the force required to turn the crankshaft with a torque wrench.
 - If the SST or shop tools do not fit the specific vehicle type, remove the front passenger wheel and wheel liner or underbody tray as needed to rotate the crankshaft.
