Technical Service Bulletin

70 Rattle from rear subwoofer grille

70 16 52 2044503/1 June 9, 2016.

Model(s)	Year	VIN Range	Vehicle-Specific Equipment
A4	2017	All	Not Applicable

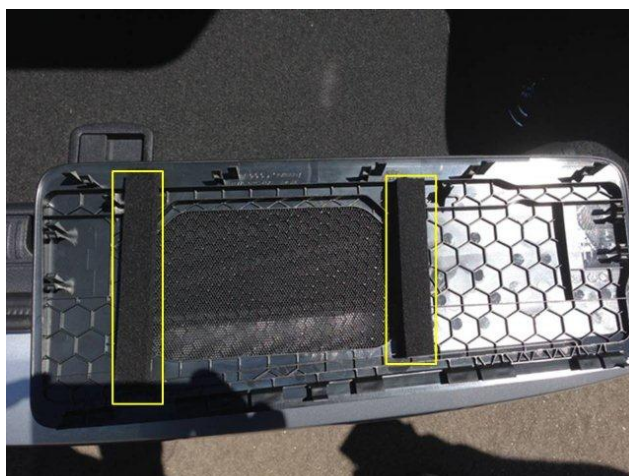
Figure 1. Foam strip installation for vehicles with Audi sound (PR code 9VD).

Customer may report a rattle coming from the rear parcel shelf or rear subwoofer grille when playing music.

The rear parcel shelf speaker grille will rattle when loud music with heavy bass is being played.

Install foam strips (part number 8E0831575A) as shown. Note that there are two different types of speaker grilles, and the foam strips are installed differently on each one:

- Vehicles with Audi sound (PR code 9VD) (Figure 1).
