Radio and Integrated Thin-Film Antenna Troubleshooting, and Field Service Updates

54-148

Freightliner Service Bulletin

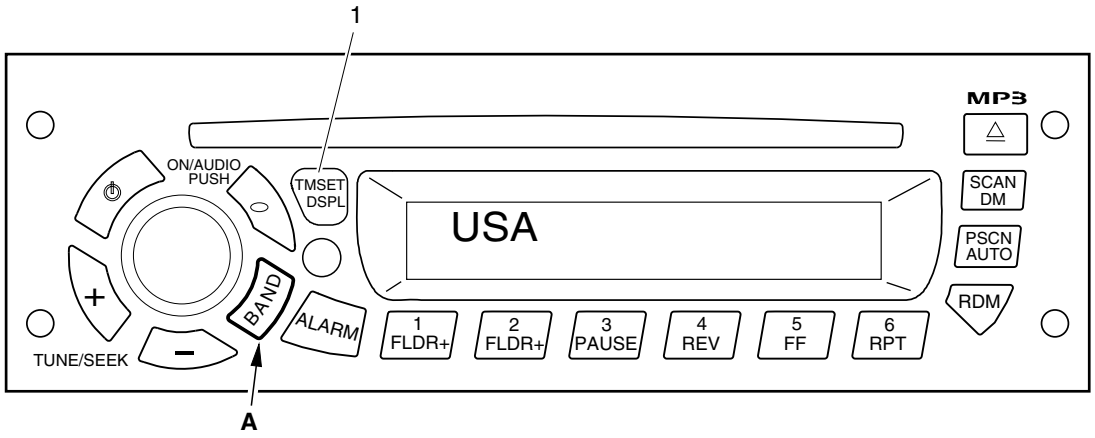
Fig. 2, Setting the Country Code

The symptoms for the radio being set for the wrong country are any of: poor reception wrong frequencies displayed radio not tuning to known local stations.

1. Turn the key to ACC or IGN.
2. Turn the radio OFF.
3. Press the "SET DSPL" button for about 3 seconds until the hour digit of the clock begins flashing.
4. Press the "BAND" button to select the country that is correct for the region where the truck is operating. See **Fig. 2**.

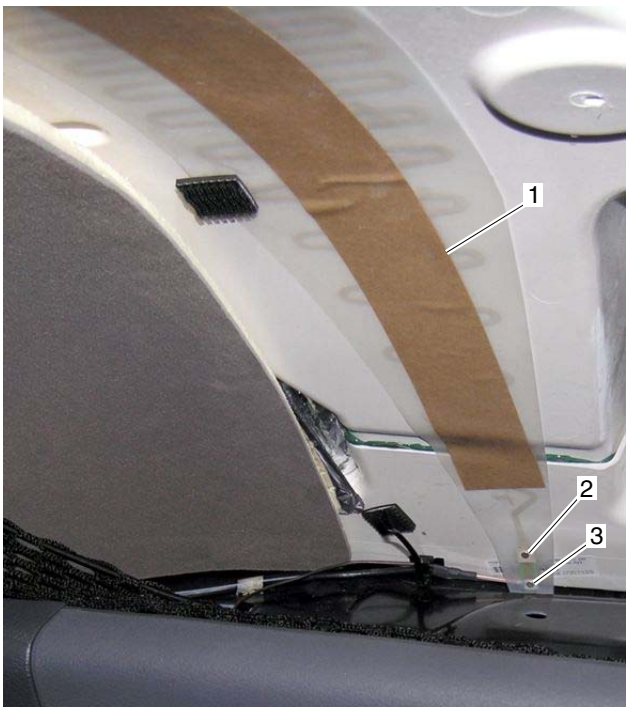
Fig. 6, Thin-Film Antenna Fuse (headliner removed)

No	Go to step 5.
5	On the CB thin-film antenna, measure the resistance between the two rivets, where the antenna wire attaches to the antenna film. See **Fig. 6**. This is a resistance test of the fuse. The fuse opens when too much wattage attempts to transmit through the antenna. Is the resistance less than 2 ohms?	Yes	All antenna tests pass. Test the CB radio.
		No	Replace the open fuse with Littelfuse LF 0454 750 (750 mA Time Delay).

2. Locate the fuse at the base of the antenna, in between the two rivets. See **Fig. 5**.
3. Using a removal tool, lift the fuse out of the fuse holder.
4. Insert a new fuse (LF 0454 750) in the fuse holder.
5. Turn on the radio and test the reception.
6. Install the headliner and the overhead storage bin upholstery insert.

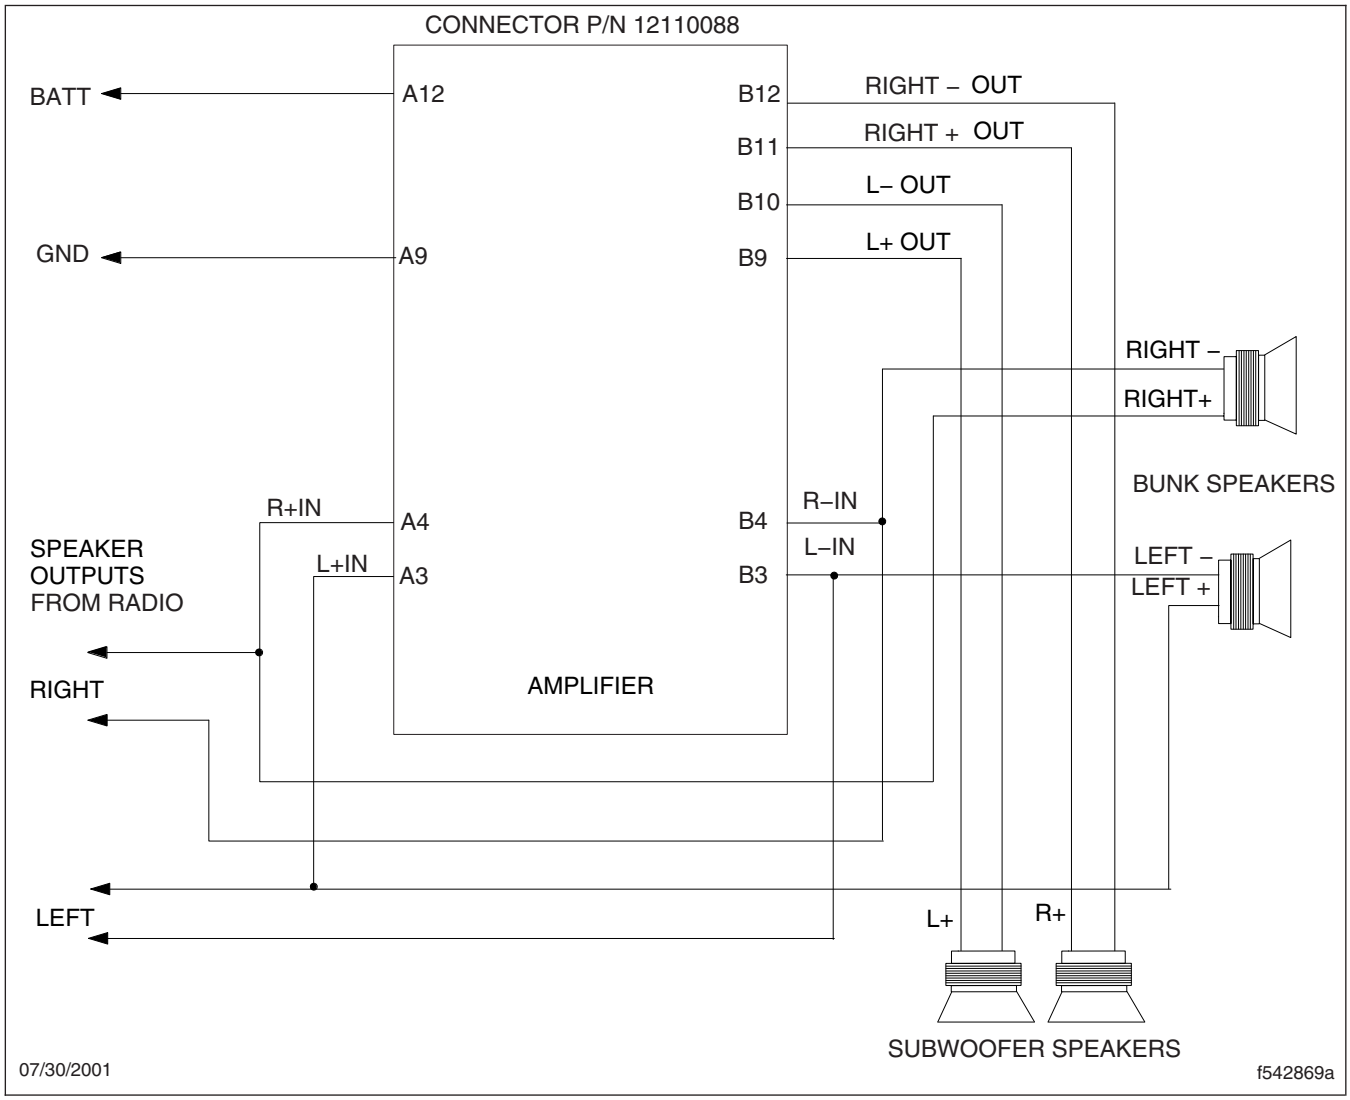
Fig. 13, Amplifier Wiring Diagram

3	Check amplifier voltage. Check between pin A12 of the amplifier harness and cab ground for battery power. See **Fig. 13**, **Fig. 14**, and **Fig. 15**. The voltage should be within 0.5 volts of battery voltage. Is the voltage correct?	Yes	Go to step 4.
		No	Check the circuit breaker and the amplifier power leads. Repair or replace as required.
4	Verify operation of the speakers. Turn on the radio and verify operation of the speakers. Are the rear speakers working?	Yes	Go to step 5.
		No	Check the speaker leads. If they are OK, replace the radio.
5	Check the resistance. Check the subwoofer speaker resistance. A good speaker should have a resistance value of 2 to 10 ohms. Measure the resistance across the speaker input terminals. Is the resistance OK?	Yes	Go to step 8.
		No	Replace the speaker.

No	Go to test 15.
15	Check for speaker output at the radio. Tune the radio to a frequency that does not have an active radio station. Set the volume to a comfortable level. Backprobe the pins of the affected speaker output(s) at the radio connector. See **Fig. 13** and **Fig. 14**. The AC voltage output will range from 0 to 1 volt, depending on volume level. Is AC voltage present?	Yes	Check the speaker leads between the radio and the auxiliary volume control. Repair or replace as necessary.
		No	Replace the radio.

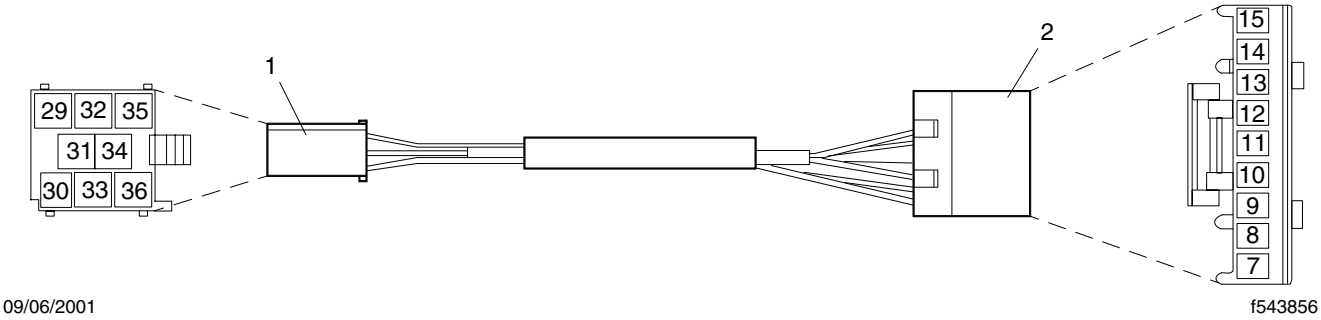
Fig. 16, CD Changer Wiring Harness

Error Message Diagnostics: "Comm Error"			
Step	**Test Procedure**	**Test Result**	**Action**
1	Disconnect the CD changer harness from the radio. See **Fig. 16** and **Table 16**. Measure for AC voltage at the radio on connector A pin 30 using a known good ground. AC voltage will vary Is AC voltage detected?	Yes	Go to step 2.
		No	Replace the radio.

Error Message Diagnostics: "Comm Error"			
Step	**Test Procedure**	**Test Result**	**Action**
2	Connect the CD changer harness to the radio and disconnect it from the CD changer. See **Fig. 16** and **Table 16**. Measure for AC voltage at the CD on connector B pin 14 using a known good ground. AC voltage will vary. Is AC voltage detected?	Yes	Replace the CD player.
		No	Replace the CD player harness.

No	Go to step 7.
6	Check the ground at the CD changer. Make sure the power to the stereo is off. Check the resistance between the ground wire (pin 13 of connector B) of the CD changer connector, and a known good ground. See **Fig. 16**. Is the ground circuit OK? Is battery voltage present?	Yes	Replace the CD changer.
		No	Repair the CD changer ground circuit.
7	Check for voltage output from the stereo. Check at pin 31 of the A connector for battery voltage. See **Fig. 16**. The A connector plugs in to the stereo.	Yes	Repair the CD changer power circuit.
		No	Replace the radio.
8	Verify that the speakers emit audio when a CD is played. When a CD is played, does sound come from the speakers?	Yes	No action necessary.
		No	Go to step 9.

CD Changer Diagnostics			
Step	**Test Procedure**	**Test Result**	**Action**
9	Check for AC voltage. Check for AC voltage from pin 29 and 32 at the stereo end of the CD changer harness, and a known good ground. See **Fig. 16**. Check for AC voltage from pin 29 and 32 at the stereo end of the CD changer harness, and a known good ground. See **Fig. 16**. Check the voltage while a CD is playing. A counter will appear on the display to indicate that the disc is playing. AC voltage will vary. Is there AC voltage at both pins?	Yes	Replace the radio.
		No	Go to step 10.
10	Check for AC voltage at both pins. Remove pins 10 and 11 from the connector, then check the voltage while a CD is playing. Check for AC voltage between pins 10 and 11 at the CD changer end of the harness, and a known good ground. AC voltage will vary. Is there AC voltage at both pins?	Yes	Repair or replace the CD changer harness.
		No	Replace the CD changer.

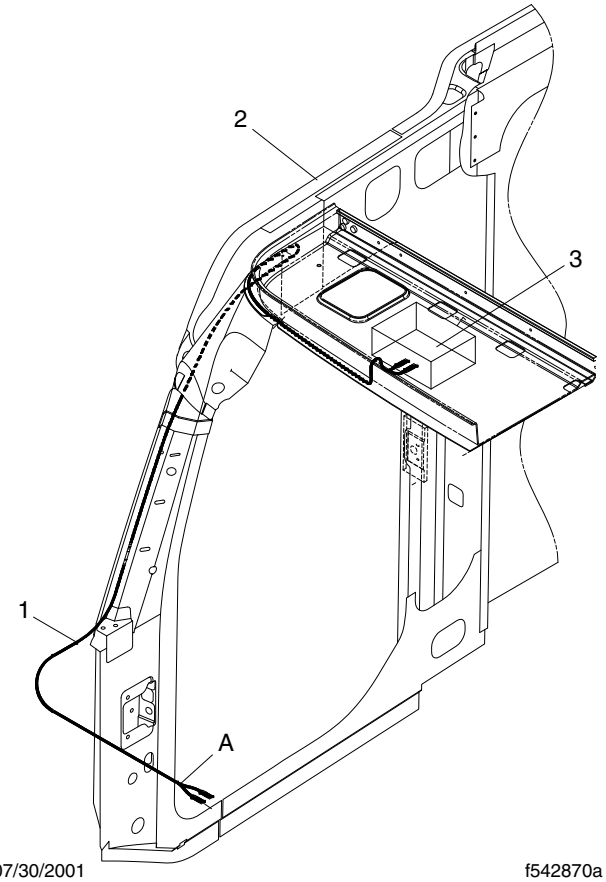
Fig. 17, CD Changer Harness Routing

NOTE: Insure the CD changer harness is properly connected at the radio and the CD changer. See **Fig. 16** and **Fig. 17**
