**Subject:** Improperly Heat-Treated Piston Oil Rings

Hyundai Motor America (Hyundai) is recalling certain 2019-2020 Elantra, 2019-2021 Kona and Veloster vehicles equipped with 2.0L Nu MPI engines. The piston oil rings may not have been properly heat-treated, which could result in engine damage.

**Description:** On certain vehicles listed below, the engine may have been assembled using piston oil rings that were out of specification. This can cause abnormal scuffing of the engine cylinder bores due to chipped piston oil rings which can also result in accelerated engine oil consumption.

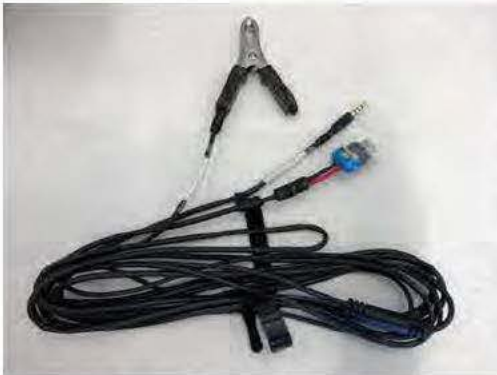
| TOOL NAME | FIGURE / TOOL NUMBER | NOTE |
|---|---|---|
| Engine Vibration Inspection Tool | <br>G1XTD-CP200-QQH | <ul style="list-style-type: none"><li>• This tool will be initially supplied by HMA through MPA. Each dealer will receive one at the start of this recall.</li><li>• A Galaxy tablet device equipped with a headphone / microphone port is required. Certain models without this port (such as the Samsung Galaxy Tab S6) are not compatible to use with this tool. <b>Do not use a USB Type C-to-3.5mm Headphone Jack Adapter.</b></li></ul> |

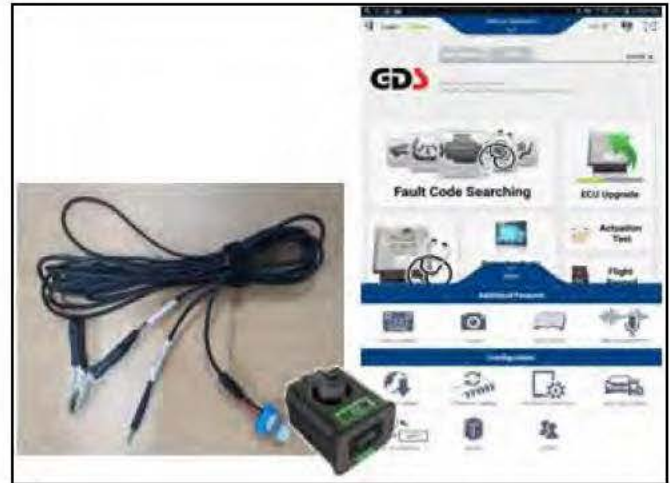
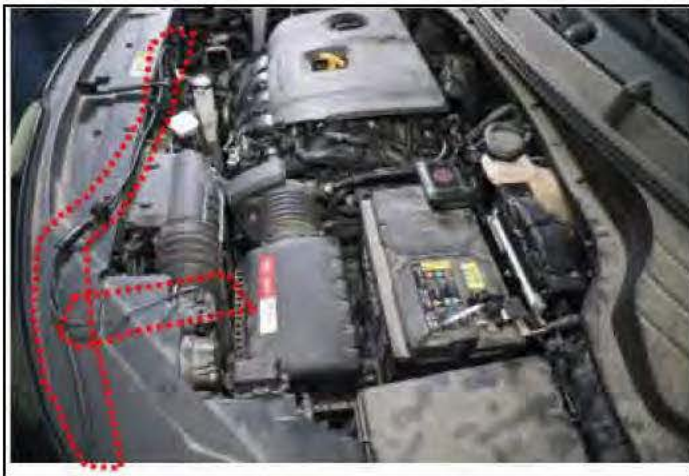
1. Prepare the engine vibration inspection tool and GDS-M.
  - Inspect the vehicle in an area where the ambient noise and vibration levels are minimal.
  - Using the last GDS-M software update, the VCI must be updated with the latest firmware also.
2. Connect the knock sensor connector (A) of the engine vibration inspection tool to the engine knock sensor (D).
3. Connect the ground clamp (B) to the battery '-' terminal.
  - Position the vibration inspection tool harness to avoid interference and vibration from the engine components which may affect the inspection result.
  - Route the wiring harness around the engine compartment as shown below.

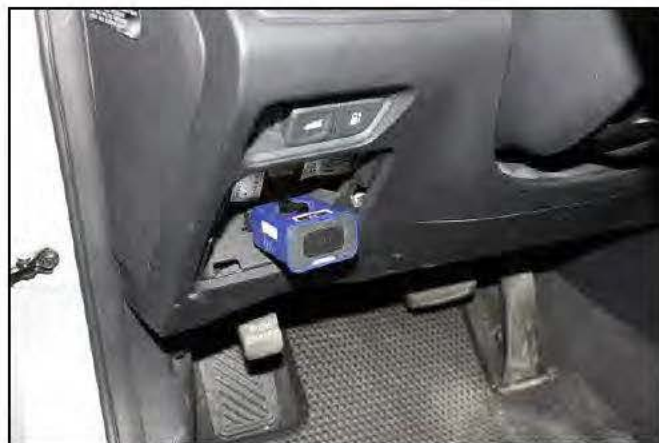
5. Connect the VCI to the vehicle's DLC port and check the Bluetooth pairing condition between the VCI and GDS-M.

- Before pairing: White lamp light
- After pairing: Green lamp light

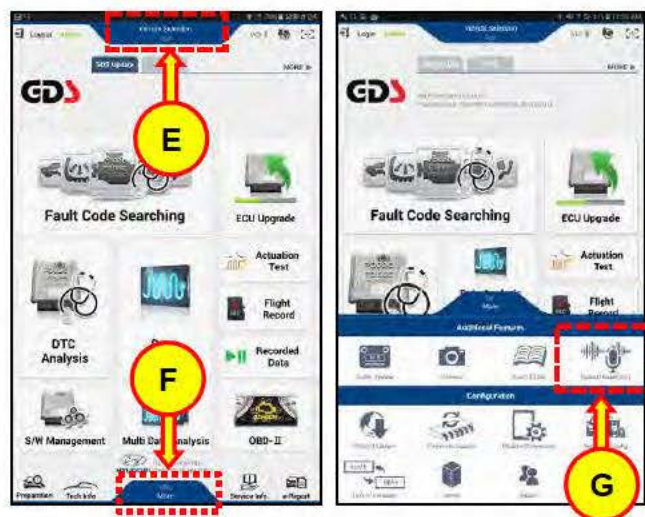
6. Turn the vehicle ignition 'ON' and prepare the GDS for the inspection procedure.

- Enter the vehicle info into the GDS (E).
- Swipe up on the "More" tab at the bottom of the GDS home screen (F).
- Select the **"Special Inspection"** function (G).

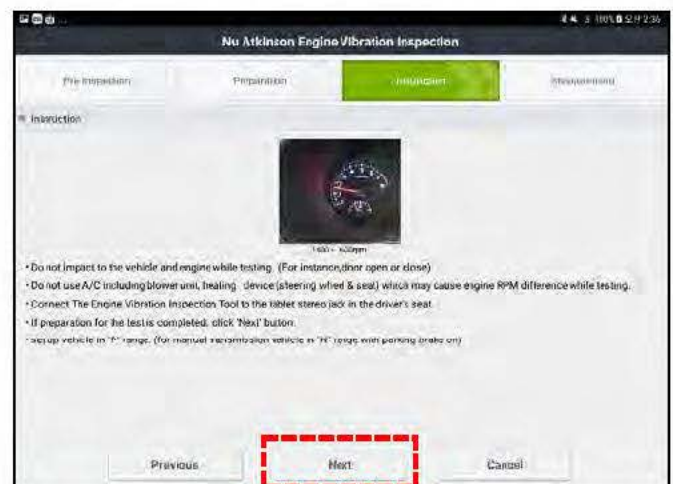
11. After reviewing the vibration inspection process explanation and precautions, press the "Next" button to proceed.
