Subject: X15 CM2350 X114B and X116B Aftertreatment NOx Sensor ATC for Navistar

Number: Atc2060 **Date:** 04-Dec-2018

Aftertreatment Outlet NOx Sensor Cup Clean Procedure.

Aftertreatment Outlet NOx Sensor Cup Drain Hole Installation Procedure.

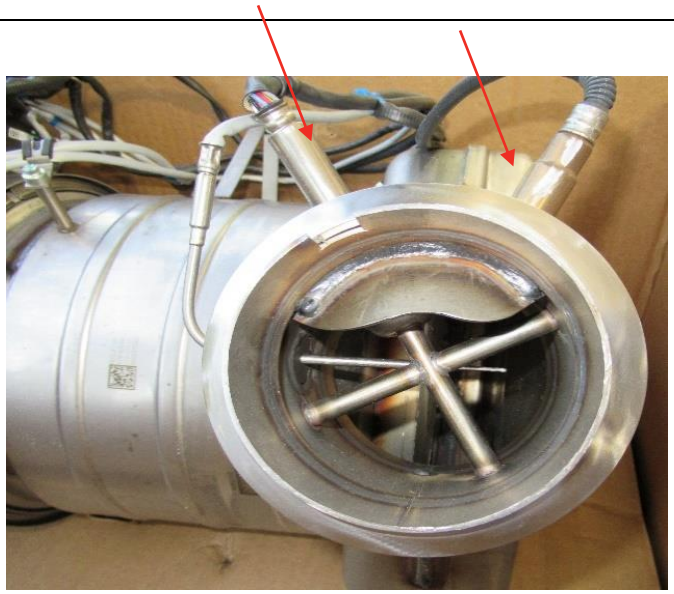
Figure 1

2. Remove outlet sensors shown in **Figure 1** and place them in **a safe place** prior to cleaning the NOx cup.

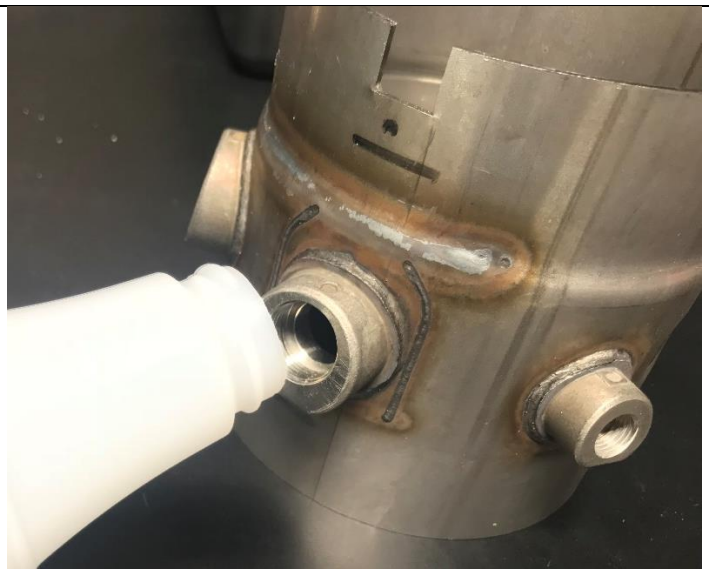
Distilled Water Delivery
Figure 2

5. Use prefer delivery method, dispense distilled water into the NOx cup. Figure 2

7. Using shop air, insert the air chuck into sensor boss to blowout the residuals until dry. (Recommended shop air pressure: 90 to 150 psi.)

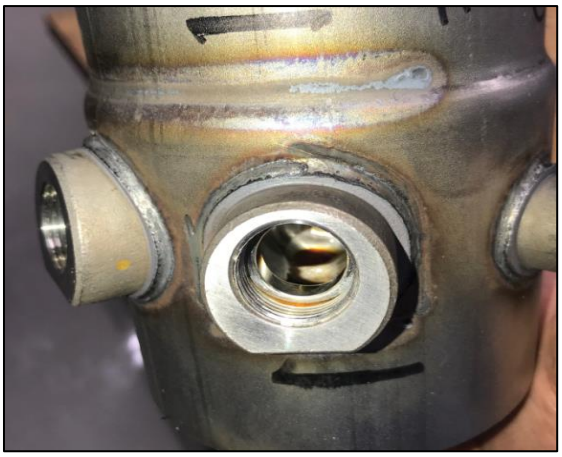
NOx Cup
Figure 1

1. Remove the NOx sensor and place it in **a safe place** prior to drilling the hole and cleaning the NOx cup.
2. Refer to **Aftertreatment Outlet NOx sensor replacement procedure in section Procedure 019-451** in section 19, in the corresponding service manual.
3. Refer to **Aftertreatment Particulate Sensor Procedure 019-478** for the removal of the PM sensor in the corresponding service manual.
4. Refer the attached **Aftertreatment Outlet NOx Sensor Cup Clean Procedure.**

5. Insert bushing into the NOx Cup as seen in **Figure 2**, ensure the guide pins are located on the bottom.

7. Secure the bushing and insert the drill bit into the guide hole.
