SERVICE BULLETIN
SB1573A

ADDRESSEES	:	ABC Customer Care and Parts Source Owners and operators of vehicles mentioned under “Application”
VEHICLE TYPE	:	CX45 with Detroit Diesel DD13 EPA16 engine
CONFIGURATION GROUP	:	8.14 Climate control – Refrigerant system
BULLETIN TYPE	:	Product improvement
DATE	:	December 12th, 2018
SUBJECT	:	**Introduction of longer refrigerant compressor discharge hose**
CONDITIONS	:	This service bulletin does not entitle to any reimbursement.

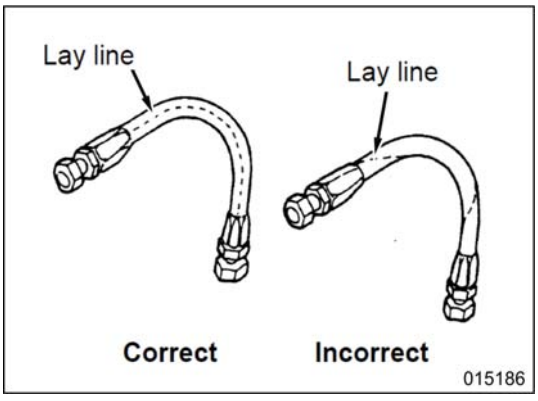
Figure 1

A flexible metal hose assembly is a durable component, which minimizes vibration to be transmitted from the compressor to the piping. However, improper storage, handling, and installation can easily damage it. The flexibility in the hose is provided by thin wall tubing, much thinner than that used for straight tubing of the same nominal dimension. Storage or handling conditions, which may crush, dent, permanently deform, or damage the hose or the braid must be avoided.

- Do not twist or bend assemblies prior to the installation.
- Do not allow the braid to be broken, pulled out of position, or otherwise damaged.
