RE: NHTSA Recall No.: 26V067 - Possible (likely) secondary cause

**TECHNICAL BULLETIN**

Air Conditioning (A/C) Inoperative

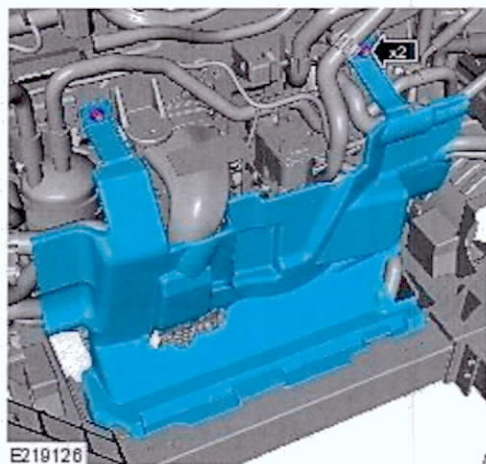
3.

Remove the cover.

- Remove the 2 nuts.
  - Torque: **10 Nm**

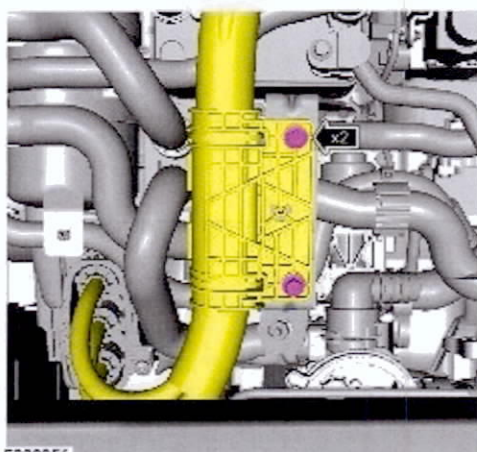
4.

Reposition the High Voltage (HV) harness away from the bracket.

- Remove the 2 bolts.
- Torque: **10 Nm**

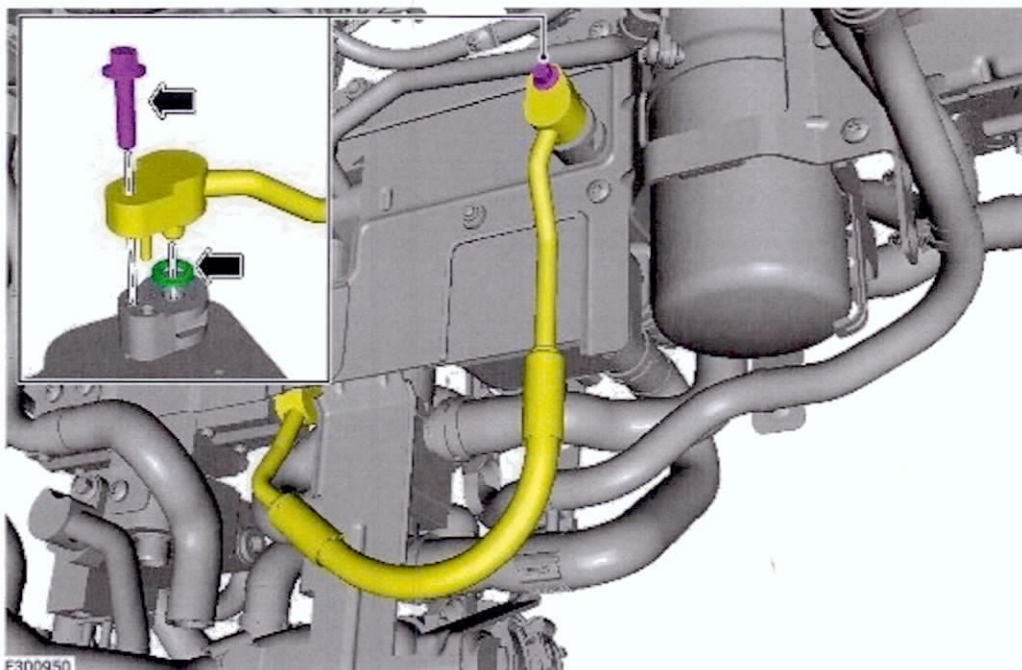
5.

A new O-ring must be installed during installation.

Disconnect the A/C pipe.

- Remove the bolt.
- Torque: **12 Nm**

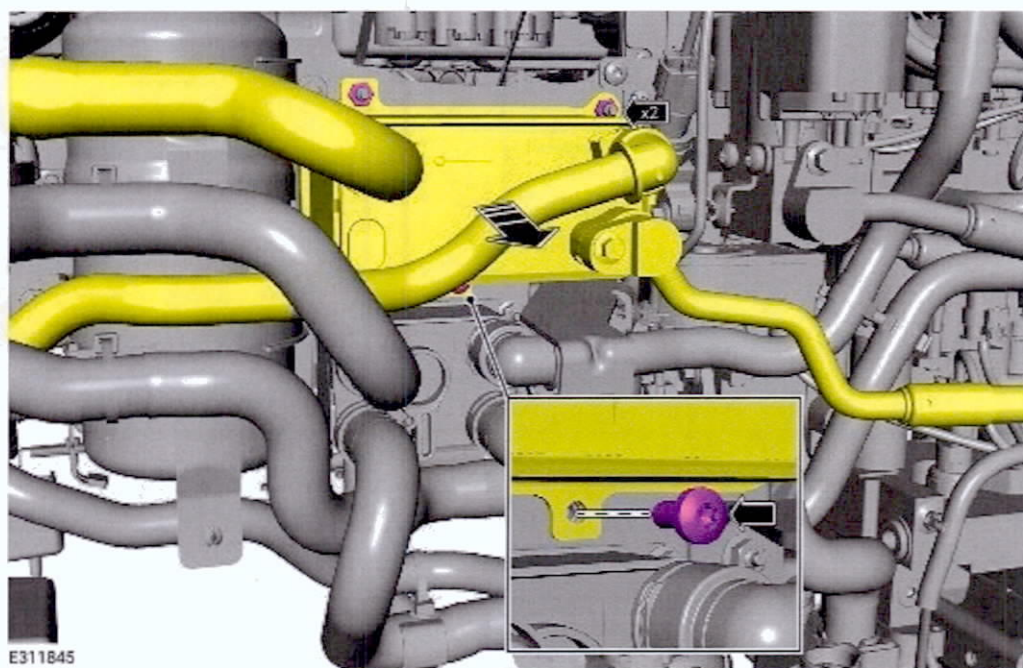
6.

Reposition the indirect condenser away from the bracket.

- Remove the 2 nuts.
  - Torque: **10 Nm**
- Remove the bolt.
  - Torque: **12 Nm**

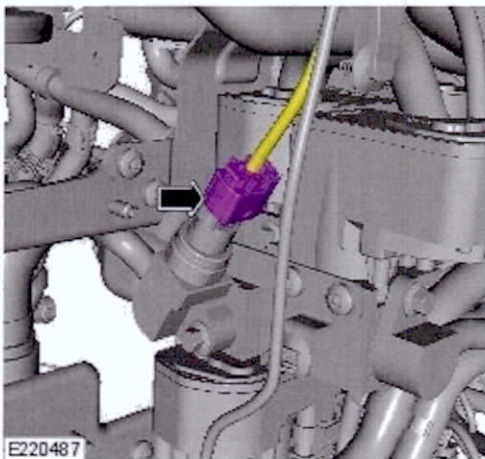
7.

Disconnect the electrical connector from the A/C HP temperature sensor.

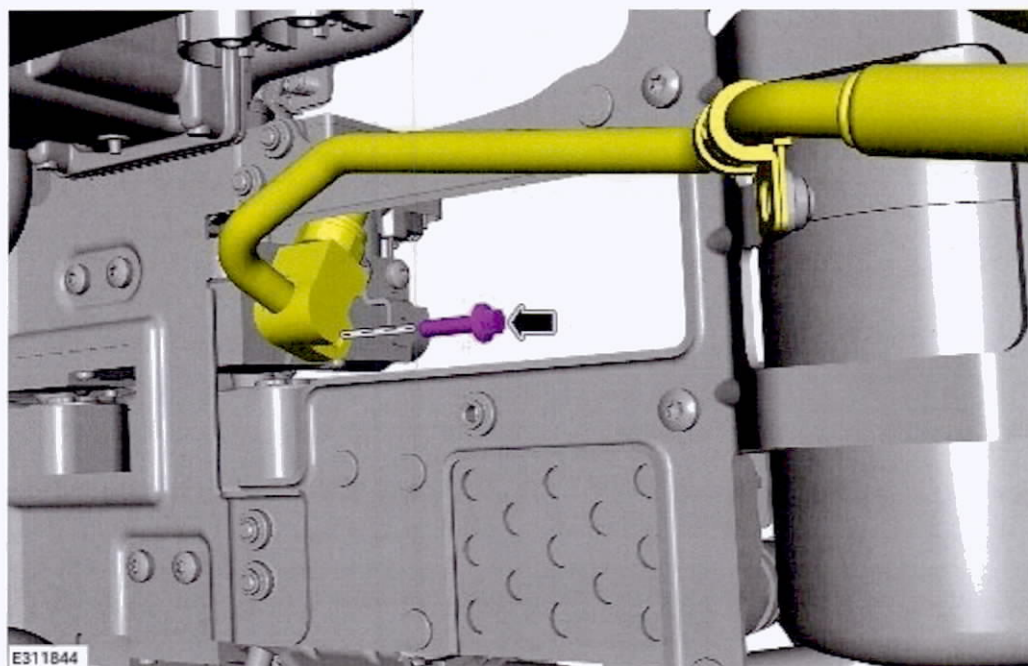
8.

Disconnect the A/C pipe.

- Remove the bolt.
- Torque: **12 Nm**

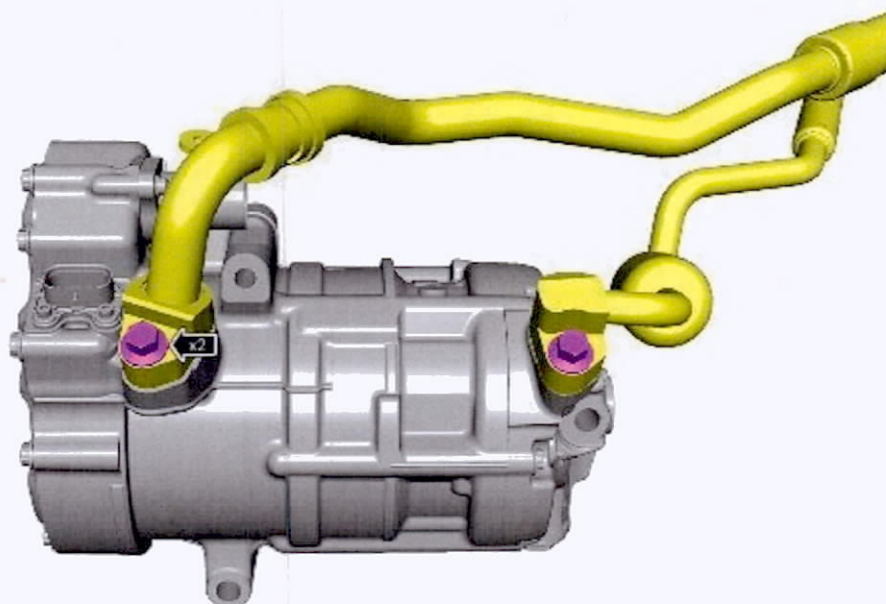
9.

Disconnect both A/C pipes from the A/C compressor.

- Remove the 2 bolts.
- Torque: **24 Nm**

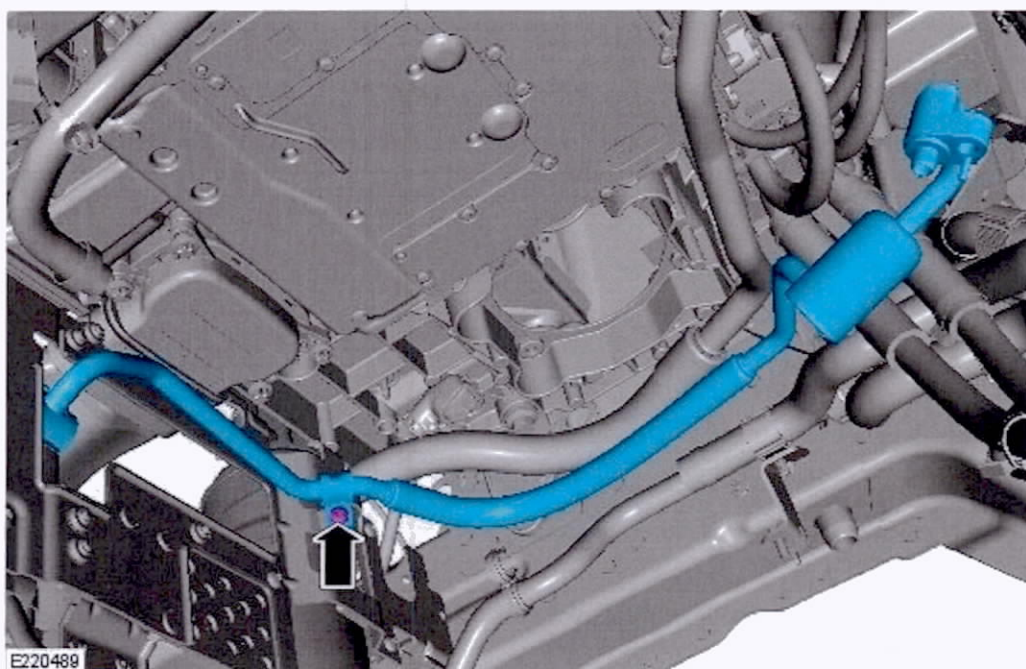
10.

Remove the A/C compressor HP pipe.

- Remove the bolt.
- Torque: **8 Nm**

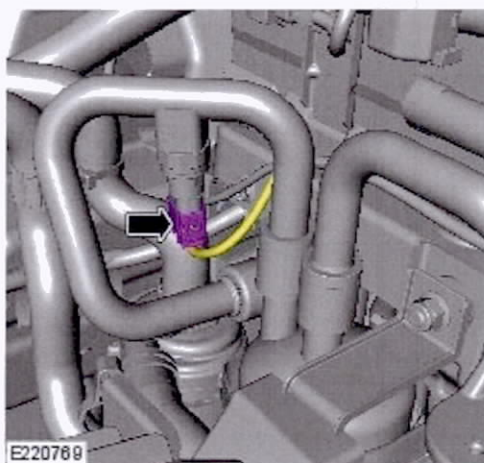
11.

Disconnect the electrical connector from the A/C temperature and pressure sensor.

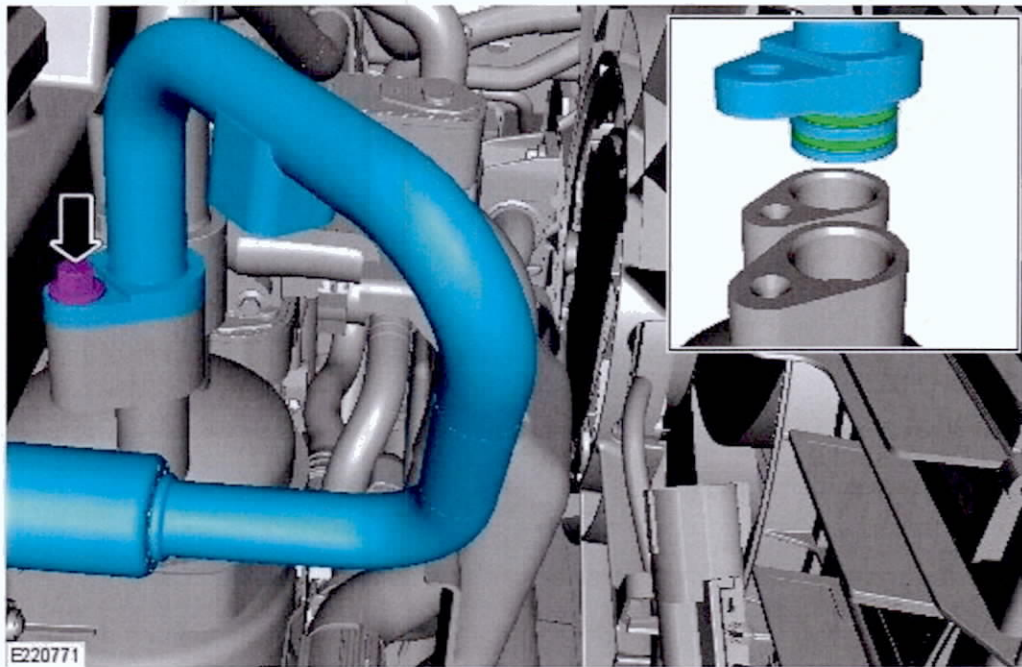
12.

Disconnect the A/C compressor LP inlet pipe from the accumulator and remove the pipe.

- Remove the bolt.
- Torque: **10 Nm**
