SERVICE BULLETIN

M1522 **2021-02-16**

M1522: 2021 TOURING - POWER OUTLET - PINNED INCORRECTLY

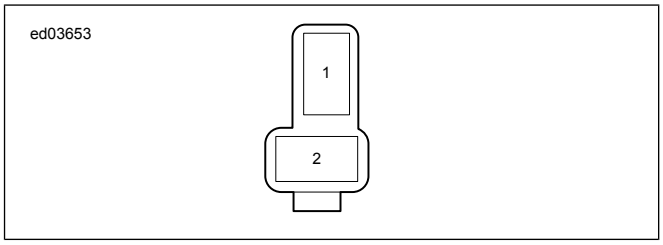
Figure 1. Front Power Outlet [132B]

This bulletin is to notify Dealers that the inner fairing front power outlet [132B] on certain 2021 Touring, Touring Police and Trike Models may have been pinned incorrectly.

a. See Figure 1. Visually check to verify the correct wire location. Refer to Table 3.

3. **If wiring is incorrectly pinned:** Remove wiring and install into correct terminals. See the Electrical Diagnostic Manual (EDM).
